Diagnosis report of 2019 OPEL ASTRA Business+

Diagnosis details

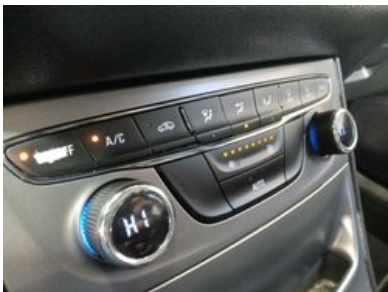
- ✔ **1. Operation:** Heating System - Functioning

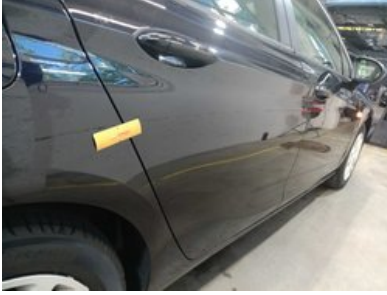
✔ **1. Side:** Left and Right Side - Visual Damage and Scratches

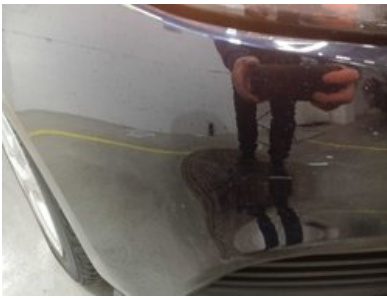
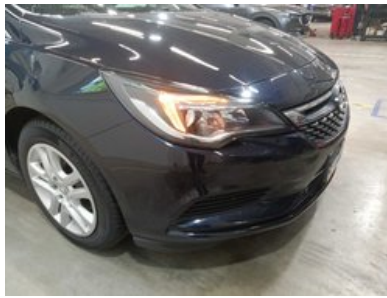
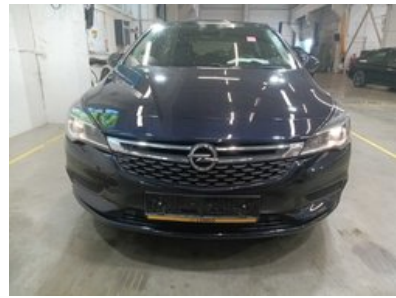
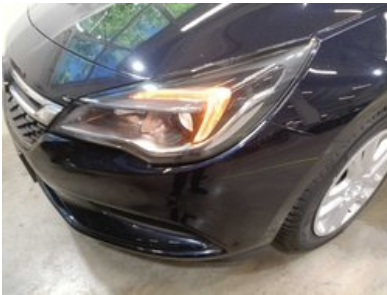
✔ **2. Front:** Front Bumper - Condition and Alignment

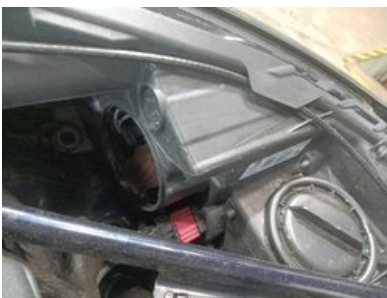
✔ **3. Lights:** Front Lights (City, Regular, Full Headlight, Fog, Indicator) - Basic Functioning, Damage, and Color

- ✓ 1. Change Light Covers

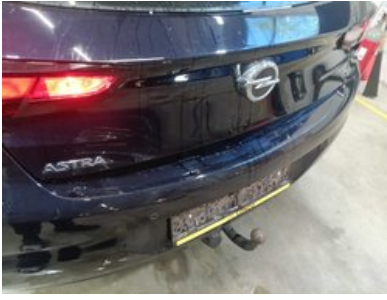
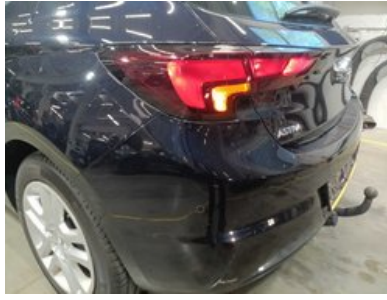
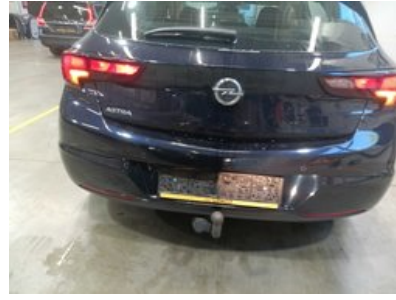
✓ **4. Rear:** Rear Bumper - Condition and Alignment

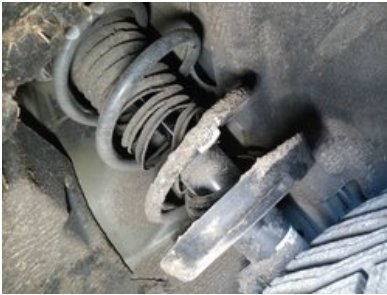
✓ **1. SUSPENSION:** Strut Assembly (Both)

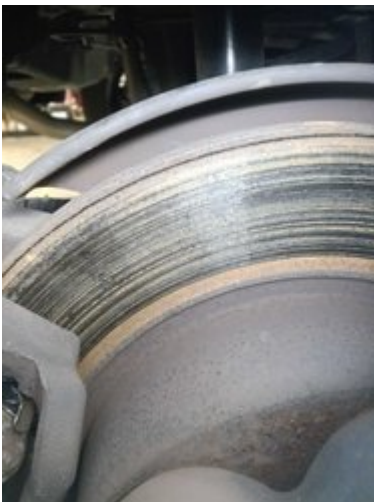
✓ **2. BRAKES:** Rear Brake Disc (Both)

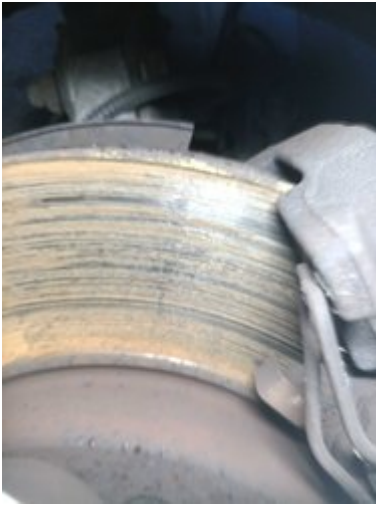
✔ **3. BRAKES:** Front Brake Discs Both
