# Diagnosis report of 2017 PEUGEOT 2008 Lion

# Preparation and repair report of 2017 PEUGEOT 2008 Lion

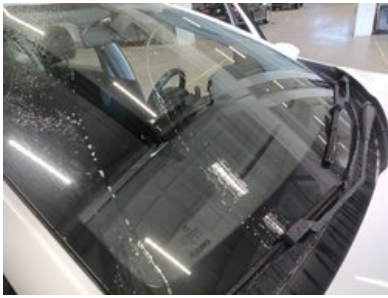
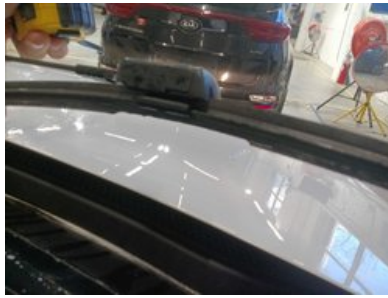
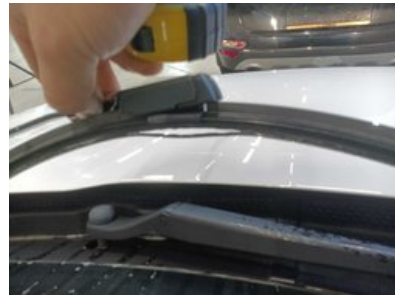
- ✓ **1. Front:** Window Wiper Rubber and Handle (Front and Rear) - Condition

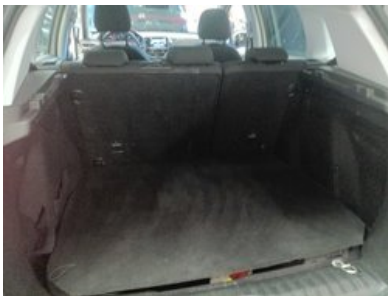
- ✓ **2. Inside:** Parcel Shelf - Operation and Condition

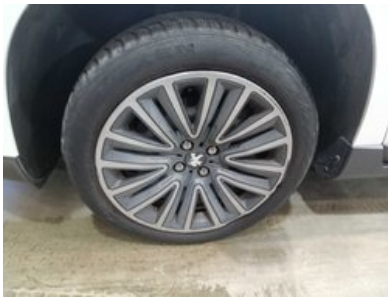
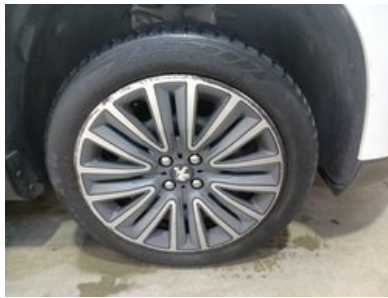
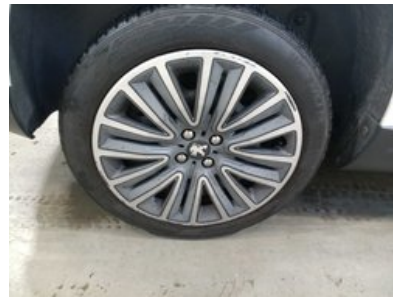
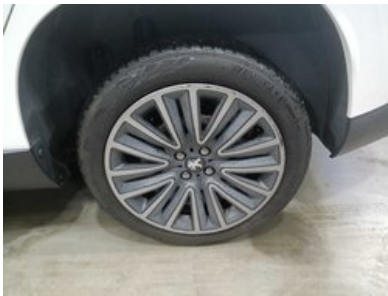
✓ **2. Side: Wheels - Condition**

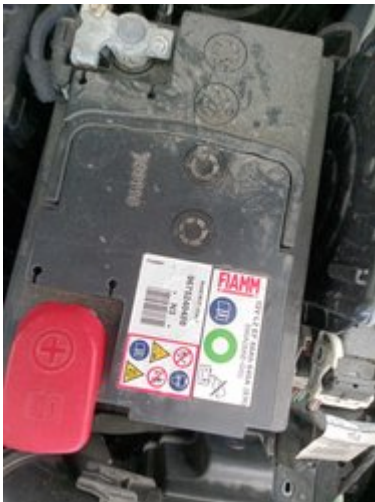
✓ **1. GENERAL ELECTRICS: Battery**

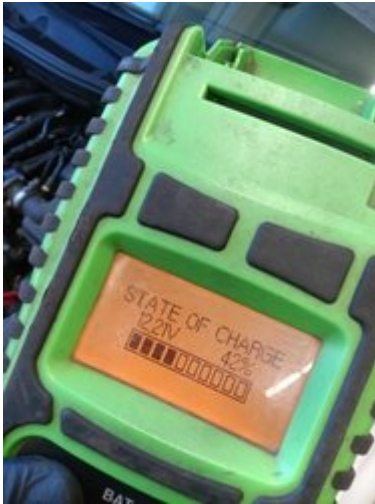
✓ **2. OTHER:** Charge Battery

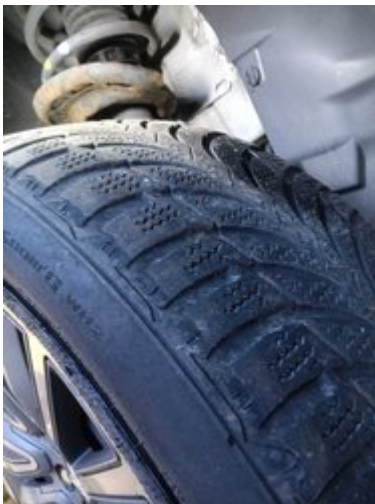
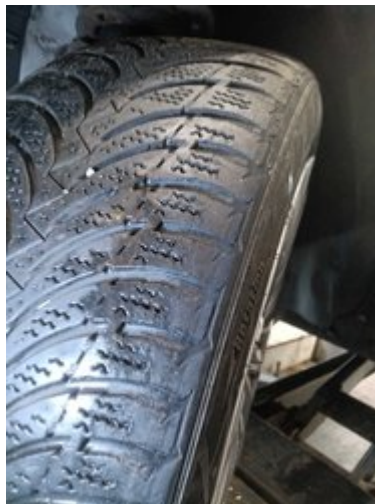
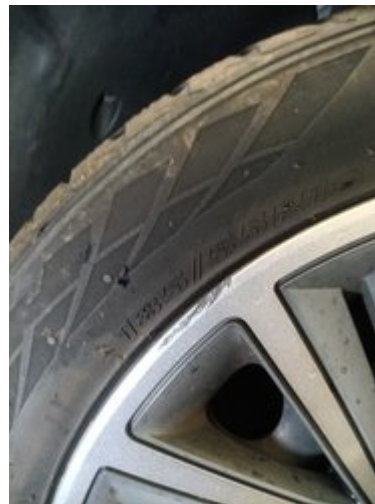
✓ **4. OTHER:** Change Tires

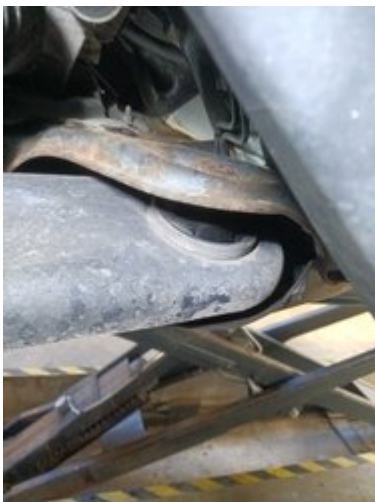
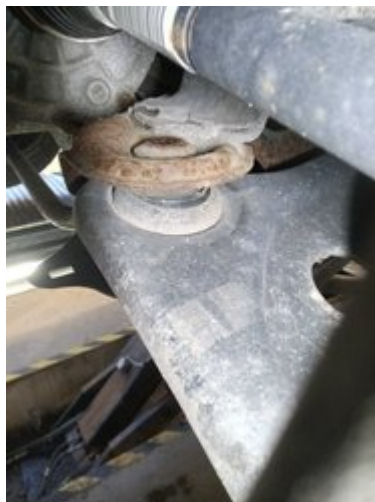
✓ **5. SUSPENSION:** Suspension Lower Arm Both

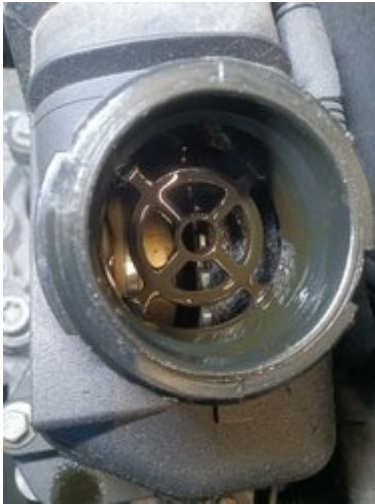
✓ **6. ENGINE:** Camshaft Drive Belt

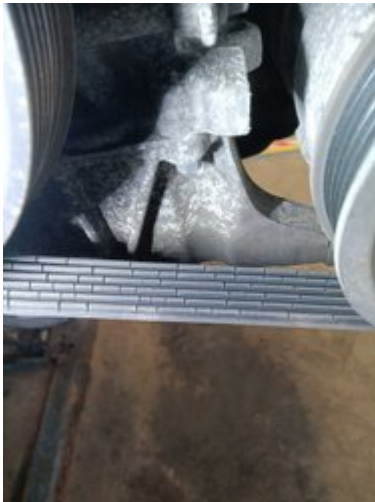
✓ **7. ENGINE:** Auxiliary Drive Belt
