# Diagnosis report of 2018 TOYOTA C-HR Executive

# Preparation and repair report of 2018 TOYOTA C-HR Executive

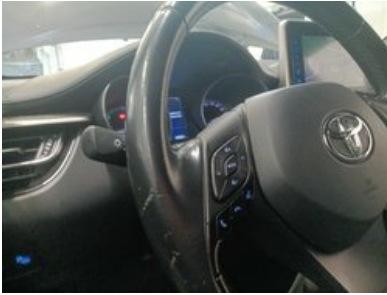
### ✓ 1. Front: Steering Wheel - Condition

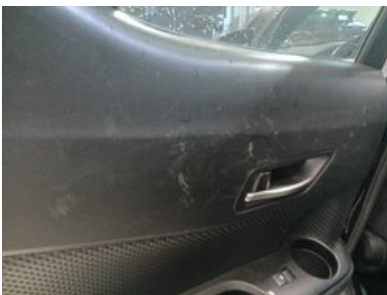
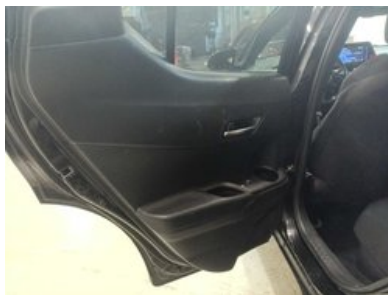
### ✓ 2. Doors: Trims - Condition

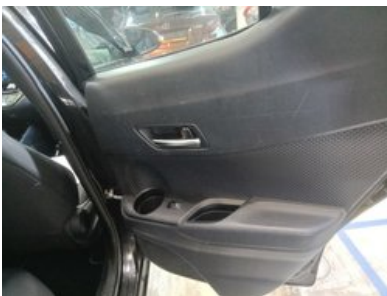
### ✓ 3. Doors: Trims - Condition

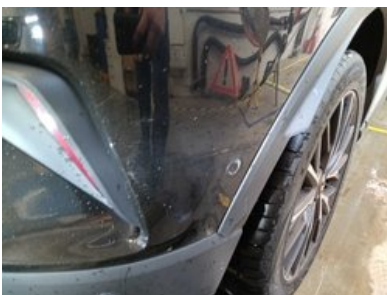
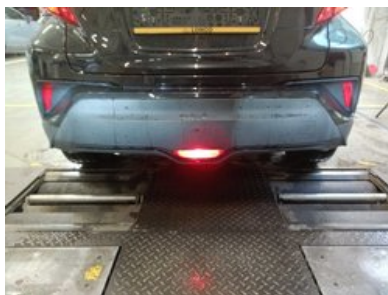
### ✓ 2. Rear: Rear Bumper - Condition and Alignment

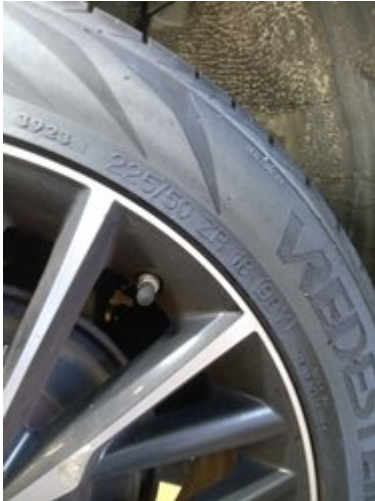
### ✓ 1. OTHER: Change Tires

- ✓ 1. Change Tires

- 1. Bridgestone 225/50R18 Summer Tire (BRIDGESTONE 225/50R18 SUMMER)

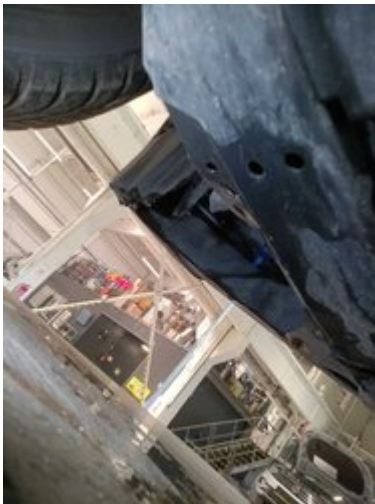
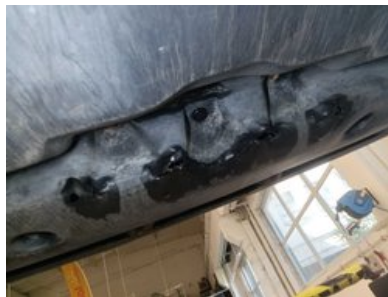
### ✓ 2. BODY - FRONT SECTION: Damage

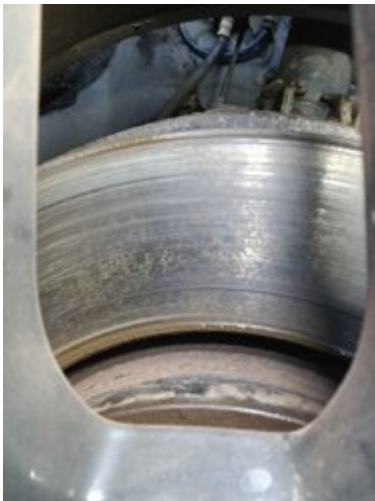
### ✓ 3. BRAKES: Front Brake Discs Both
