# Diagnosis report of 2021 PEUGEOT 2008 Active

# Preparation and repair report of 2021 PEUGEOT 2008 Active

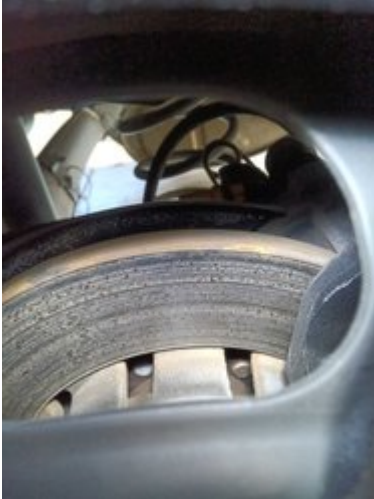
### ✓ 1. BRAKES: Rear Brake Disc (Both)
