# Diagnosis report of 2020 PEUGEOT 5008 GT-Line

## Summary of diagnosed issues

During the comprehensive diagnosis conducted by Longo, 12 issues were identified in the vehicle.

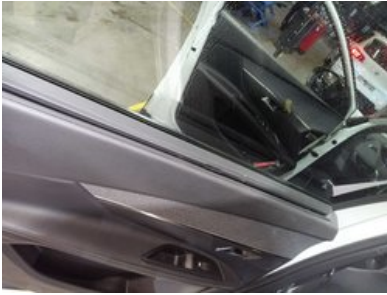
### ✓ 1. Doors: Electronic Window Operation - All Windows

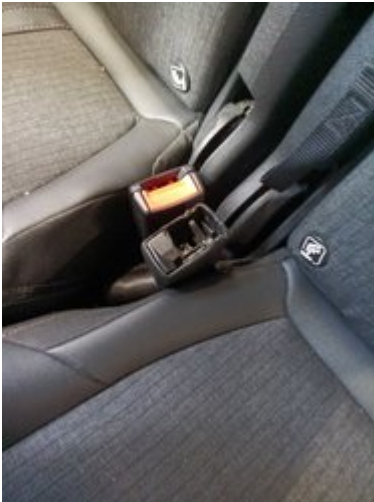
### ✓ 2. Seats: Seatbelts - Functioning and Locking Mechanism

- ✓ 1. Change Seatbelts / Mountings
- ✓ 2. Paintless Dent Repair

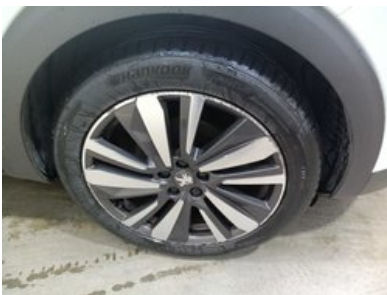
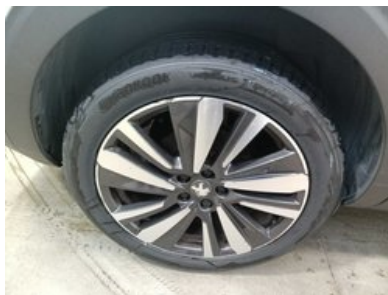
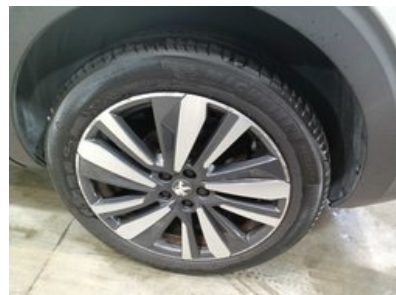
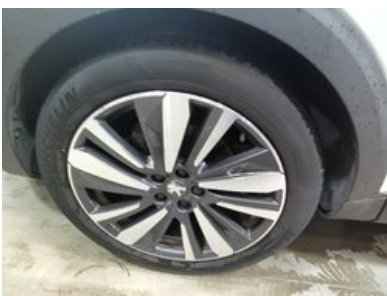
### ✓ 1. Side: Wheels - Condition

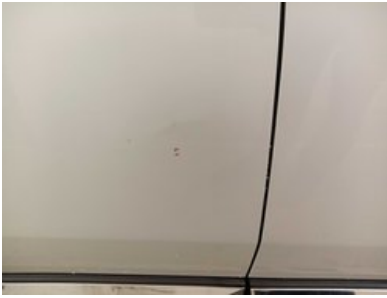
✓ **2. Side:** Left and Right Side - Visual Damage and Scratches

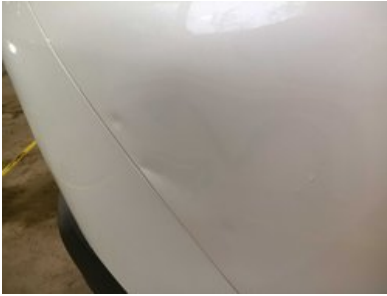
✓ **3. Side:** Left and Right Side - Visual Damage and Scratches

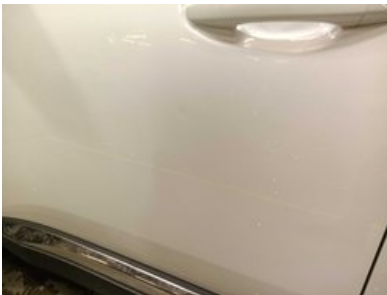
✓ **4. Side:** Left and Right Side - Visual Damage and Scratches

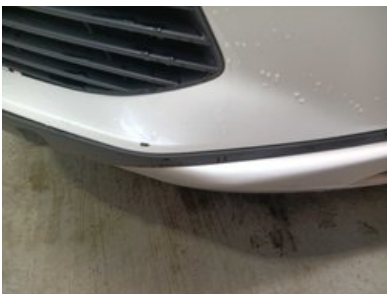
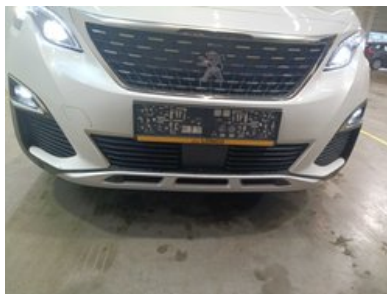
✓ **5. Front:** Front Bumper - Condition and Alignment

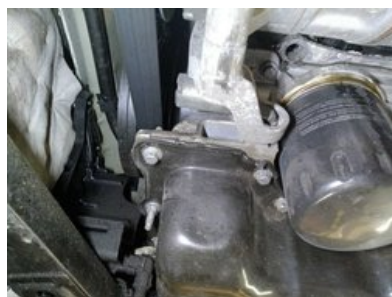
### ✓ 3. OTHER: Oil Pan

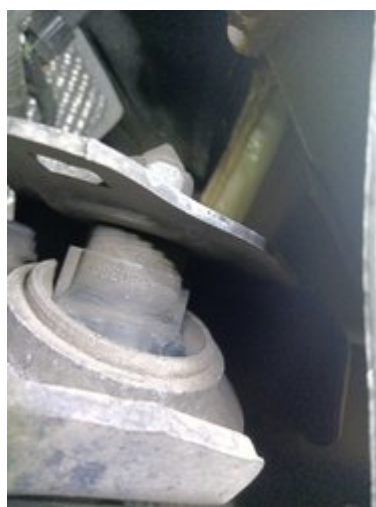
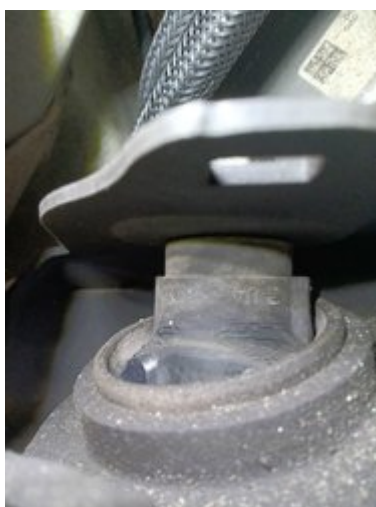
### ✓ 5. OTHER: Suspension Lower Arm
