# Diagnosis report of

## 2015 VOLKSWAGEN GOLF 7 GTE

Diagnosis report of

2015 VOLKSWAGEN GOLF 7 GTE

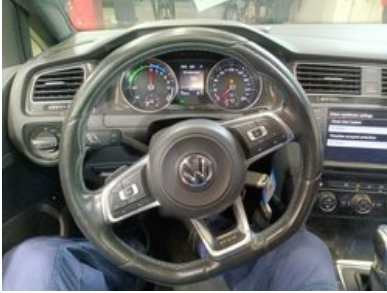
### ✓ 1. Front: Steering Wheel - Condition

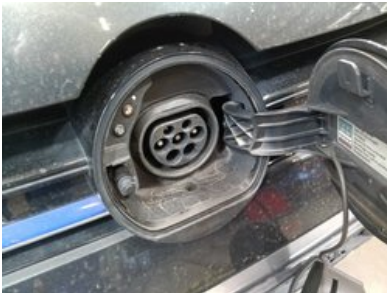
### ✓ 2. Inside: Accessories - Functioning and Condition

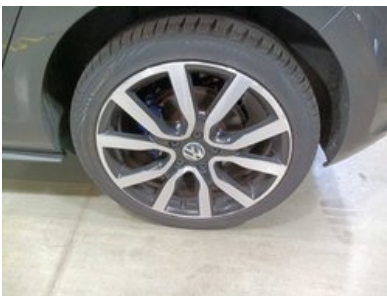
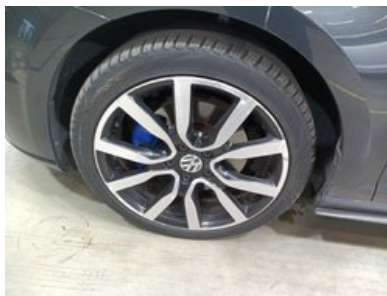
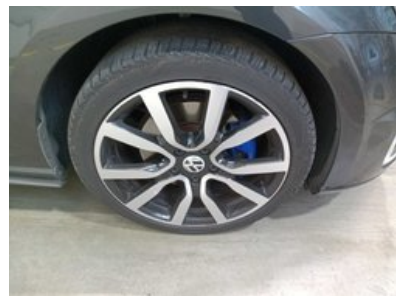
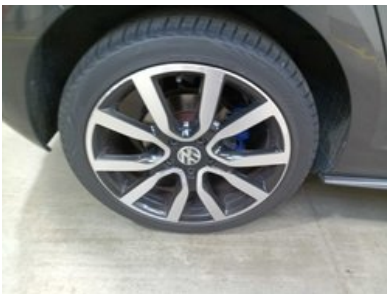
### ✓ 1. Side: Wheels - Condition

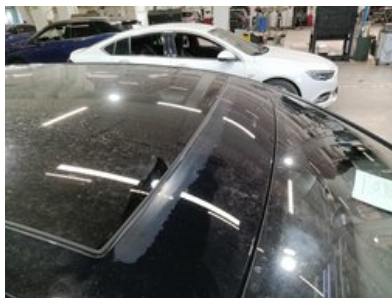
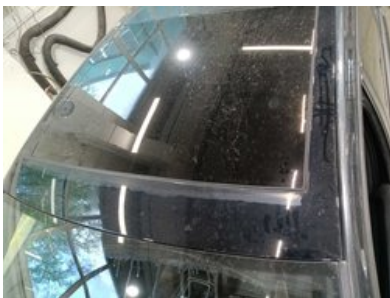
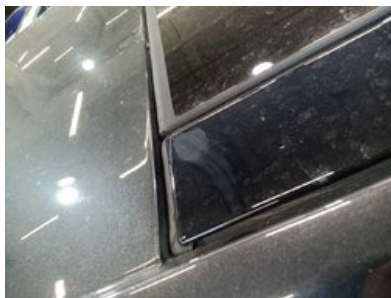
✔ **2. Other:** Roof - Visual Damage (e.g., Hail Damage)

- ✓ 1. Paint Roof

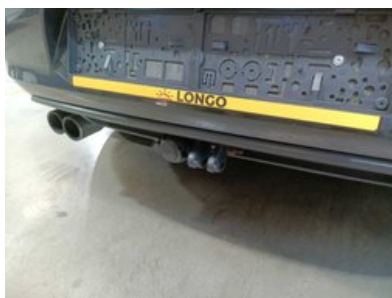
✔ **3. Rear:** Tow Hitch (Attachment, Removal Mechanism, External Light Connector, Connector Thickness)

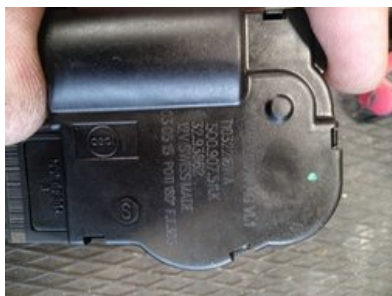
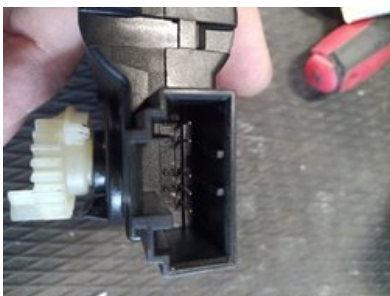
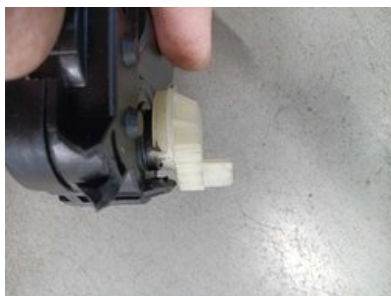
✔ **1. GENERAL ELECTRICS:** Throttle Actuator

- ✓ 1. Throttle Actuator Motor
- ✓ 2. Engine Oil & Filter Change
- ✓ 3. Hybrid Charging Cable

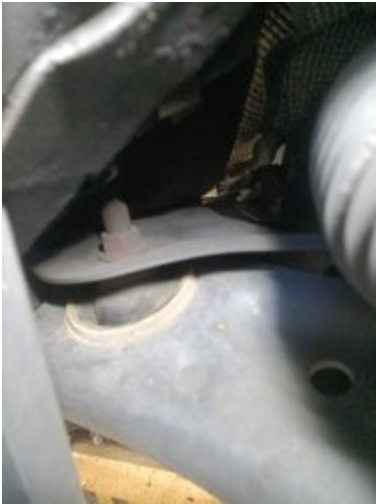
✔ **3. SUSPENSION:** Suspension Lower Arm Rear Bush LH
