# Diagnosis report of 2017 OPEL MERIVA Blitz

# Preparation and repair report of 2017 OPEL MERIVA Blitz

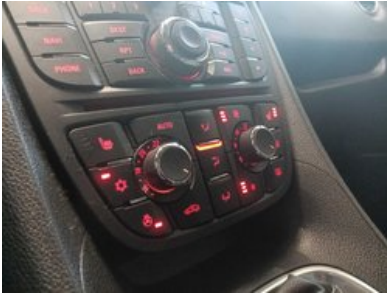
- ✓ **1. Operation:** Seat Heating System - Functioning (Driver and Passenger)

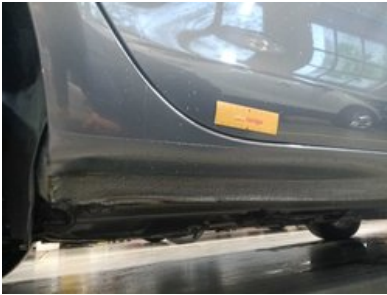
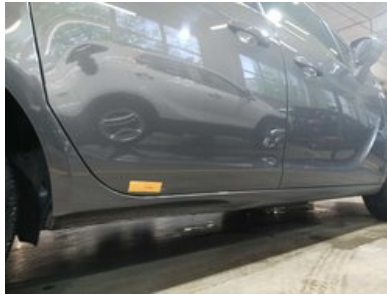
- ✓ **1. Side:** Left and Right Side - Visual Damage and Scratches

- ✓ 1. Paint Door
- ✓ 2. Paint Rear Fender
- ✓ 3. Paint Sill

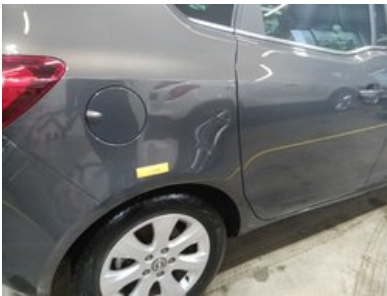
- ✓ **2. Side:** Left and Right Side - Visual Damage and Scratches

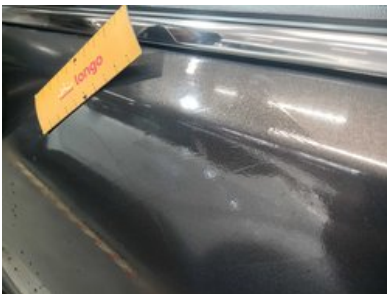
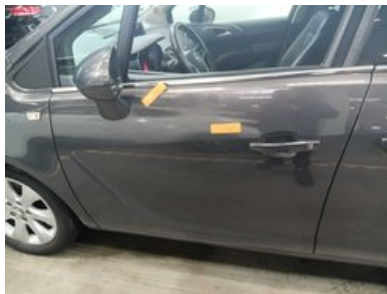
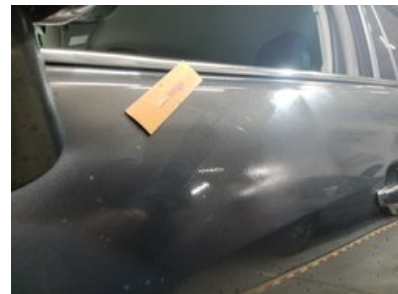
- ✓ **3. Side:** Left and Right Side - Visual Damage and Scratches

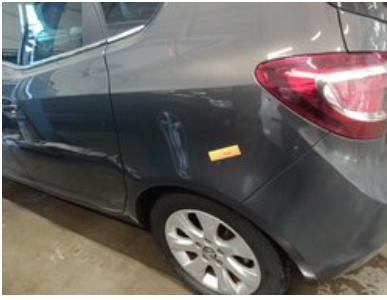
✓ **4. Side:** Left and Right Side - Visual Damage and Scratches

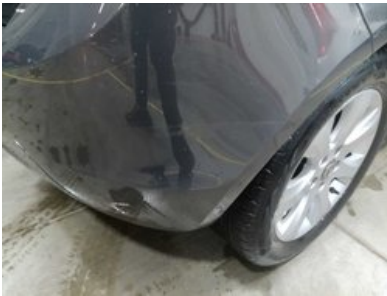
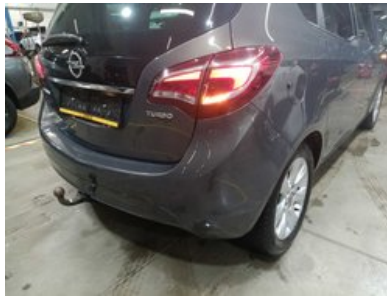
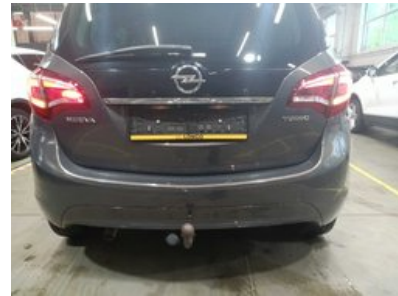
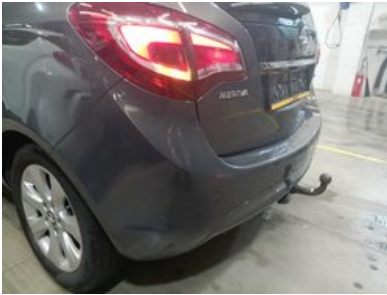
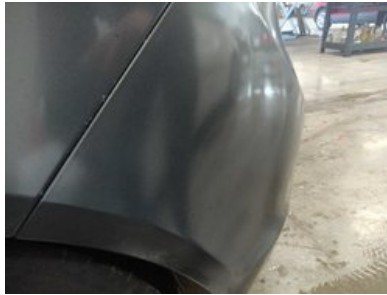
✓ **5. Rear:** Rear Bumper - Condition and Alignment
