# Diagnosis report of 2021 PEUGEOT 2008 Active

# Preparation and repair report of 2021 PEUGEOT 2008 Active

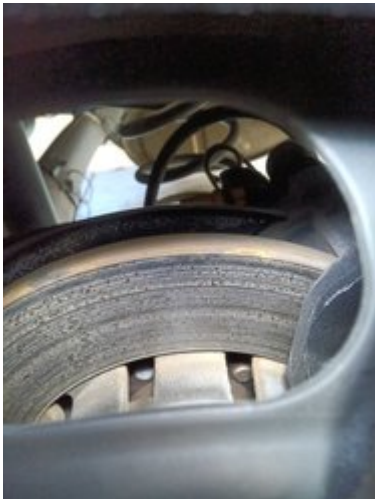
### ✓ 1. BRAKES: Rear Brake Disc (Both)

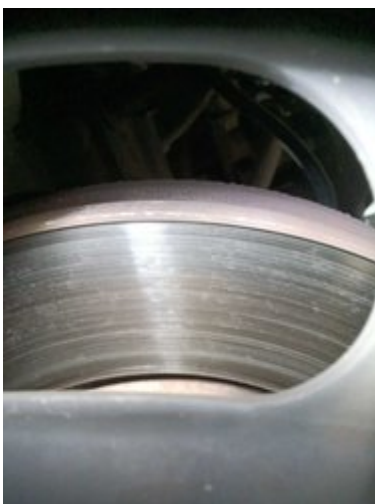
### ✓ 2. BRAKES: Front Brake Discs Both

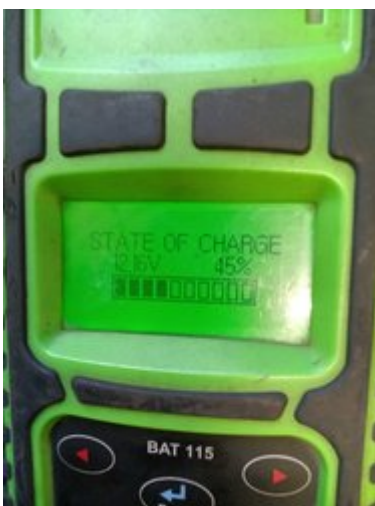
### ✓ 3. OTHER: Charge Battery

- ✓ 1. Engine Oil & Filter Change
- ✓ 2. Charge Battery

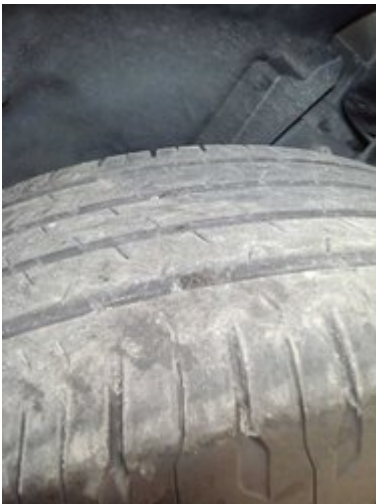
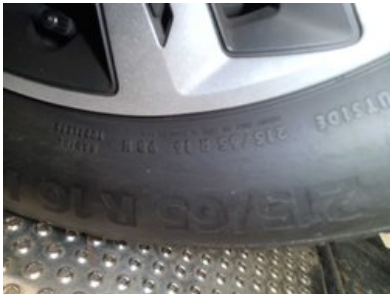
5. OTHER: Change Tires
