# Diagnosis report of 2021 PEUGEOT 2008 Active

# Preparation and repair report of 2021 PEUGEOT 2008 Active

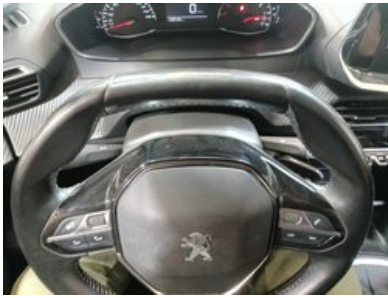
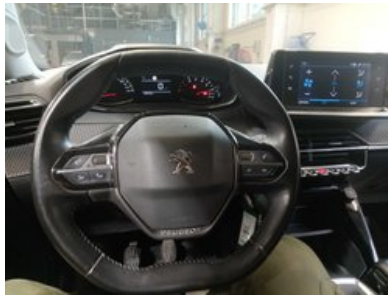
### ✓ 1. Front: Steering Wheel - Condition

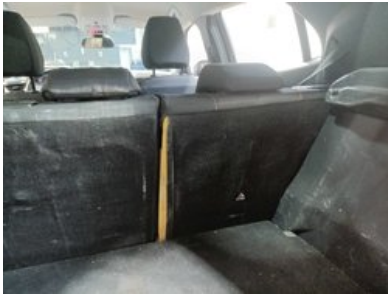
### ✓ 2. Seats: All Seats - Condition

- ✓ 1. Change Bumper Grills
- ✓ 2. Headlamp Alignment
- ✓ 3. Repair Seat

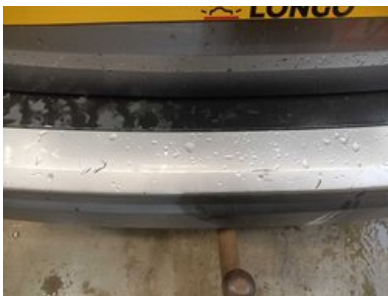
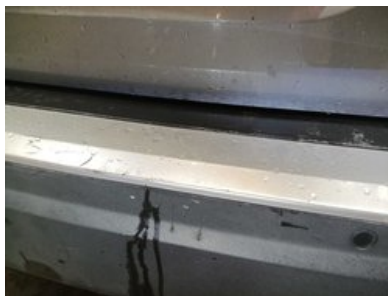
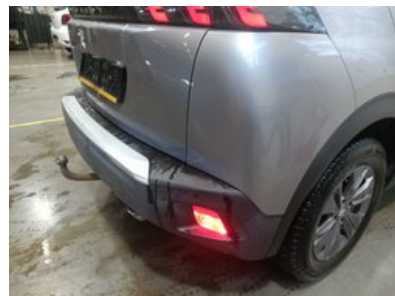
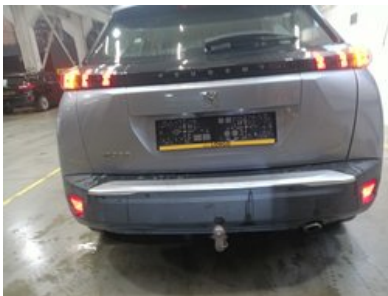
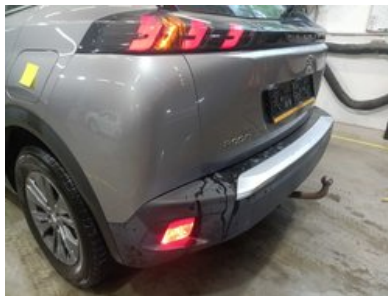
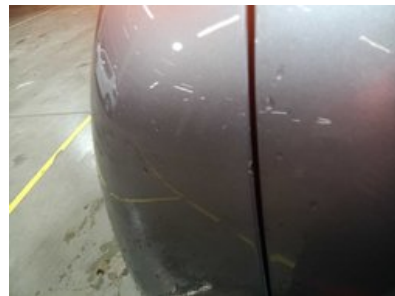
### ✓ 1. Rear: Rear Bumper - Condition and Alignment

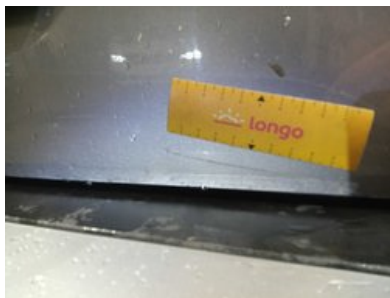
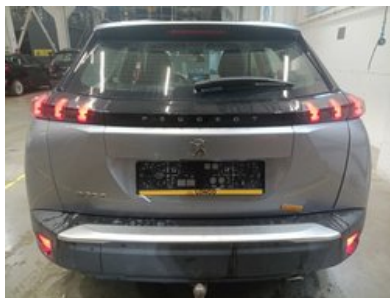
✓ **2. Rear:** Trunk - Visual Damage

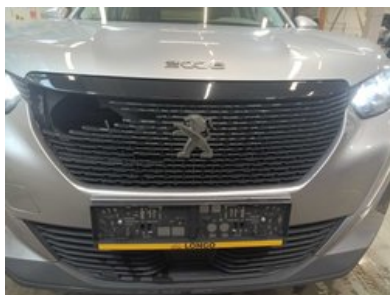
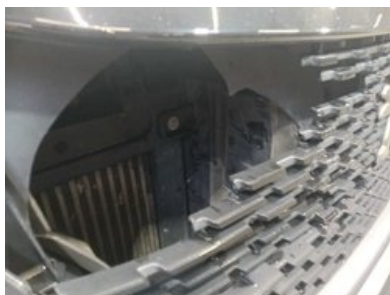
✓ **3. Front:** Front Grille - Condition

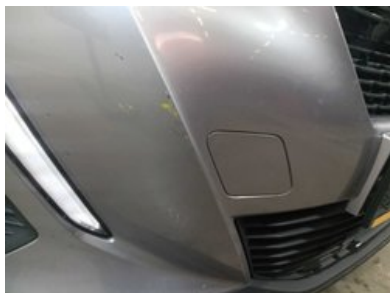
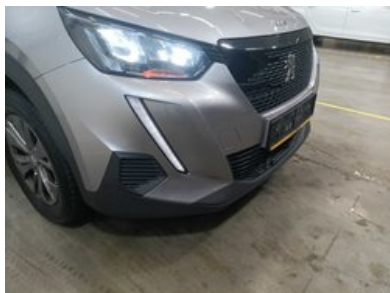
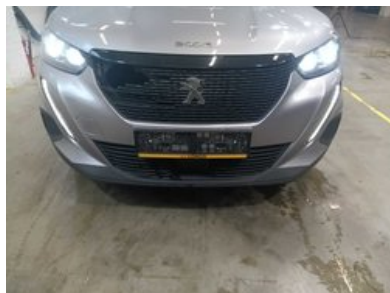
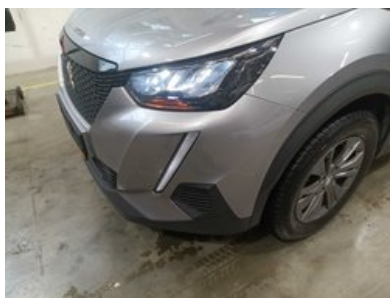
✓ **4. Front:** Front Bumper - Condition and Alignment

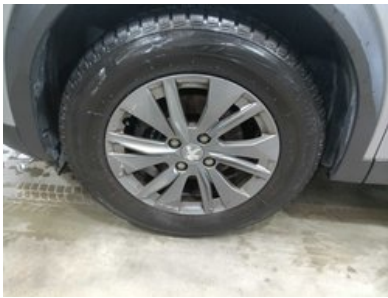
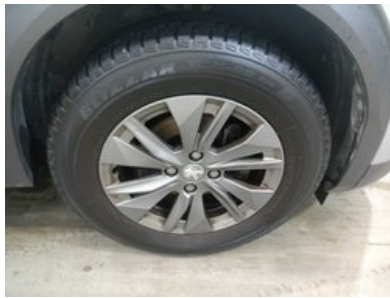
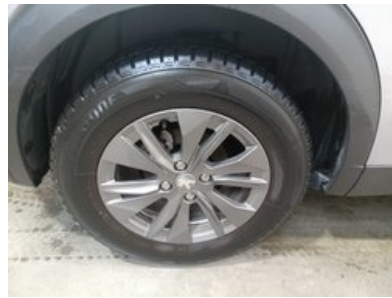
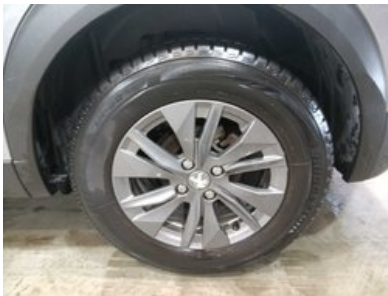
✓ **5. Side:** Wheels - Condition

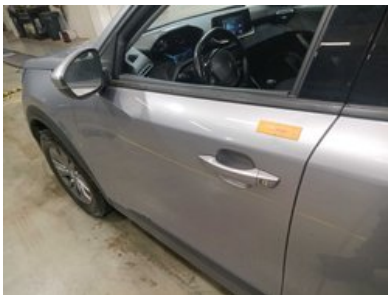
✓ **6. Side:** Left and Right Side - Visual Damage and Scratches

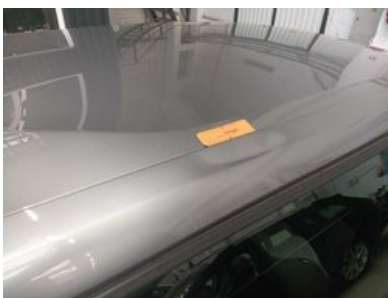
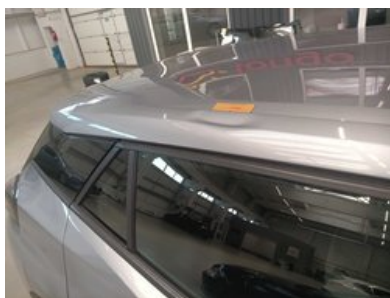
✓ **7. Side:** Left and Right Side - Visual Damage and Scratches

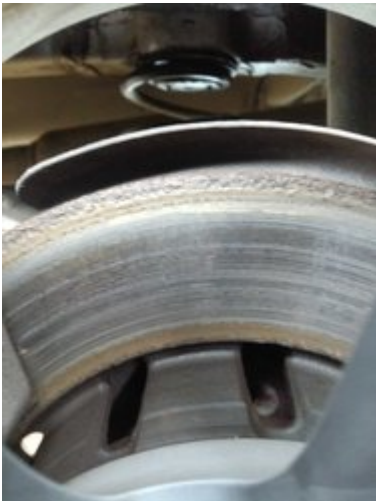
1. BRAKES: Rear Brake Disc (Both)
