# Diagnosis report of 2015 OPEL ZAFIRA TOURER Business+

## Diagnosis details

# Preparation and repair report of 2015 OPEL ZAFIRA TOURER Business+

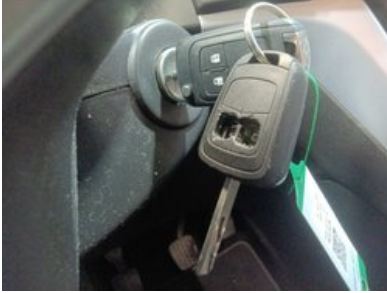
✓ **1. Inside:** Accessories - Functioning and Condition

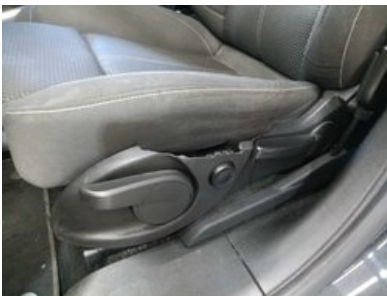
✓ **2. Seats:** All Seats - Condition

- ✓ 1. Change Seat Side Plastic

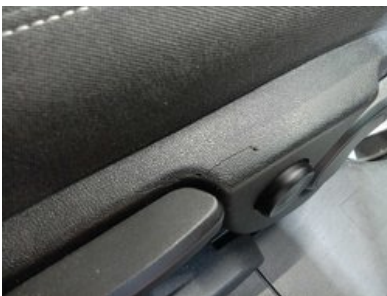
✓ **3. Seats:** All Seats - Condition

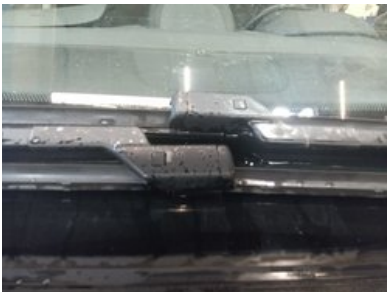
✓ **4. Front:** Window Wiper Rubber and Handle (Front and Rear) - Condition

- ✓ 1. Glow Plugs
- ✓ 2. Socket
- ✓ 3. Change Front Wiper (Mechanical)
- ✓ 4. Engine Oil & Filter Change
- ✓ 5. Front Brake Pads (All) — Wheels Removed
- ✓ 6. Particulate Matter Sensor

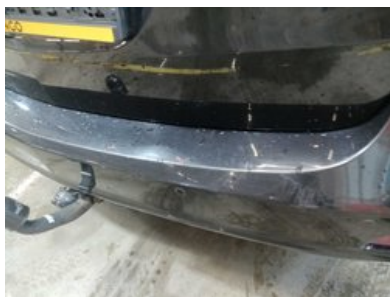
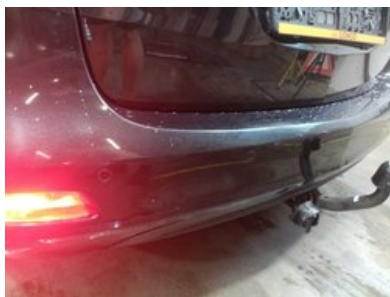
- ✓ **1. Rear:** Rear Bumper - Condition and Alignment

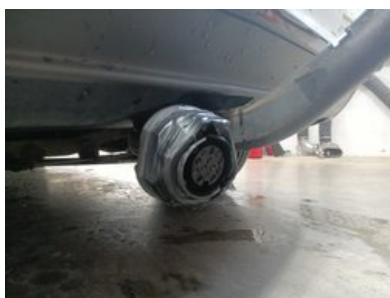
- ✓ **2. Rear:** Tow Hitch (Attachment, Removal Mechanism, External Light Connector, Connector Thickness)

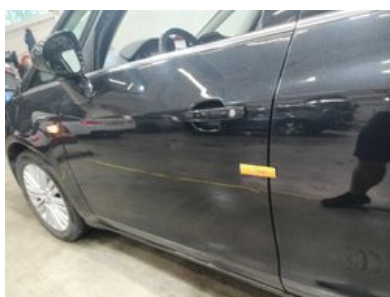
- ✓ **3. Side:** Left and Right Side - Visual Damage and Scratches

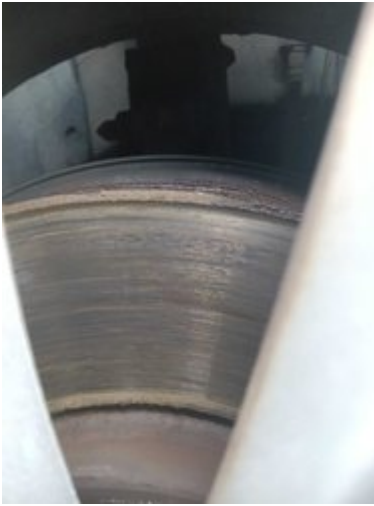
✓ **3. BRAKES:** Front Brake Discs Both (Pads Removed)

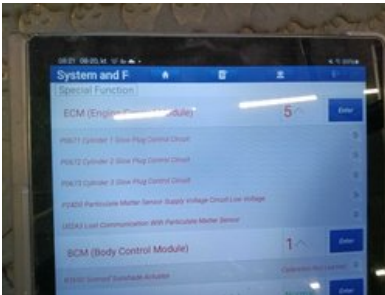
✓ **4. ENGINE:** Glow Plugs

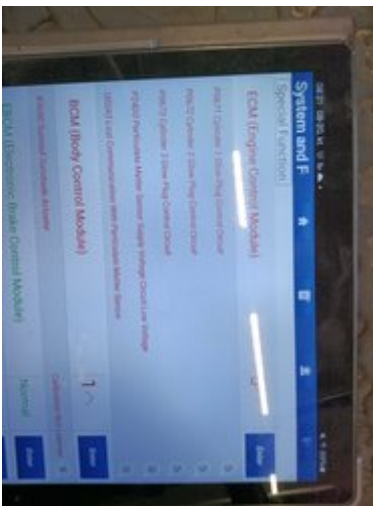
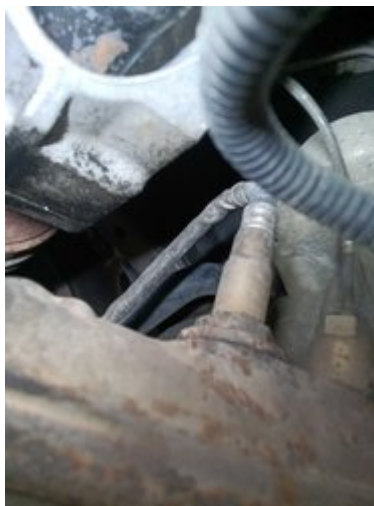
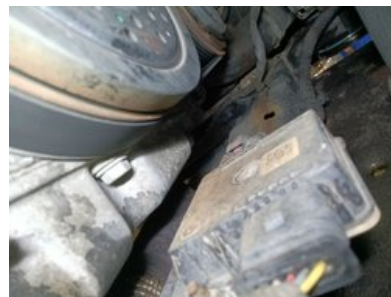
✓ **5. ENGINE:** Particulate Matter Sensor

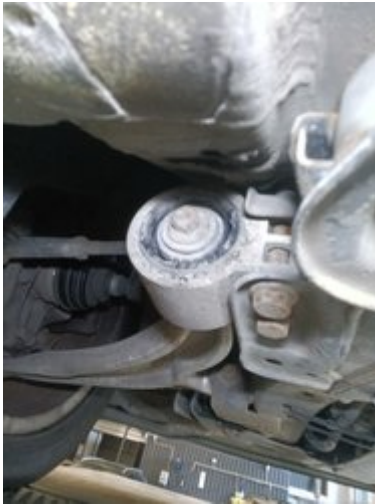
✓ **6. SUSPENSION:** Suspension Lower Arm Rear Both
