# Diagnosis report of 2022 PEUGEOT 2008 Allure

# Preparation and repair report of 2022 PEUGEOT 2008 Allure

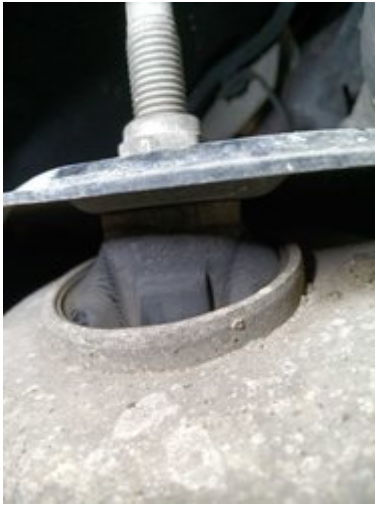
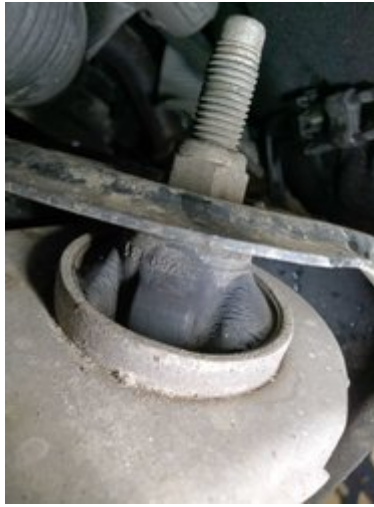
- ✓ **1. OTHER:** Engine Oil & Filter Change
- ✓ **2. SUSPENSION:** Suspension Lower Arm Both

- ✓ 1. Engine Oil & Filter Change

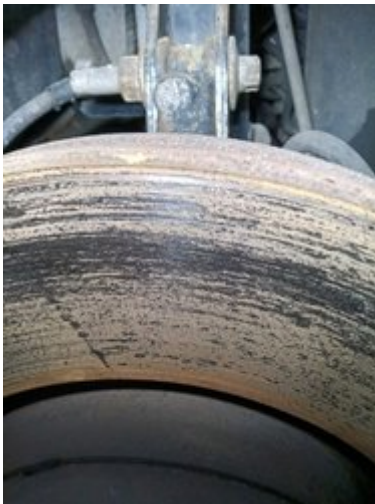
- ✓ **3. BRAKES:** Front Brake Discs Both

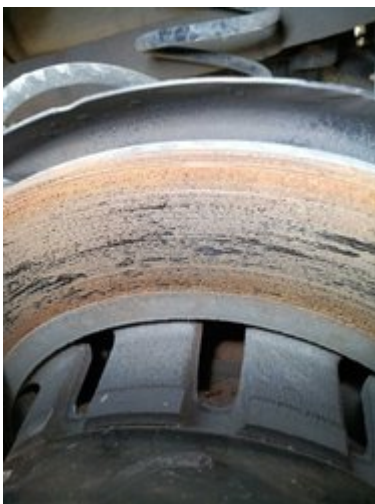
- ✓ **4. BRAKES:** Rear Brake Disc (Both)
