# Diagnosis report of 2015 NISSAN JUKE Acenta

Color: Grey	CO <sub>2</sub> NEDC Emission: 153 g/km
Fuel type: Petrol	
Body type: SUV	Gross Vehicle Weight (GVW): 1880 kg
Number of doors: 4	Engine size: 1.60 l
Number of seats: 5	Cylinders: 4
Mileage: 51 061 km	Power: 140 kw
VIN Code: SJNFANF15U7089546	Fuel consumption: 6.50 l/100km
Gearbox: Automatic	Tire size: 215/55 - 17"
Drive type: All-Wheel Drive	Longo Stock ID: G615661
Longo Certified

# Preparation and repair report of 2015 NISSAN JUKE Acenta

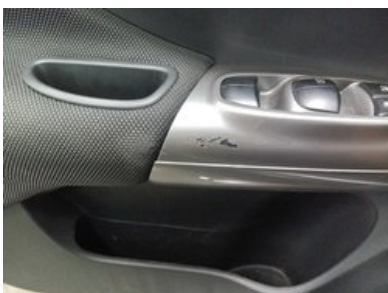
- ✔ **1. Doors:** Trims - Condition

- ✓ 1. Paint Wheel (4 Pieces)
- ✓ 2. Paint Door

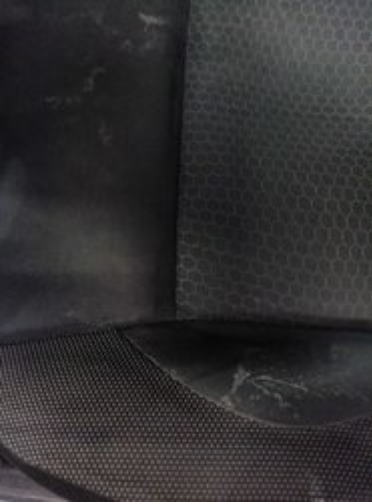
✔ **2. Seats:** All Seats - Condition

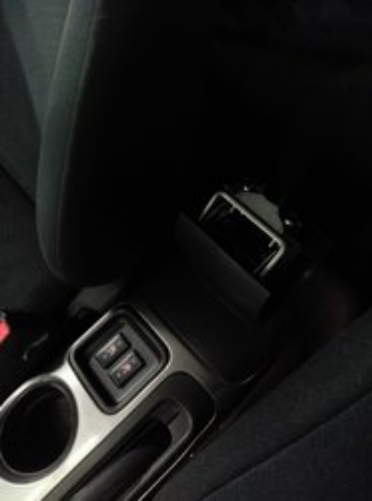
✔ **3. Inside:** Armrest - Operation and Condition

- ✓ 1. Change Armrest

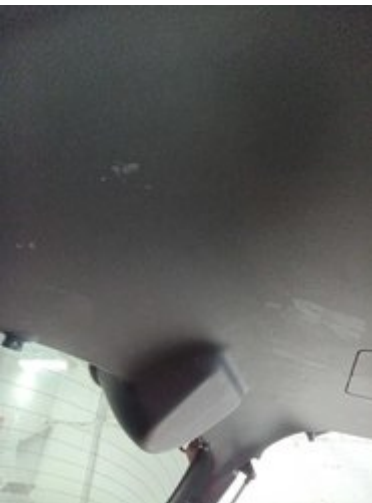
✔ **4. Inside:** Trims - Condition

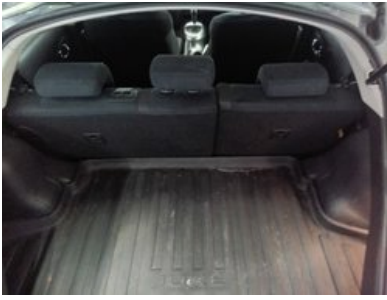
✔ **5. Inside:** Parcel Shelf - Operation and Condition

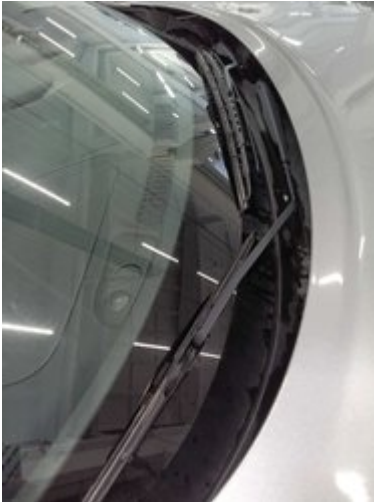
✔ **6. Front:** Window Wiper Rubber and Handle (Front and Rear) - Condition

- ✓ 1. Change Front Wiper (Mechanical)
- ✓ 2. Charge Battery
- ✓ 3. Engine Oil & Filter Change
- ✓ 4. Change Rear Wiper (Mechanical)
- ✓ 5. Remove Locking Wheel Bolts

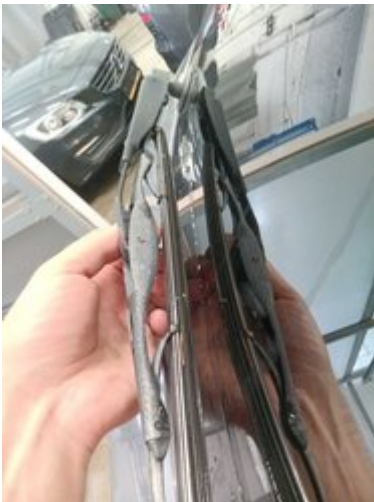
✔ **7. Front:** Window Wiper Rubber and Handle (Front and Rear) - Condition

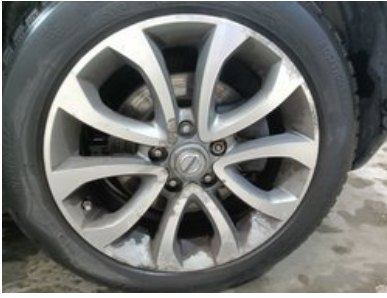
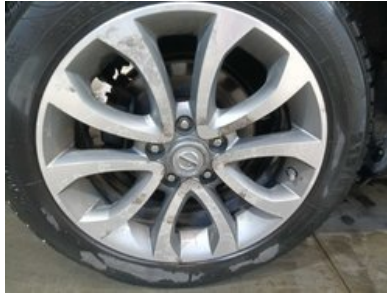
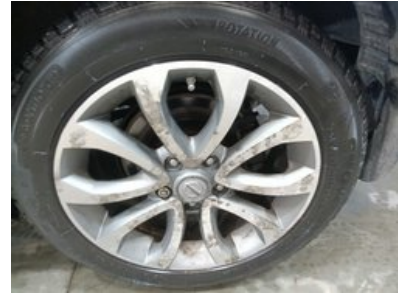
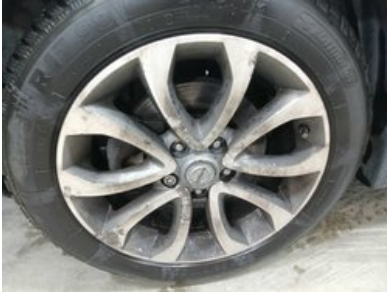
### ✓ 1. Side: Wheels - Condition

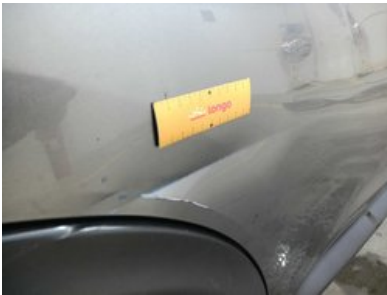
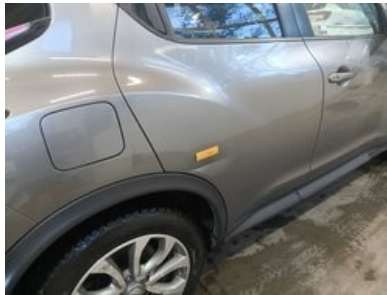
### ✓ 2. Side: Left and Right Side - Visual Damage and Scratches
