# Diagnosis report of 2016 OPEL MERIVA Blitz

# Preparation and repair report of 2016 OPEL MERIVA Blitz

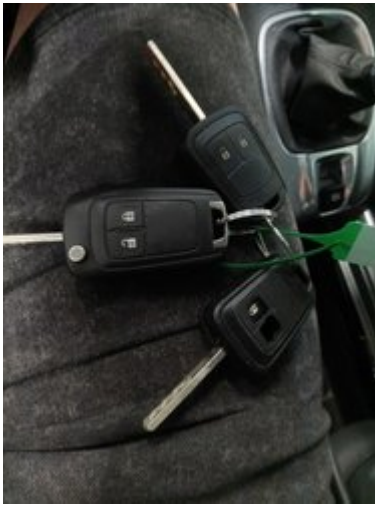
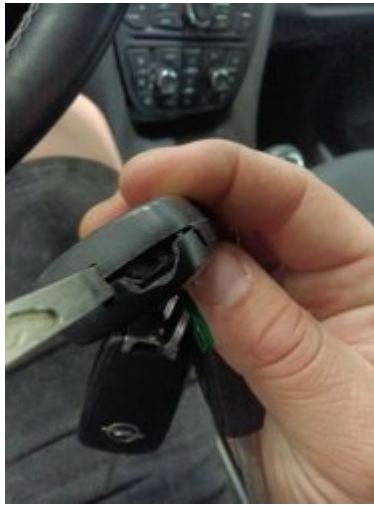
### ✓ 1. Inside: Accessories - Functioning and Condition

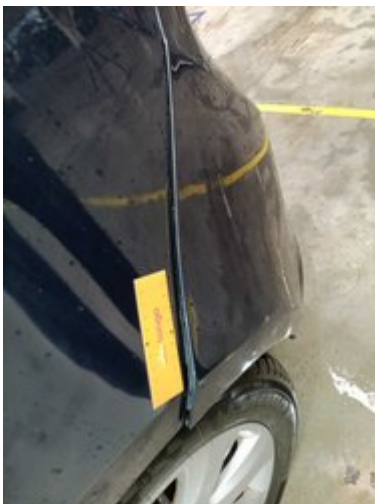
### ✓ 1. Rear: Rear Bumper - Condition and Alignment

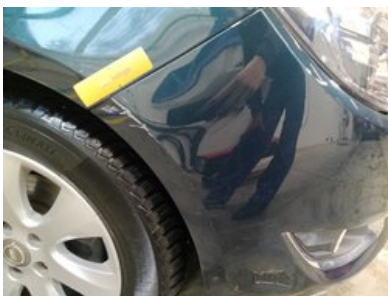
### ✓ 2. Front: Front Bumper - Condition and Alignment

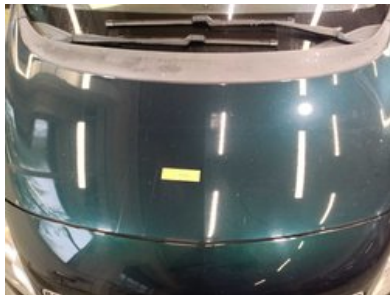
✓ **3. Front:** Hood - Visual Damage

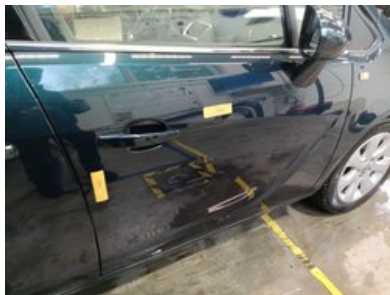
✓ **4. Side:** Left and Right Side - Visual Damage and Scratches

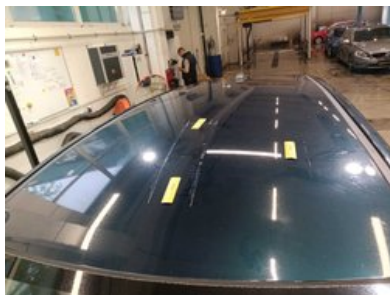
✓ **5. Other:** Roof - Visual Damage (e.g., Hail Damage)

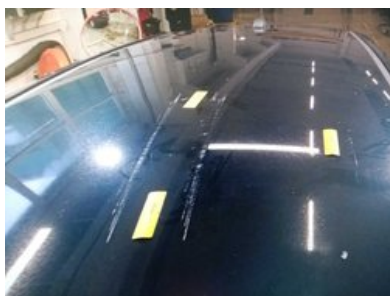
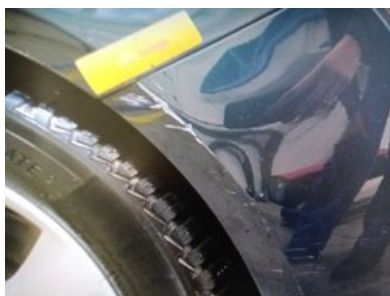
✓ **6. Other:** Additional Polishing Tasks

- ✓ 1. Body wet wash
- ✓ 2. Full interior deep clean using only hypoallergenic cleaning products
- ✓ 3. Post cleaning body polish
