# Diagnosis report of 2015 OPEL MOKKA Active

Diagnosis report of

2015 OPEL MOKKA Active

During the comprehensive diagnosis conducted by Longo, 15 issues were identified in the vehicle.

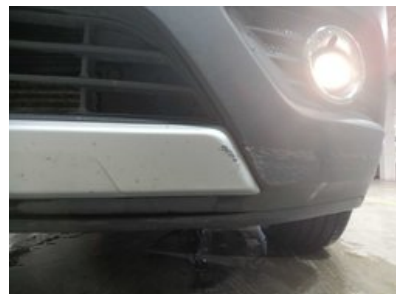
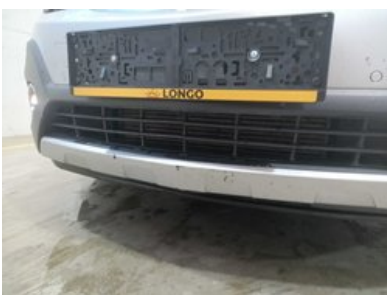
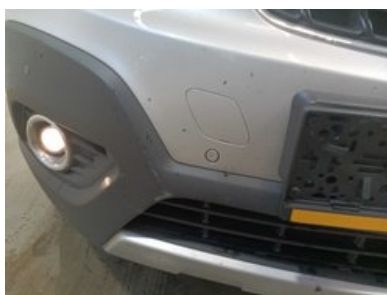
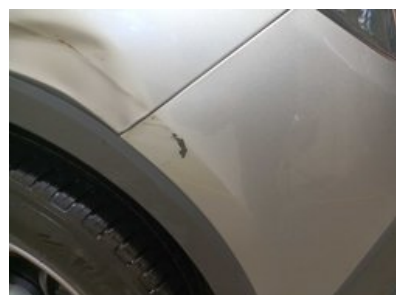
✓ **5. Front:** Front Bumper - Condition and Alignment

- ✓ 1. Change Element in Front Panel
- ✓ 2. Other: PDR in LSS
