# Diagnosis report of 2015 MITSUBISHI OUTLANDER Executiv

Diagnosis details

During the comprehensive diagnosis conducted by Longo, 16 issues were identified in the vehicle.

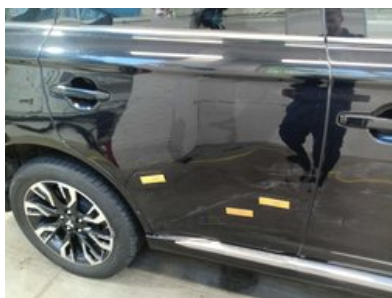
✓ **5. Side:** Left and Right Side - Visual Damage and Scratches

- ✓ 1. Paint Door
- ✓ 2. Paint Rear Fender
- ✓ 3. Paint Sill
