# Diagnosis report of 2014 TOYOTA AURIS Aspiration

# Preparation and repair report of 2014 TOYOTA AURIS Aspiration

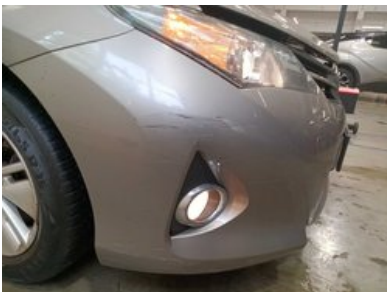
- ✔ **1. Front:** Front Bumper - Condition and Alignment

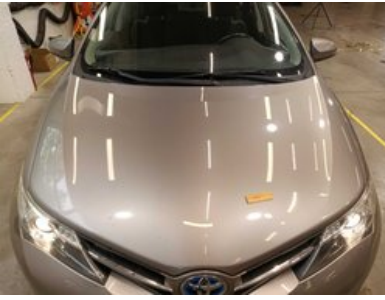
✔ **2. Front:** Hood - Visual Damage

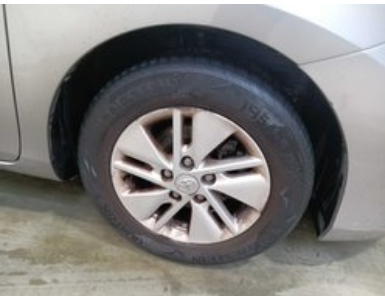
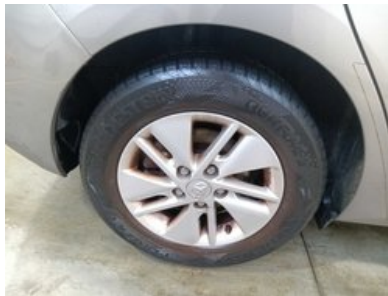
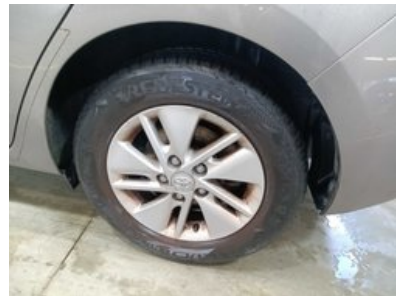
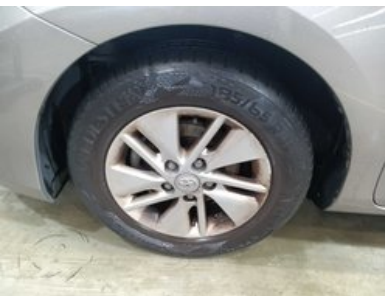
✔ **4. Side:** Wheels - Condition

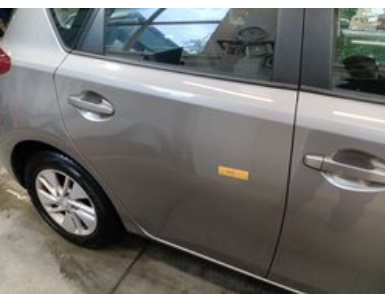
✔ **5. Side:** Left and Right Side - Visual Damage and Scratches

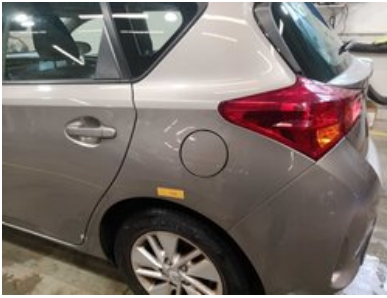
✔ **6. Side:** Left and Right Side - Visual Damage and Scratches

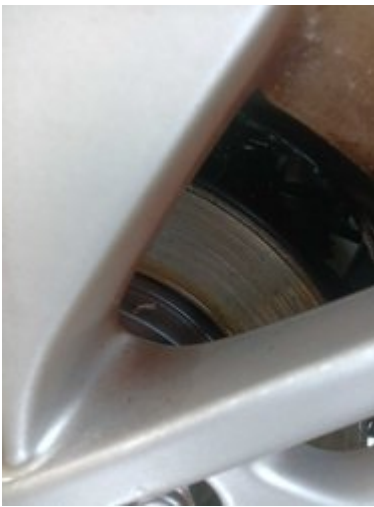
✔ **1. BRAKES:** Rear Brake Disc (Both)

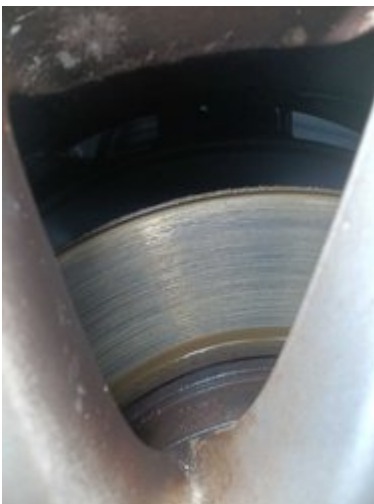
✔ **2. BRAKES:** Front Brake Discs Both

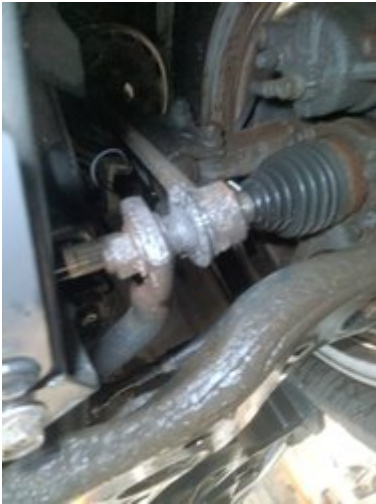
✓ **3. SUSPENSION:** Anti-Roll Bar Bush, Outer

- ✓ 1. Anti-Roll Bar Bush - Outer

- 1. Stabilizer Link (CTRCL0586)
