# Diagnosis report of 2016 OPEL MERIVA Blitz

## Diagnosis details

During the comprehensive diagnosis conducted by Longo, 12 issues were identified in the vehicle.

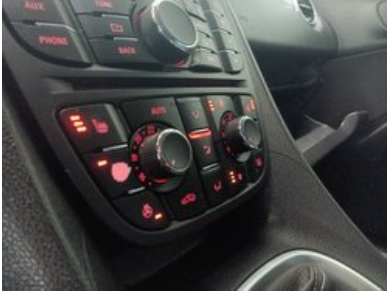
✓ **1. Front:** Trims - Condition

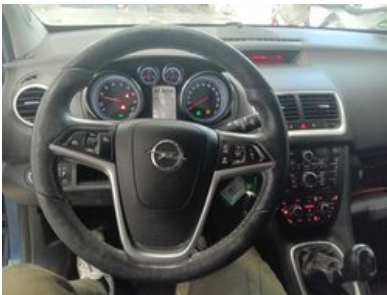
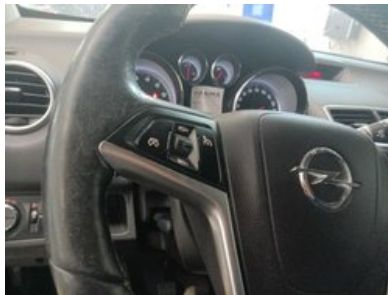
✓ **2. Front:** Steering Wheel - Condition

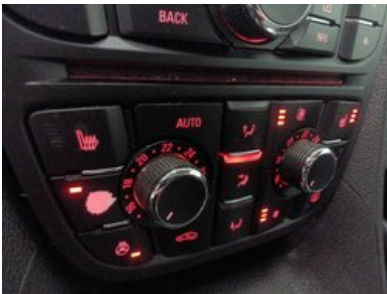
✓ **3. Operation:** Seat Heating System - Functioning (Driver and Passenger)

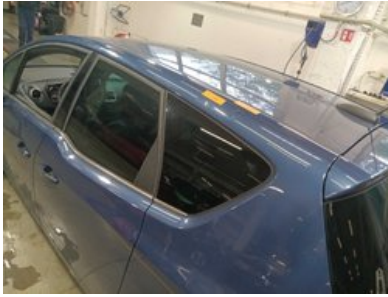
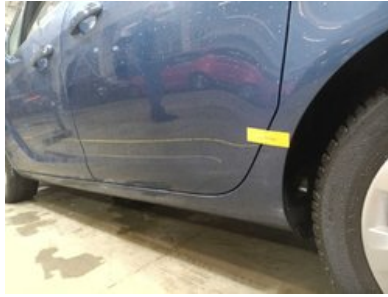
✓ **2. Side:** Left and Right Side - Visual Damage and Scratches

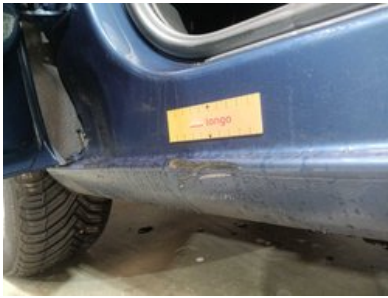
✓ **3. Side:** Left and Right Side - Visual Damage and Scratches

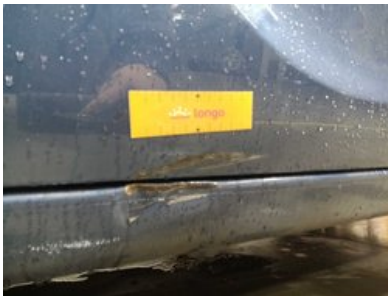
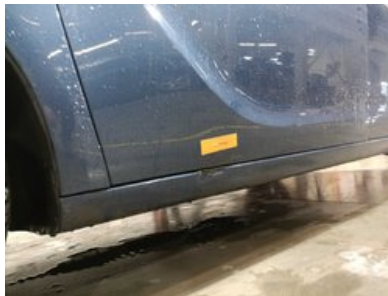
✓ **4. Side:** Left and Right Side - Visual Damage and Scratches

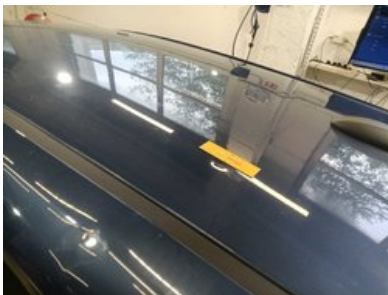
✓ **5. Other:** Roof - Visual Damage (e.g., Hail Damage)

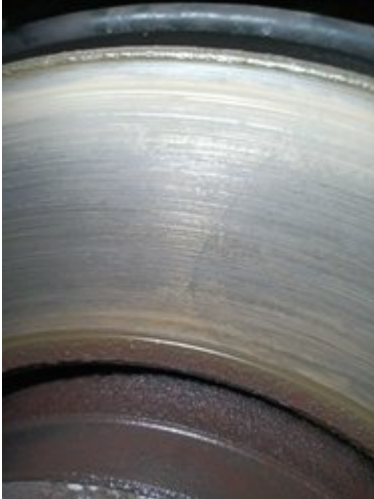
### ✓ 1. BRAKES: Front Brake Discs Both

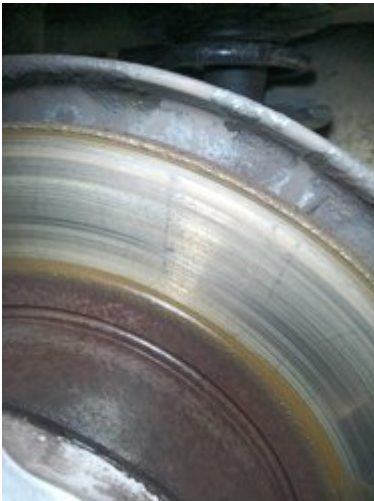
### ✓ 2. BRAKES: Rear Brake Disc (Both)

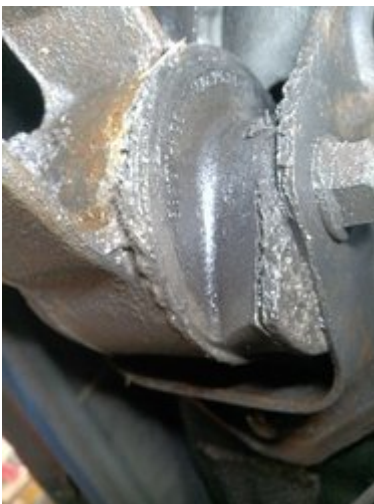
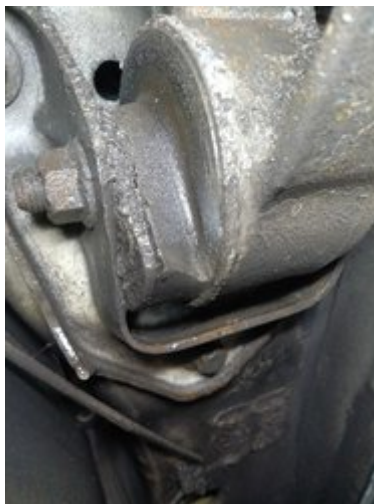
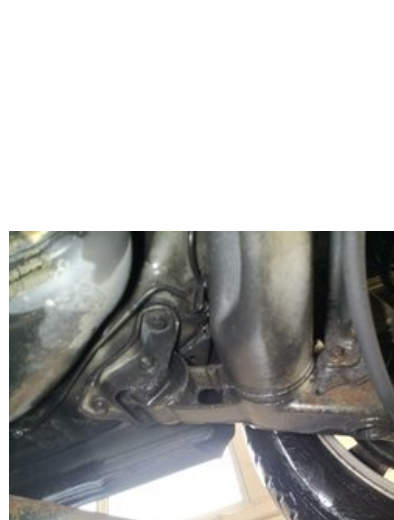
### ✓ 3. SUSPENSION: Trailing Arm Bushings

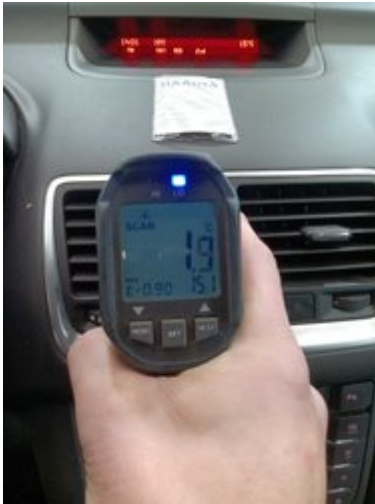
#### ✓ 4. Air-Conditioning Measurement
