# Diagnosis report of

## 2014 OPEL ZAFIRA TOURER Business+

# Diagnosis report of 2014 OPEL ZAFIRA TOURER Business+

## Diagnosis details

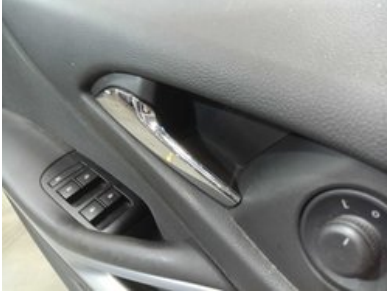
### ✓ 1. Doors: Door Handles - Operation and Condition

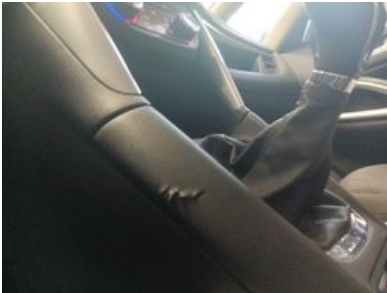
### ✓ 2. Front: Trims - Condition

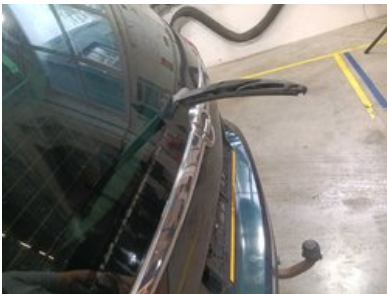
### ✓ 3. Front: Window Wiper Rubber and Handle (Front and Rear) - Condition

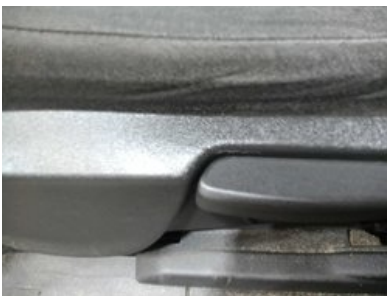
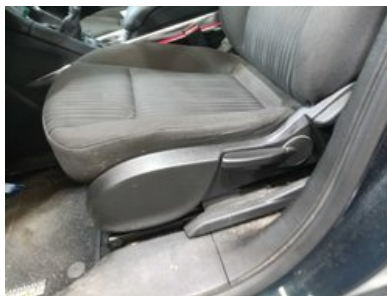
### ✓ 4. Seats: All Seats - Condition

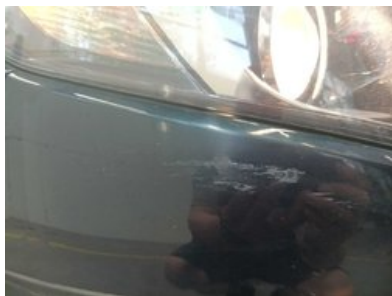
### ✓ 1. Front: Front Bumper - Condition and Alignment

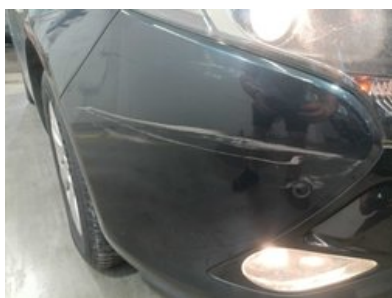
### ✓ 2. Other: Additional Polishing Tasks

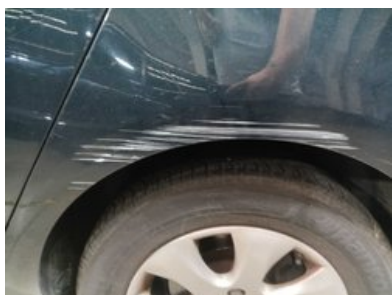
### ✓ 3. Other: Additional Polishing Tasks

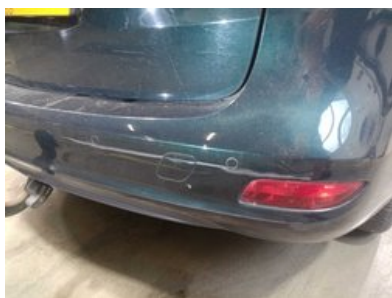
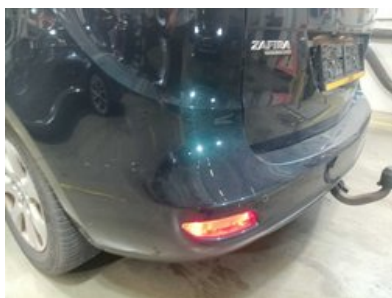
### ✓ 4. Rear: Rear Bumper - Condition and Alignment

- ✓ 1. Paint Rear Fender

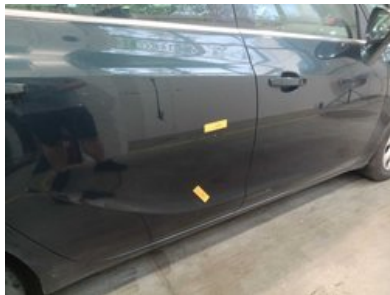
✓ **5. Side:** Left and Right Side - Visual Damage and Scratches

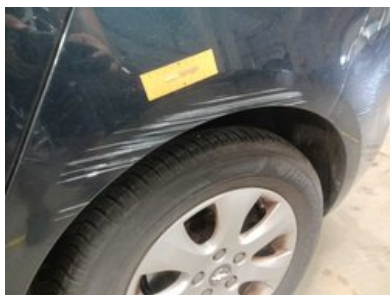
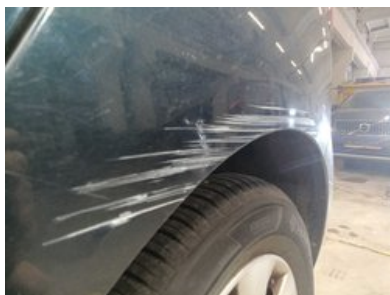
✓ **6. Side:** Left and Right Side - Visual Damage and Scratches

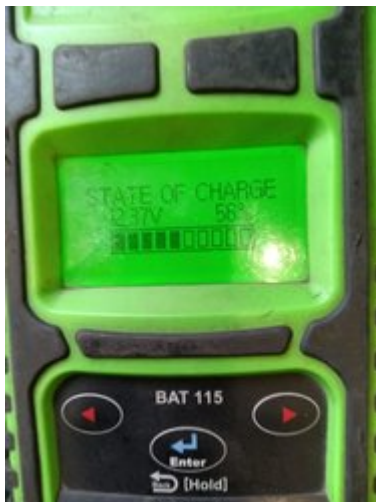
✓ **1. OTHER:** Charge Battery

- ✓ 1. Front Brake Discs (Both)
- ✓ 2. Charge Battery
- ✓ 3. Change Tires
- ✓ 4. Engine Oil & Filter Change

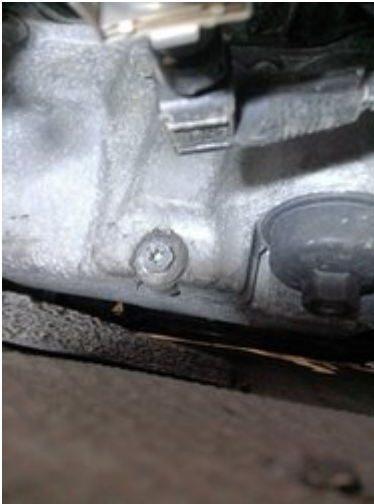
✓ **2. OTHER:** Engine Oil & Filter Change

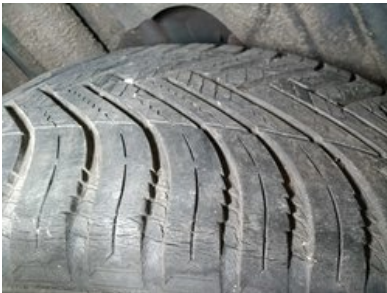
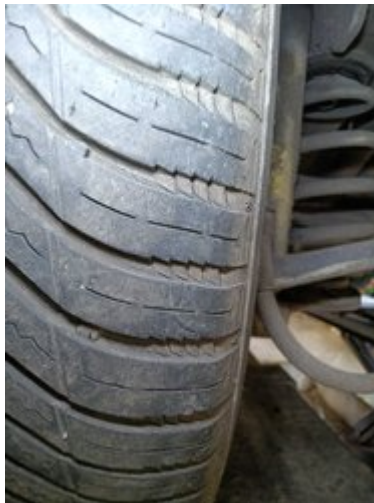
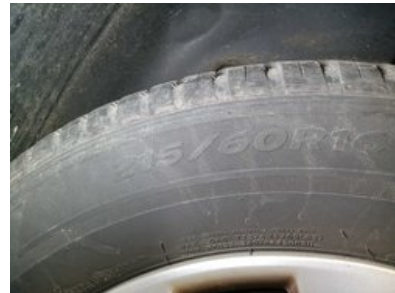
✓ **3. OTHER:** Change Tires

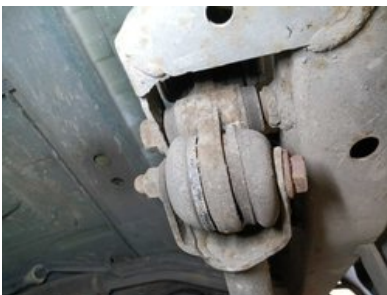
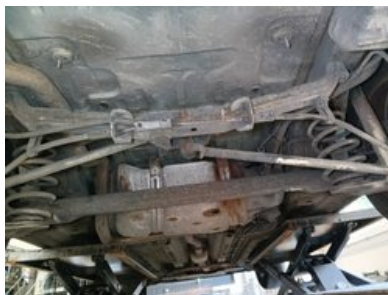
✓ **4. SUSPENSION:** Axle/Axle Tube/Crossmember

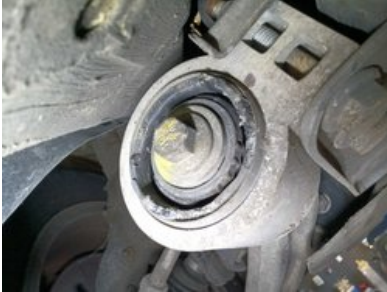
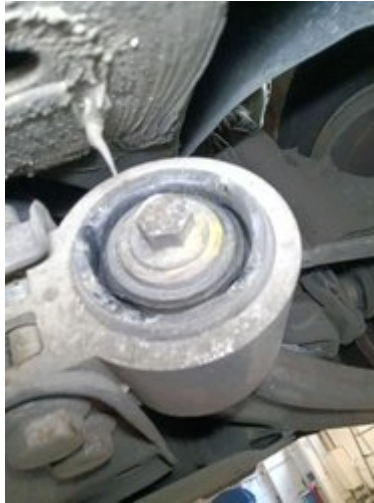
✓ **5. SUSPENSION:** Suspension Lower Arm Bushes Both

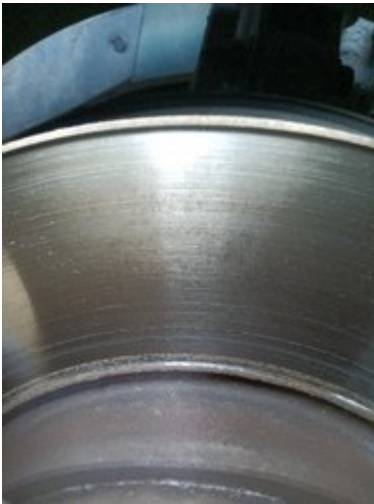
✓ **6. BRAKES:** Front Brake Discs Both

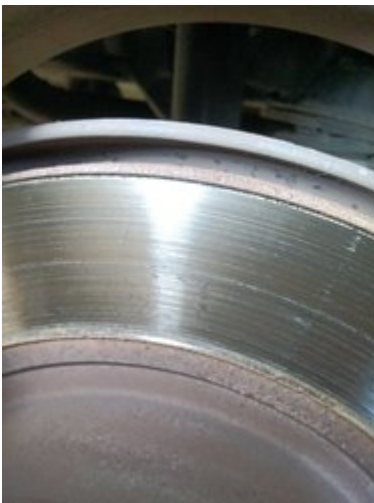
✓ **7. BRAKES:** Rear Brake Disc (Both)
