# Diagnosis report of 2018 PEUGEOT 2008 Allure

During the comprehensive diagnosis conducted by Longo, 9 issues were identified in the vehicle.

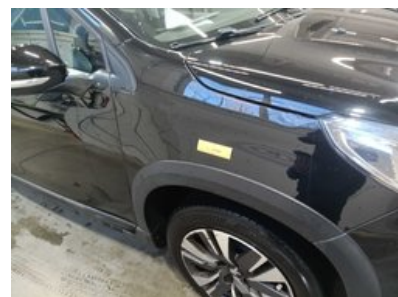
- ✔ 1. Side: Left and Right Side - Visual Damage and Scratches

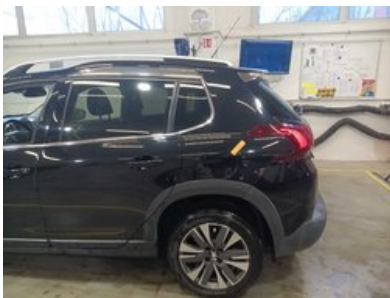
✓ **2. Side:** Left and Right Side - Visual Damage and Scratches

- ✓ 1. Repair Bumper Corners
- ✓ 2. Change Brake Lights

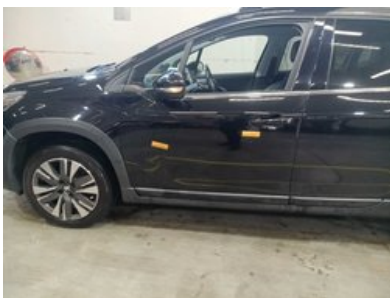
✓ **3. Side:** Left and Right Side - Visual Damage and Scratches

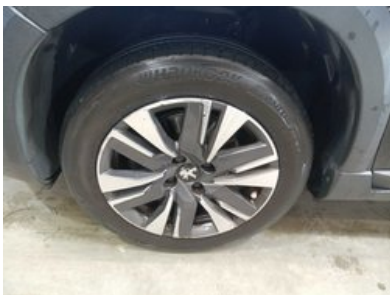
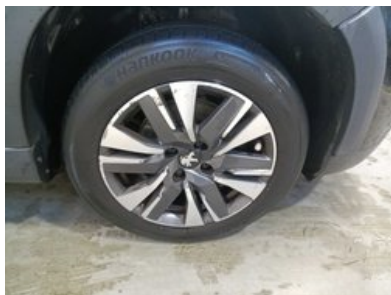
✓ **4. Side:** Wheels - Condition

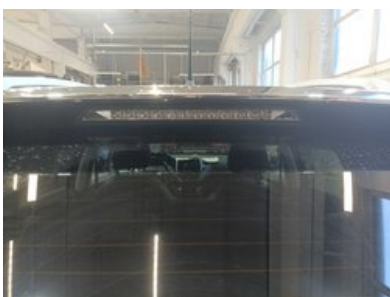
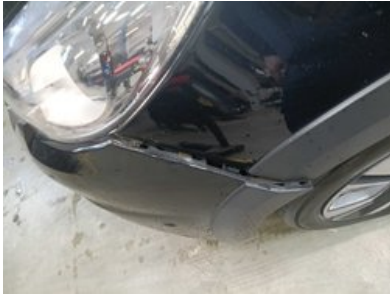
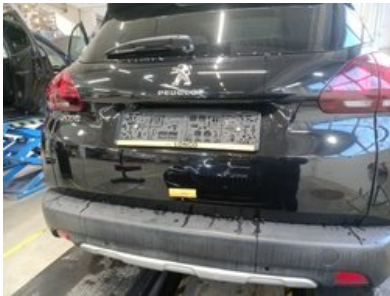
✓ **5. Lights:** Rear Lights (Brake, Fog, Indicator) - Basic Functioning, Damage, and Color

- 1. Brake Light (TYC15-0703-00-2)

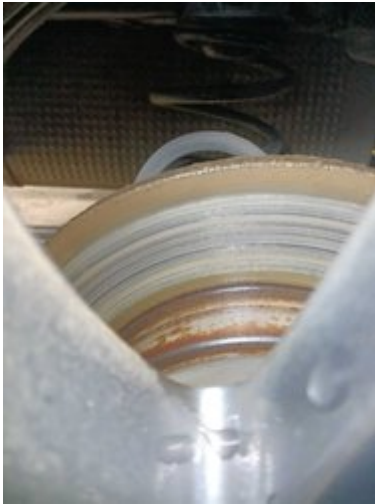
✓ **2. BRAKES:** Rear Brake Disc (Both)
