Diagnosis report of 2016 PEUGEOT 3008 Active

Preparation and repair report of 2016 PEUGEOT 3008 Active

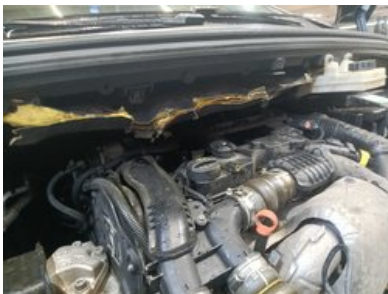
- ✔ **1. Front:** Firewall Integrity

- ✓ 1. Repair Firewall

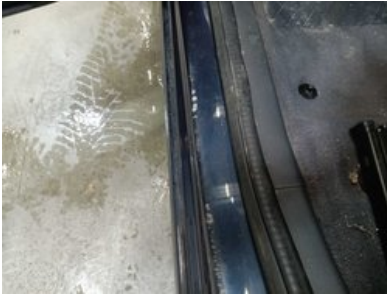
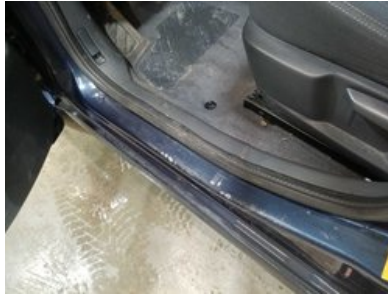
✔ **2. Side:** Left and Right Side - Visual Damage and Scratches

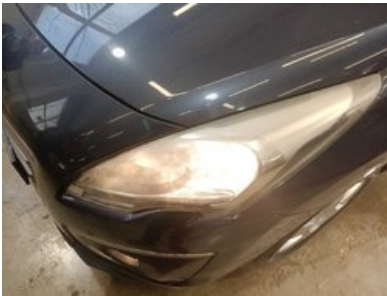
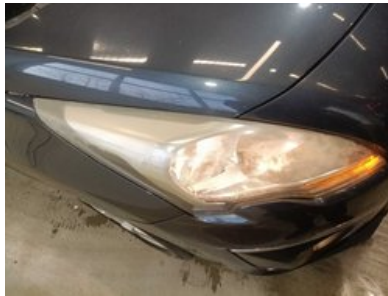
✔ **3. Other:** Additional Polishing Tasks

- ✓ 1. Body wet wash
- ✓ 2. Full interior deep clean using only hypoallergenic cleaning products
- ✓ 3. Post cleaning body polish

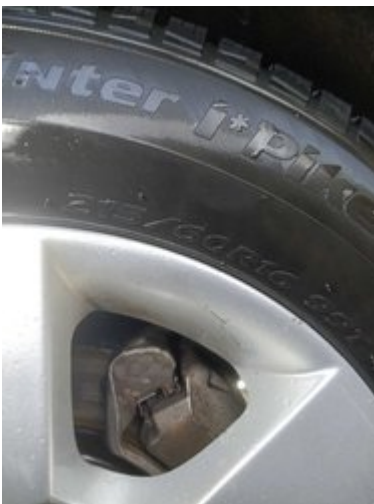
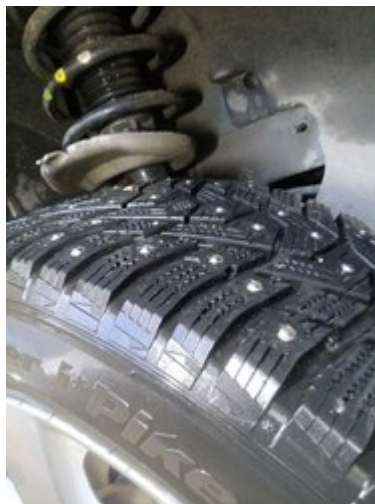
✔ **2. OTHER:** Change 4 Tires

- ✓ 1. Change Tires
- ✓ 2. Engine Oil & Filter Change
- ✓ 3. Front Brake Discs (Both)
- ✓ 4. Front Brake Hoses (Both)

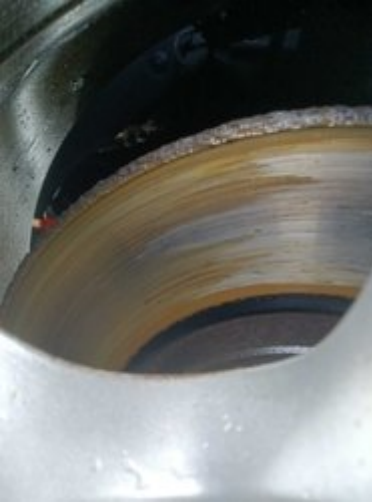
✔ **3. BRAKES:** Front Brake Discs Both

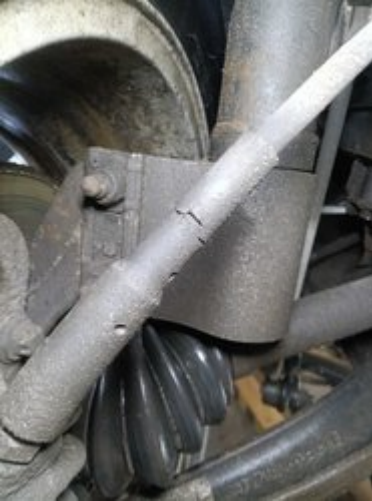
✔ **4. BRAKES:** Front Brake Hose (Both)

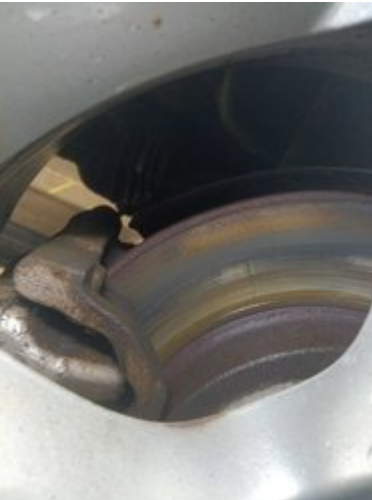
✔ **5. BRAKES:** Rear Brake Disc (Both)

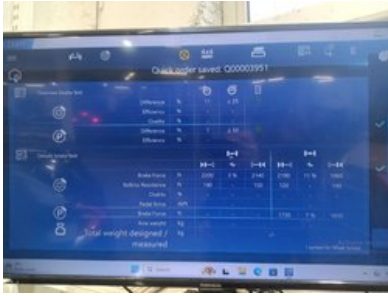
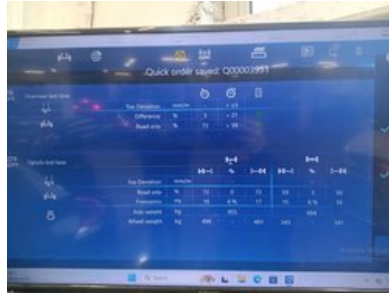
✓ 1. Brake Test Line Results

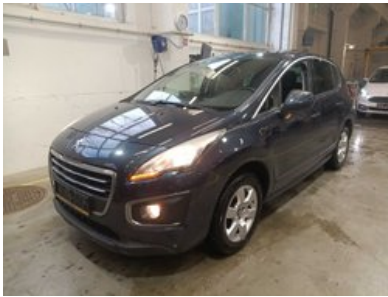
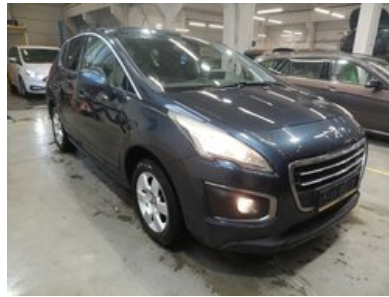
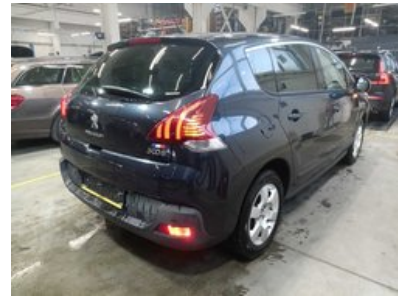
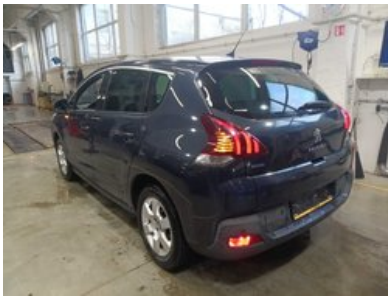
✓ 3. Diagnostic Photo

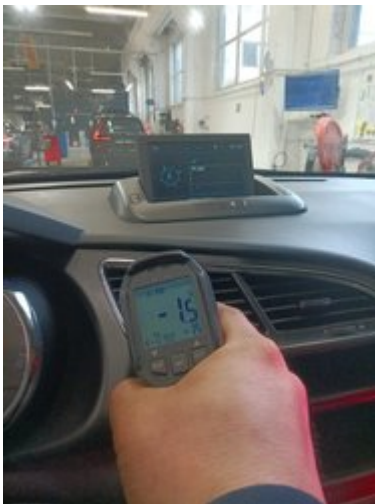
✓ 4. Air-Conditioning Measurement
