# Diagnosis report of 2020 PEUGEOT 3008 Executive

## Summary of diagnosed issues

During the comprehensive diagnosis conducted by Longo, 4 issues were identified in the vehicle.

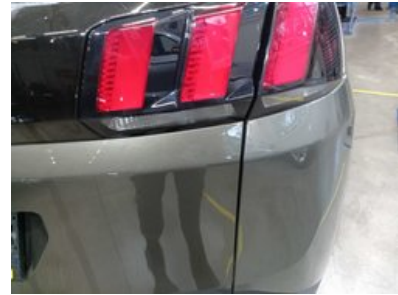
- ✓ **1. Rear:** Trunk - Visual Damage
