# Diagnosis report of 2017 PEUGEOT 2008 Active

# Preparation and repair report of 2017 PEUGEOT 2008 Active

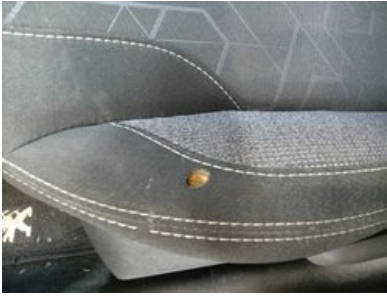
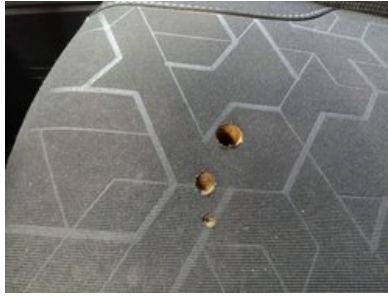
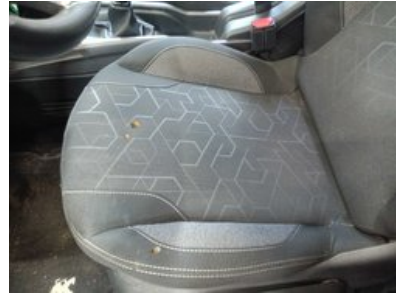
### ✓ 1. Seats: All Seats - Condition

- ✓ 1. Sew Front Seat
- ✓ 2. Headlamp Alignment

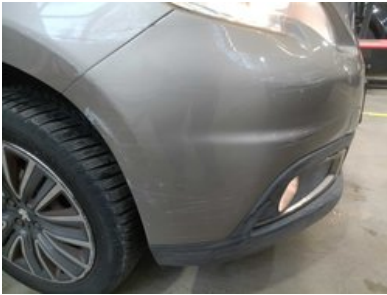
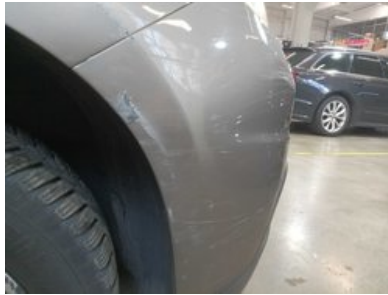
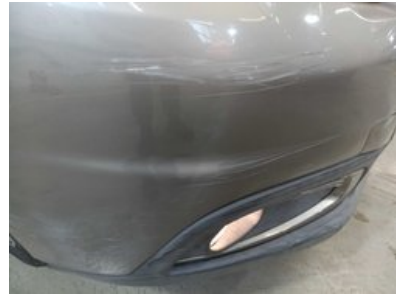
### ✓ 1. Front: Front Bumper - Condition and Alignment

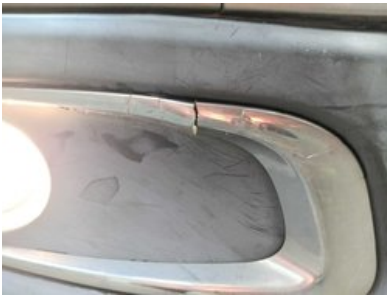
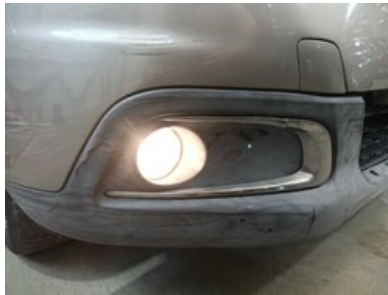
### ✓ 2. Front: Front Grille - Condition

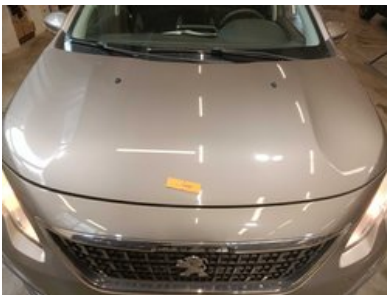
### ✓ 3. Front: Hood - Visual Damage

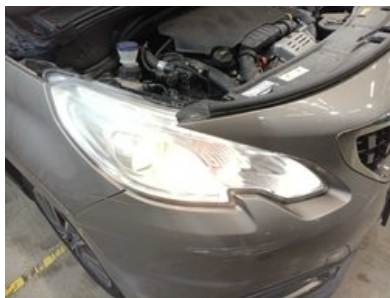
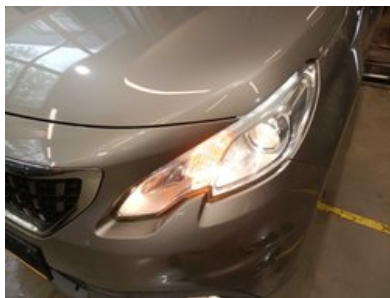
✓ **4. Other:** Additional Polishing Tasks

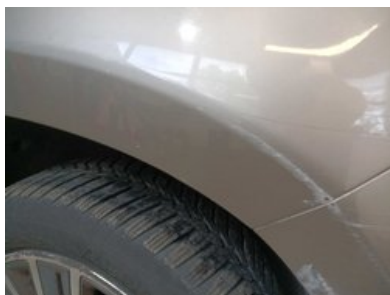
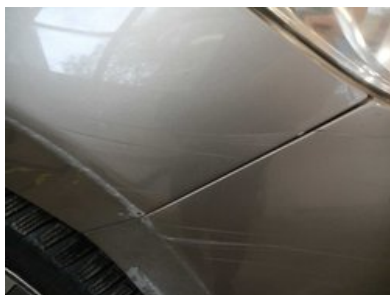
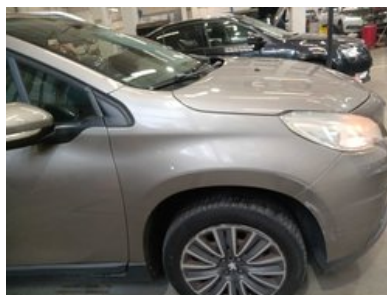
✓ **5. Side:** Left and Right Side - Visual Damage and Scratches

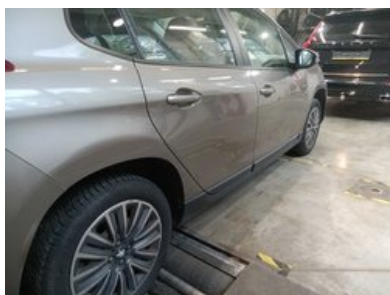
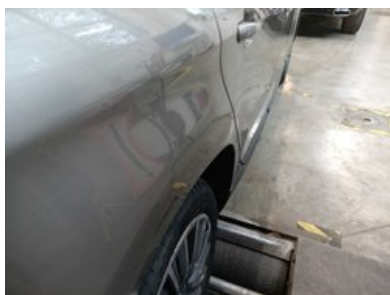
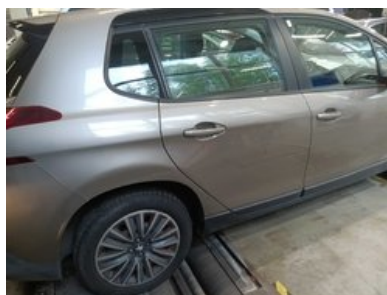
✓ **6. Side:** Left and Right Side - Visual Damage and Scratches

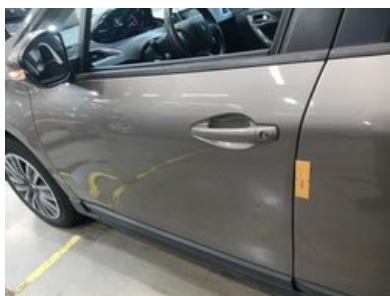
✓ **7. Side:** Left and Right Side - Visual Damage and Scratches

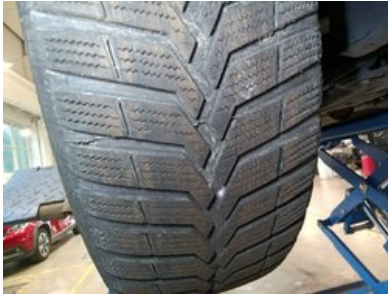
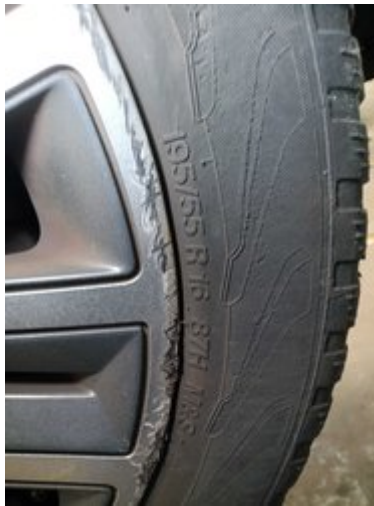
✓ **2. OTHER:** Change Tires

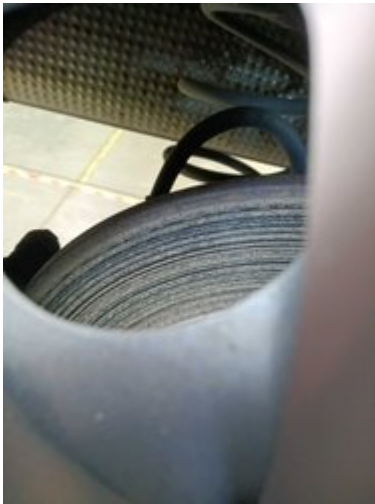
✓ **3. BRAKES:** Rear Brake Disc (Both) with Pads

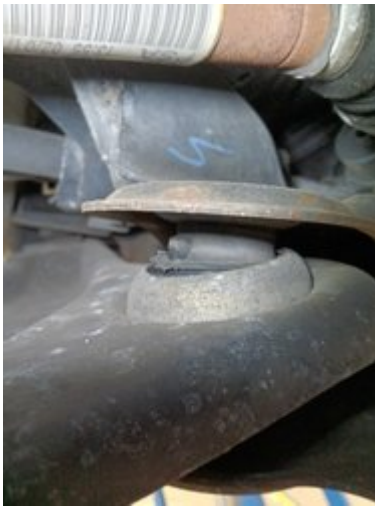
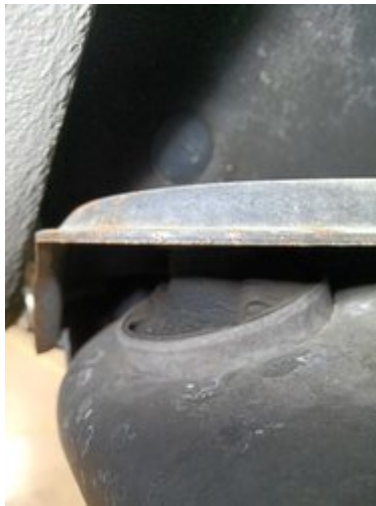
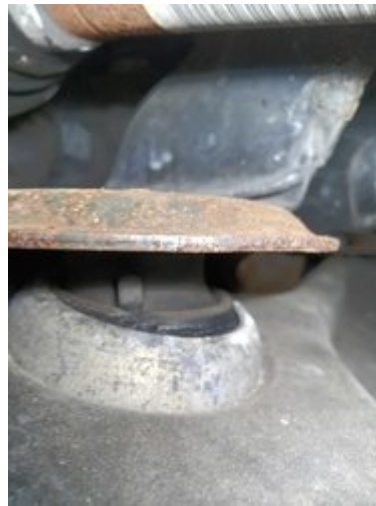
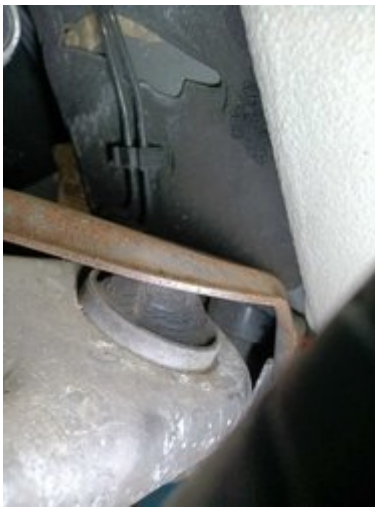
✓ **4. SUSPENSION:** Suspension Lower Arm Bushes Both

- ✓ 1. Suspension Lower Arm Bushes (Both)
- ✓ 2. Charge Battery

- 1. Arm (TC2492)
- 2. Arm (TC2493)
