# Diagnosis report of 2021 NISSAN LEAF Acenta 40 kWh

## Diagnosis details

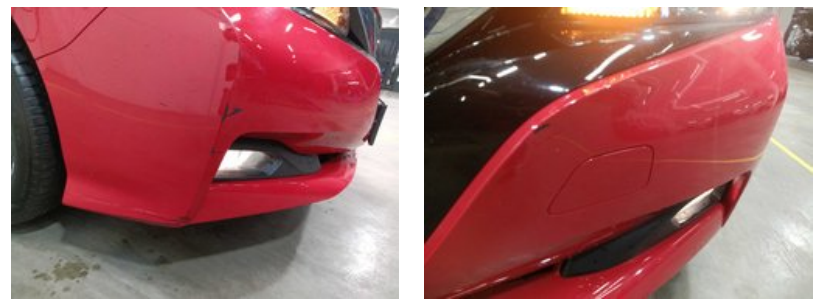
- ✔ 1. Front: Front Bumper - Condition and Alignment

- ✓ 1. Paint Rear Fender
- ✓ 2. Paint Door
- ✓ 3. Paint Front Bumper
- ✓ 4. Paint Rear Bumper

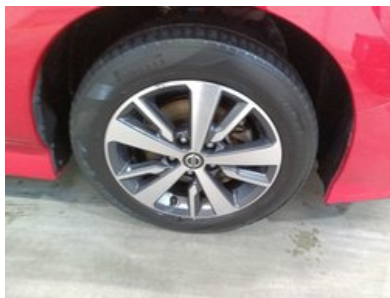
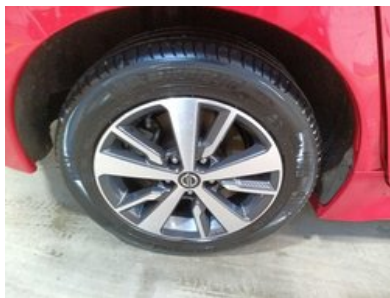
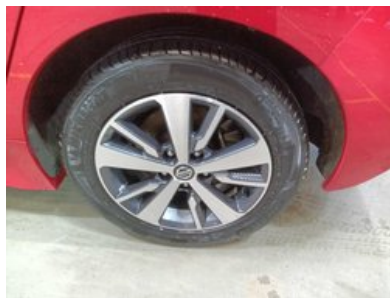
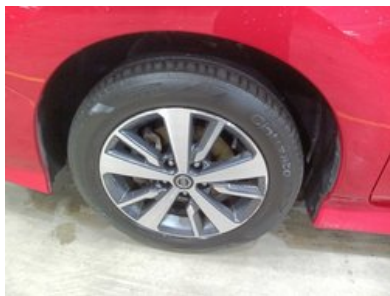
✓ **2. Side:** Wheels - Condition

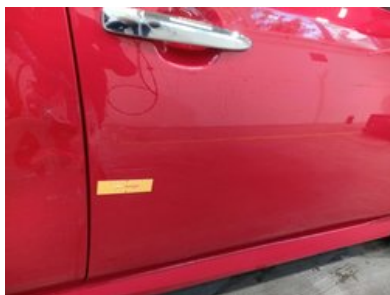
✓ **3. Side:** Left and Right Side - Visual Damage and Scratches

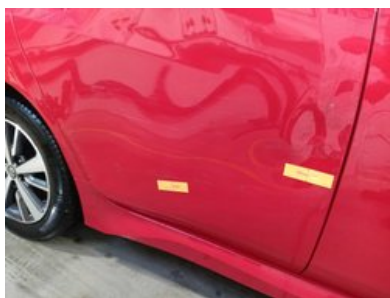
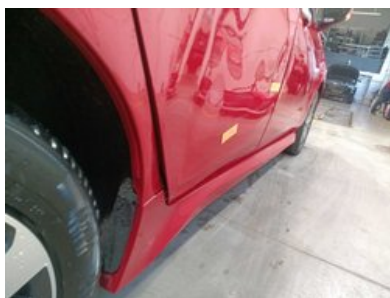
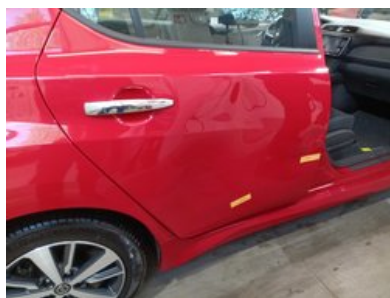
✓ **4. Side:** Left and Right Side - Visual Damage and Scratches

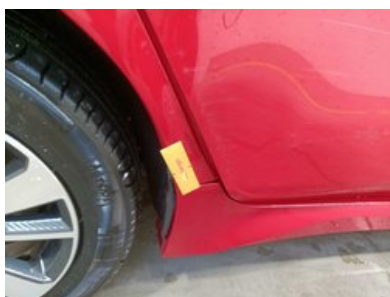
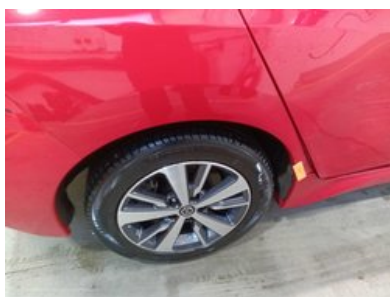
✓ **5. Side:** Left and Right Side - Visual Damage and Scratches

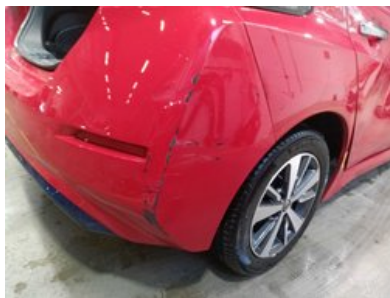
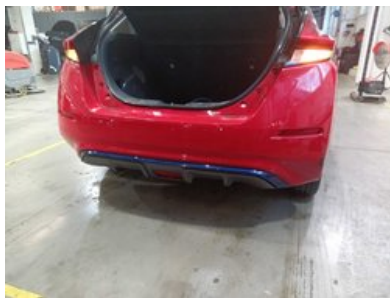
✔ **6. Rear:** Rear Bumper - Condition and Alignment

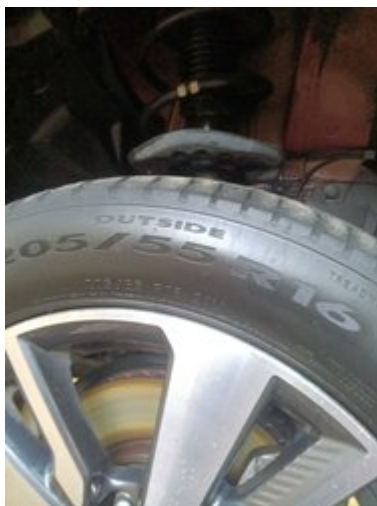
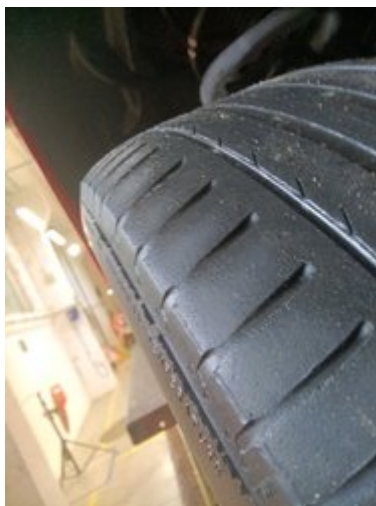
✔ **1. OTHER:** Change Tires

- ✓ 1. Change Tires

- 1. 205/55 R16 91V Royal Black Royalmile (20555 R16 91V ROYALMILE ROYALBLACK)
- 2. Rear Door Right (TSM379843)
