Diagnosis report of 2015 MITSUBISHI OUTLANDER Business

Diagnosis details

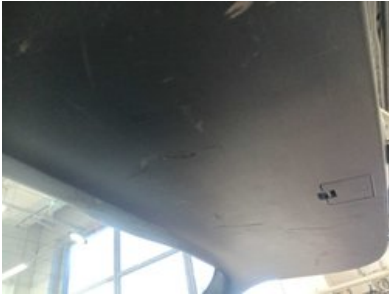
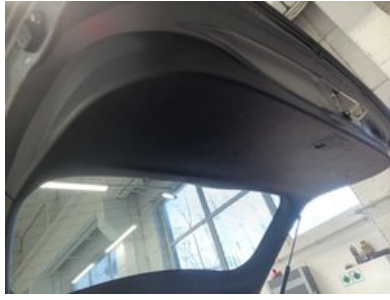
✔ **2. Inside:** Trims - Condition

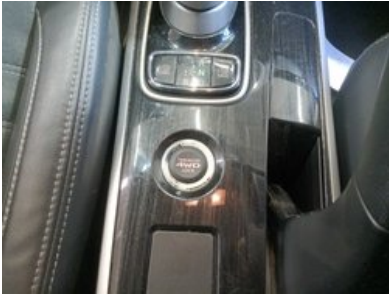
✔ **3. Inside:** Trims - Condition

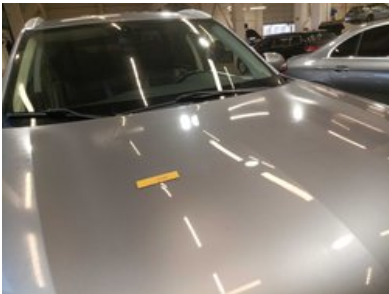
✔ **1. Front:** Hood - Visual Damage

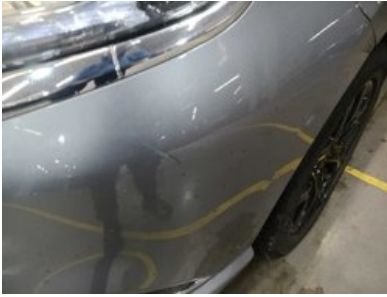
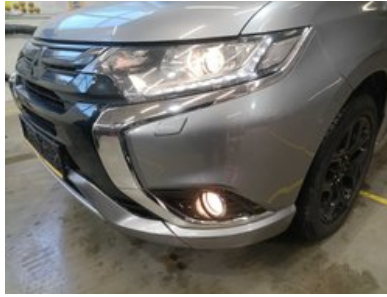
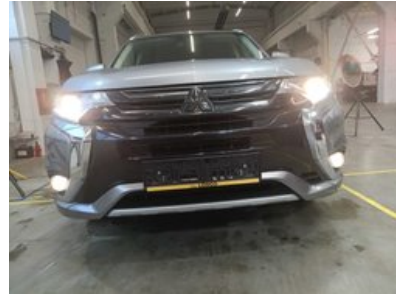
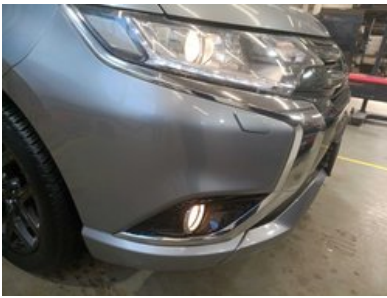
✔ **2. Front:** Front Bumper - Condition and Alignment

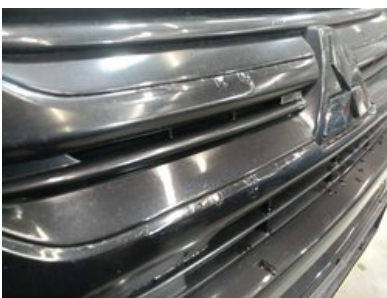
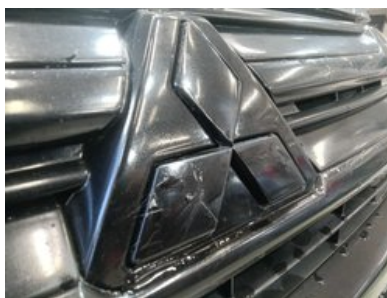
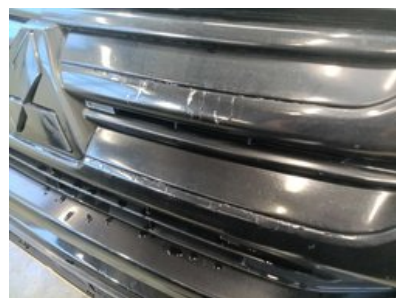
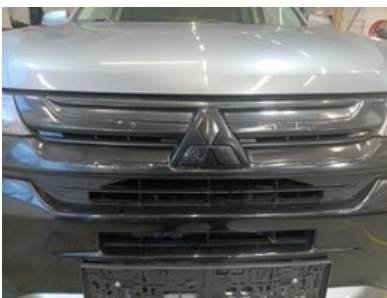
✔ **4. Front:** Front Grille - Condition

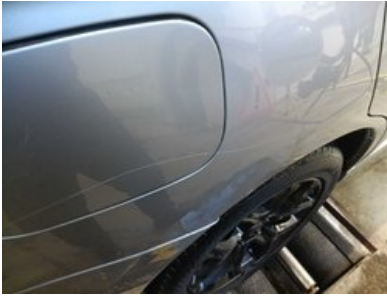
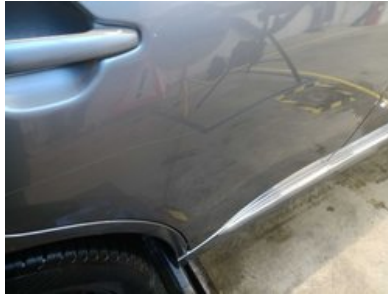
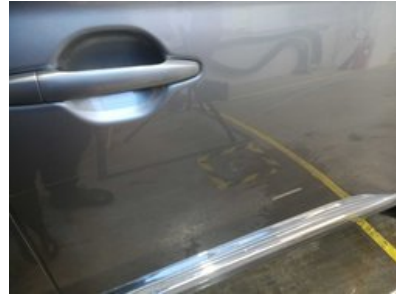
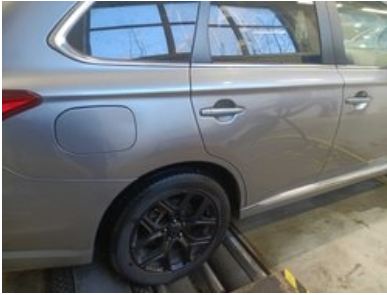
✔ **5. Other:** Additional Polishing Tasks

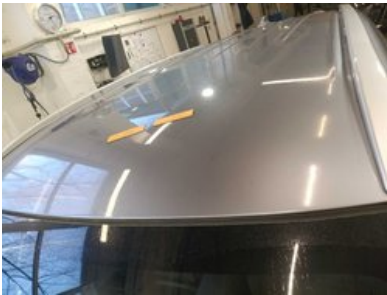
✔ **6. Other:** Roof - Visual Damage (e.g., Hail Damage)

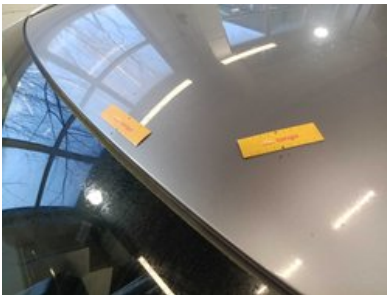
✔ **7. Other:** Roof - Visual Damage (e.g., Hail Damage)

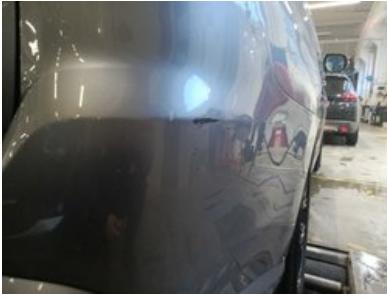
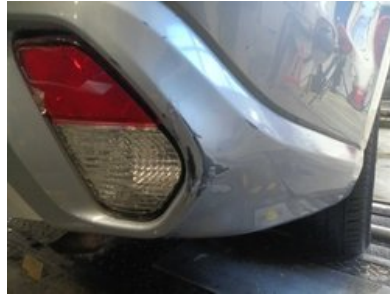
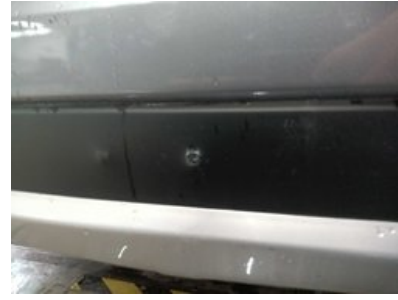
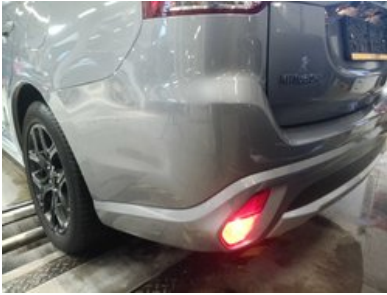
✓ **8. Rear:** Rear Bumper - Condition and Alignment

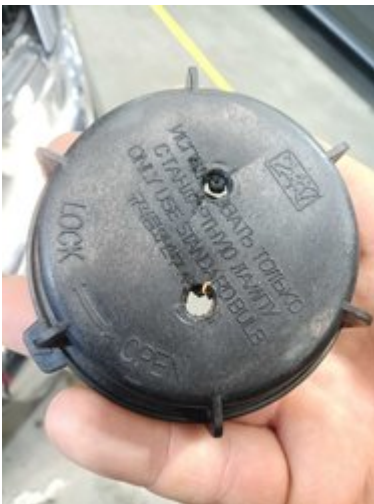
✓ **9. Lights:** Front Lights (City, Regular, Full Headlight, Fog, Indicator) - Basic Functioning, Damage, and Color

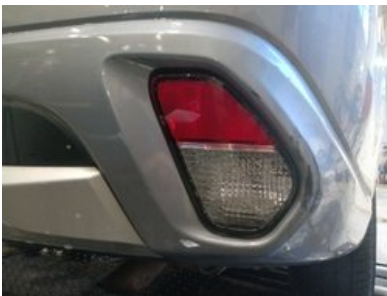
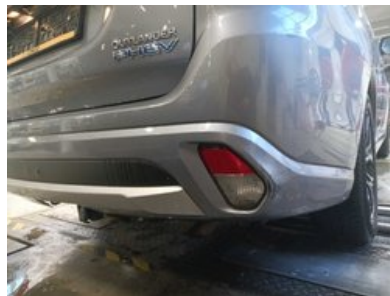
✓ **10. Lights:** Rear Lights (Brake, Fog, Indicator) - Basic Functioning, Damage, and Color

- ✓ 1. Repair Washer Mechanism
- ✓ 2. Other: Missing Clips
- ✓ 3. Change Rear Lights

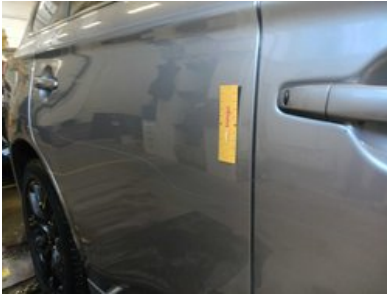
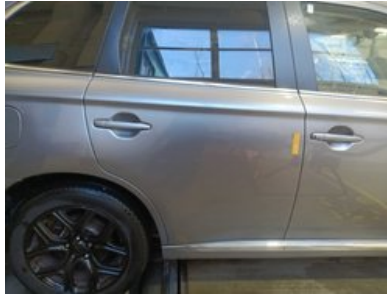
✔ **11. Side:** Left and Right Side - Visual Damage and Scratches

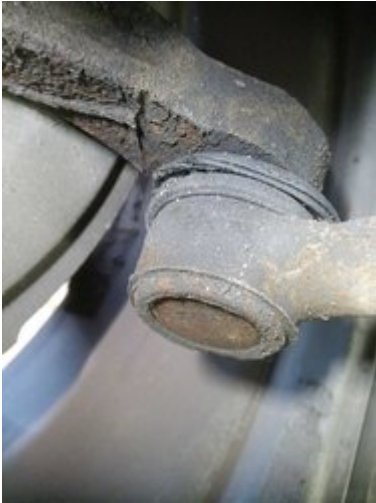
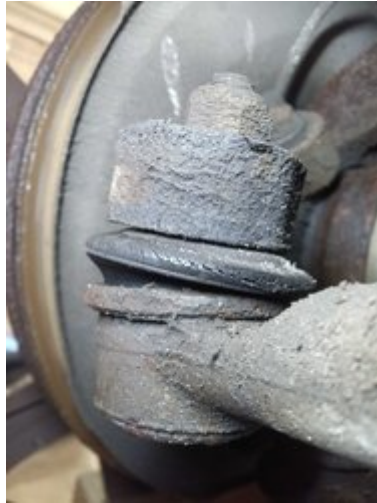
✔ **6. STEERING:** Track Rod End Joint (Both)

- ✓ 1. Track Rod End Joint (Both)
- ✓ 2. Engine Oil & Filter Change
- ✓ 3. Charge Battery
- ✓ 4. Change Light Covers
- ✓ 5. Front Wheel Alignment (Toe)

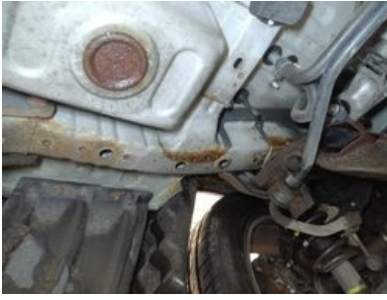
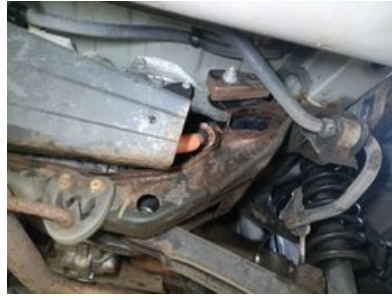
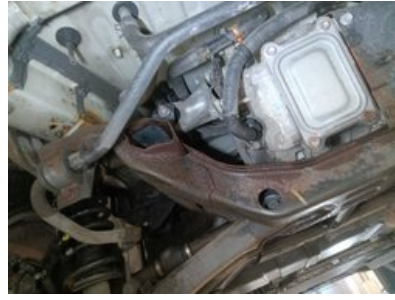
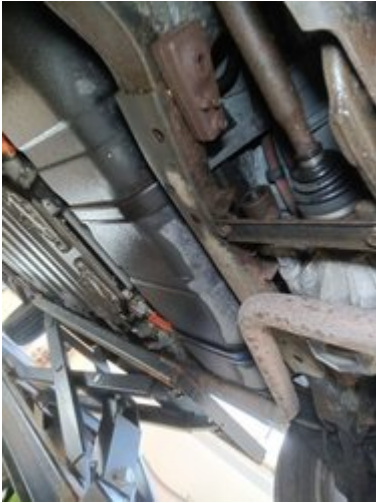
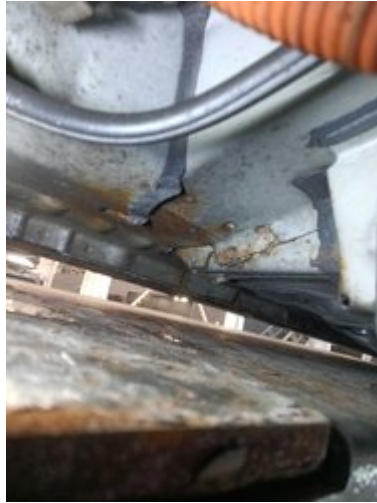
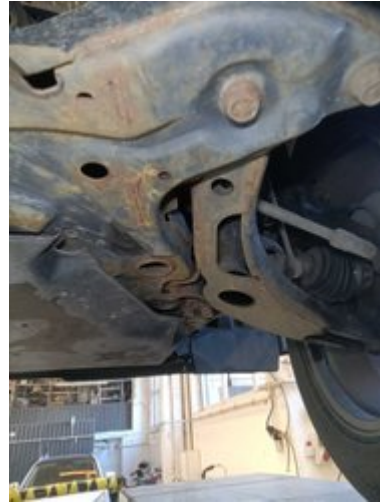
7. BODY - REAR SECTION: Corrosion
