# Diagnosis report of 2015 TOYOTA AURIS Aspiration

| Mileage on completion date: 183 122 km |

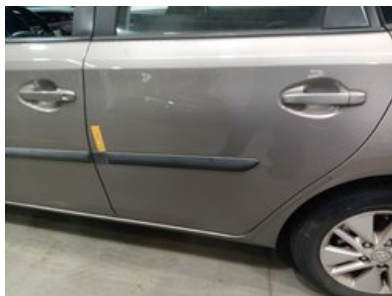
### ✓ 1. Side: Left and Right Side - Visual Damage and Scratches

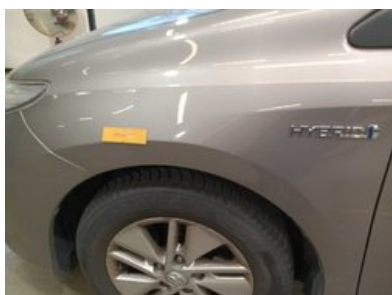
### ✓ 2. Side: Left and Right Side - Visual Damage and Scratches

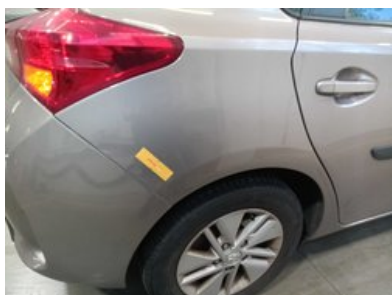
### ✓ 3. Side: Left and Right Side - Visual Damage and Scratches

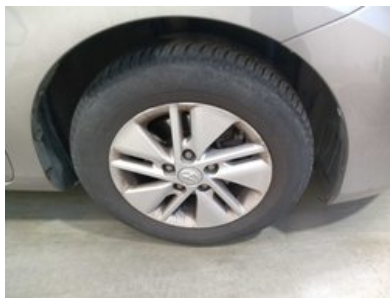
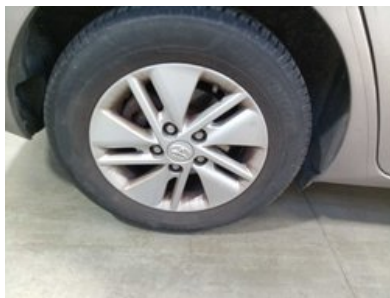
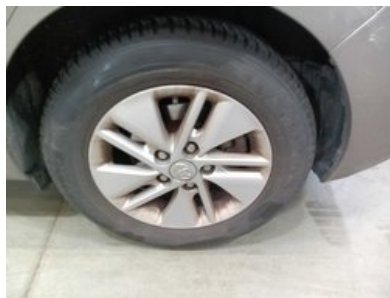
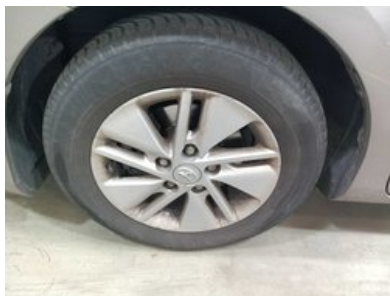
✓ **4. Side:** Wheels - Condition

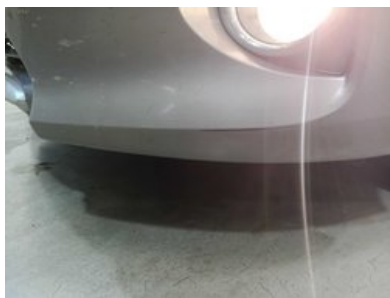
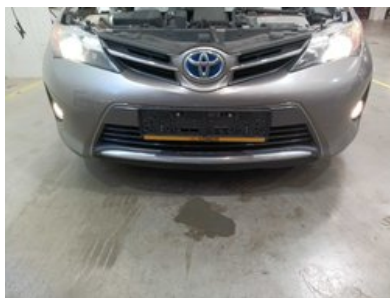
✓ **5. Front:** Front Bumper - Condition and Alignment

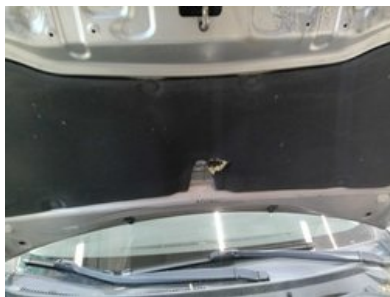
✓ **6. Front:** Hood Sound Insulation - Condition

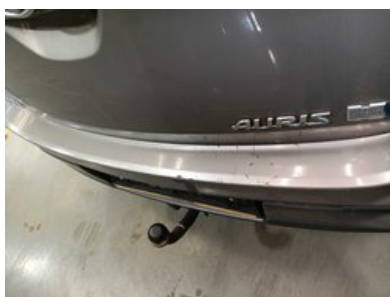
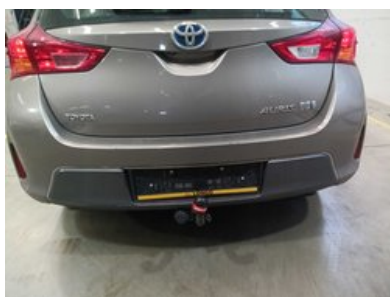
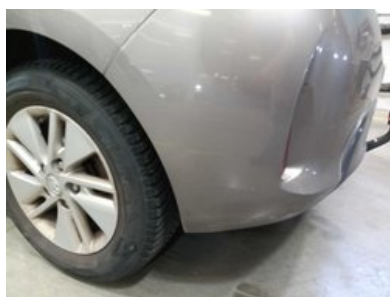
✓ **7. Rear:** Rear Bumper - Condition and Alignment

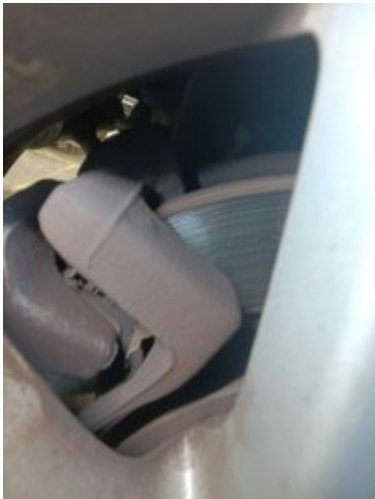
### ✓ 1. BRAKES: Rear Brake Disc (Both)

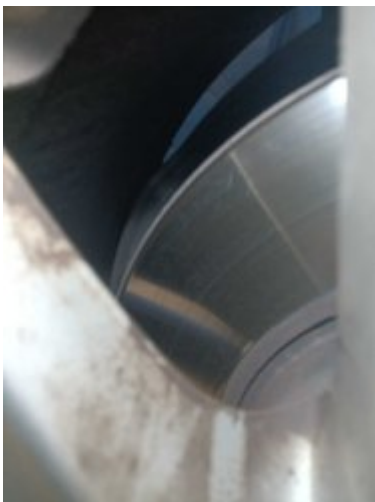
### ✓ 2. BRAKES: Front Brake Discs Both

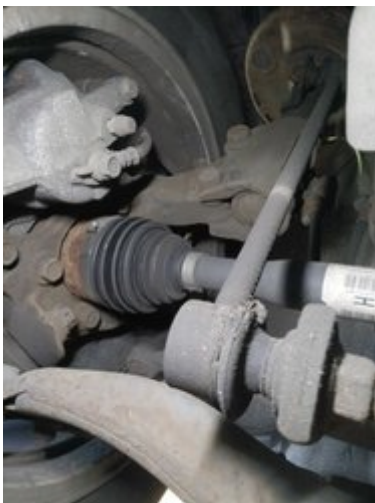
### ✓ 3. SUSPENSION: Anti-Roll Bar
