# Diagnosis report of 2021 PEUGEOT 2008 Allure

# Preparation and repair report of 2021 PEUGEOT 2008 Allure

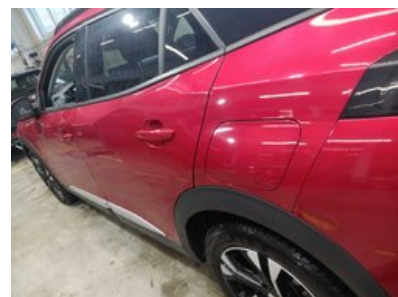
- ✔ 1. Other: Additional Polishing Tasks

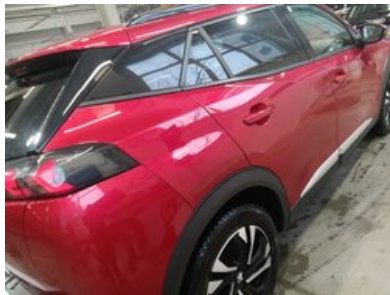
✓ **2. Other:** Additional Polishing Tasks

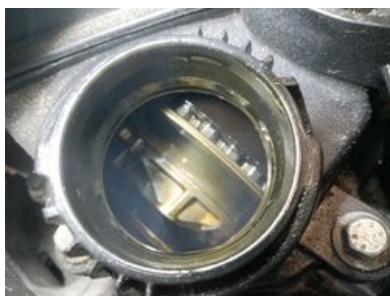
✓ **1. ENGINE:** Camshaft Drive Belt and Coolant Pump Kit

- ✓ 1. Charge Battery
- ✓ 2. Engine Oil & Filter Change
- ✓ 3. Camshaft Drive Belt and Coolant Pump Kit
- ✓ 4. Camshaft/Valve Cover & Gasket

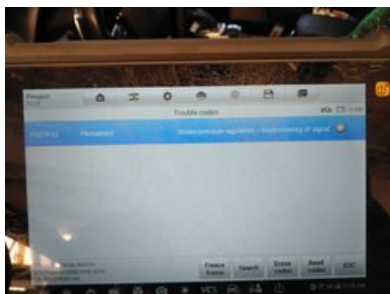
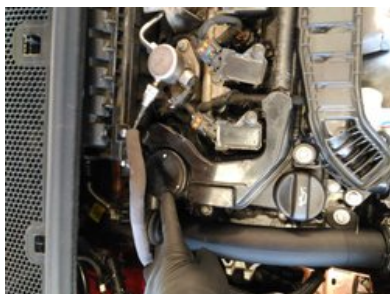
✓ **2. ENGINE:** Camshaft Valve Cover & Gasket

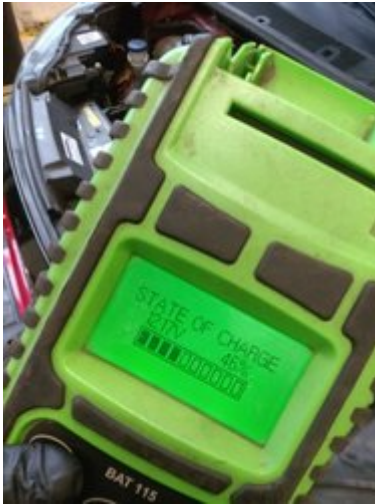
✓ **4. OTHER:** Charge Battery

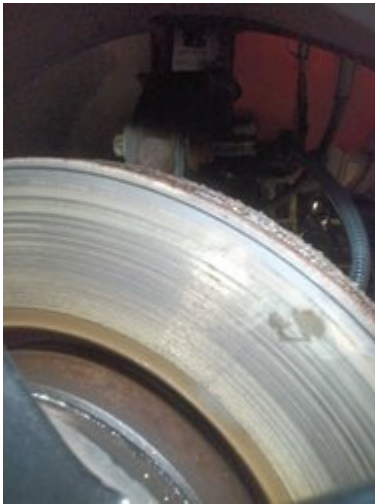
✓ **5. BRAKES:** Front Brake Discs Both

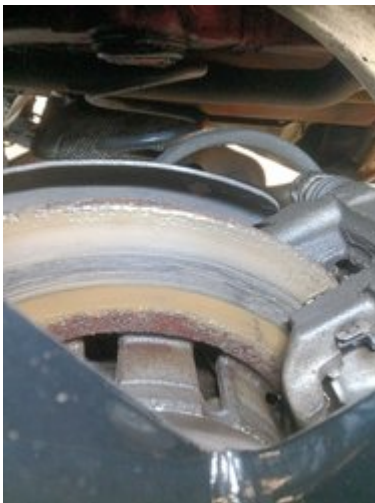
✓ **6. BRAKES:** Rear Brake Disc (Both)
