# Diagnosis report of 2022 PEUGEOT 2008 Allure

## Diagnosis details

## Summary of diagnosed issues

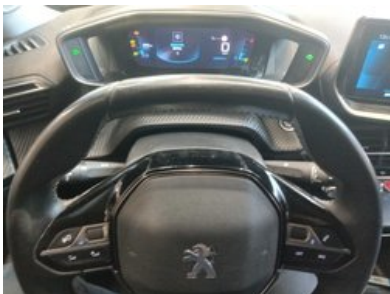
✔ **1. Front:** Steering Wheel - Condition

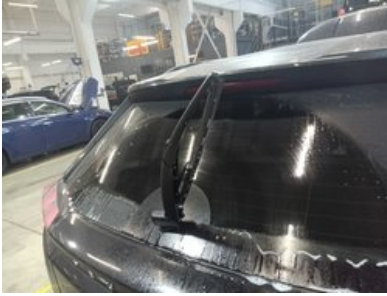
- ✓ **2. Front:** Window Wiper Rubber and Handle (Front and Rear) - Condition

- ✓ 1. Change Rear Wiper (Mechanical)
- ✓ 2. Engine Camshaft Repair "Sandwich"
- ✓ 3. Engine Oil & Filter Change
- ✓ 4. Charge Battery

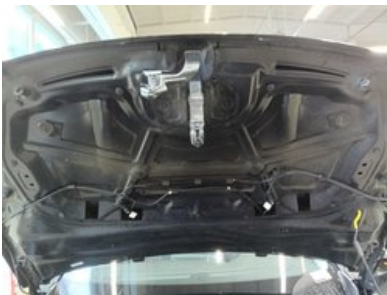
- ✓ **1. Front:** Hood Sound Insulation - Condition

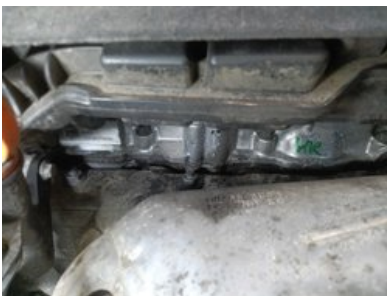
- ✓ **1. OTHER:** Engine Oil & Filter Change
- ✓ **2. OTHER:** Charge Battery
- ✓ **3. OTHER:** Engine Camshaft Repair "Sandwich"

- 1. AdBlue 9L
- 2. Engine Oil 4L
- 3. Fuel Injector Gasket (F00VC17504)
- 4. Wiper, Rear (3397004629)
- 5. Fuel Pump Repair Kit (EL795110)
- 6. Oil Drain Plug (101250)
- 7. Cylinder Head Cover Gasket (15-11035-01)
- 8. Oil Filter (OE667/6)
- 9. Camshaft Seal - Missing 1 Piece (EL966950)
- 10. Cylinder Head Gasket (929.060)

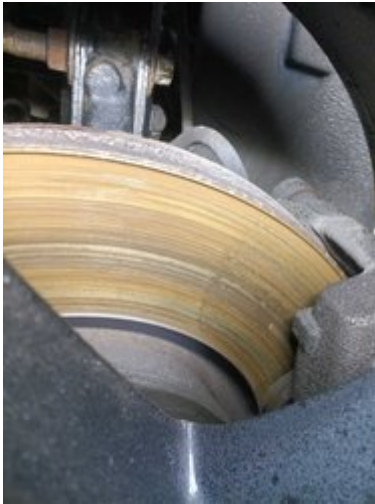
- 
- ✓ **4. BRAKES:** Rear Brake Disc (Both)
-

✓ **5. BRAKES:** Front Brake Discs Both
