# Diagnosis report of 2019 PEUGEOT 2008 Allure

During the comprehensive diagnosis conducted by Longo, 14 issues were identified in the vehicle.

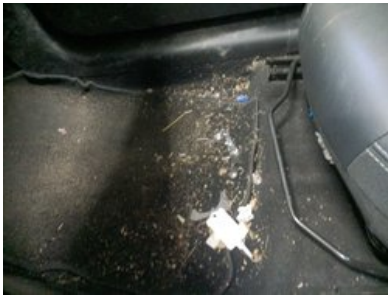
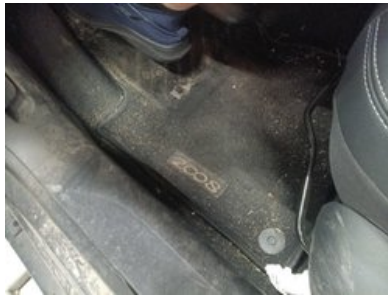
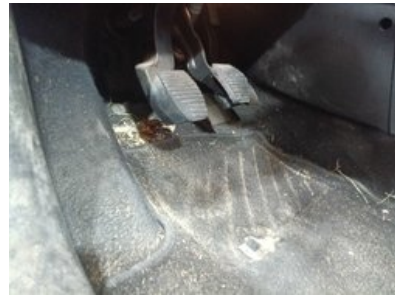
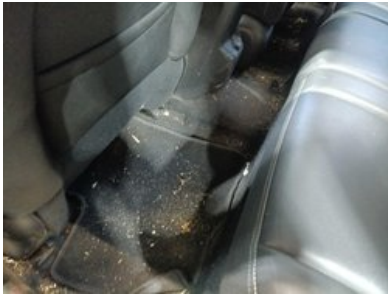
### ✓ 1. Inside: Additional Cleaning Tasks

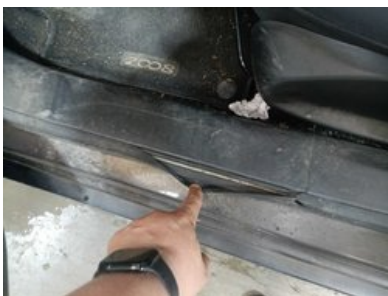
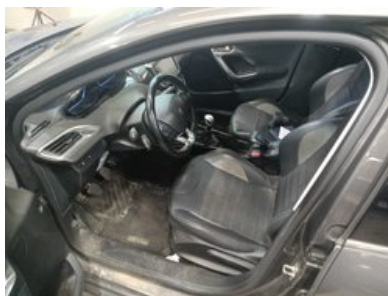
### ✓ 3. Doors: Door Rubber Seals

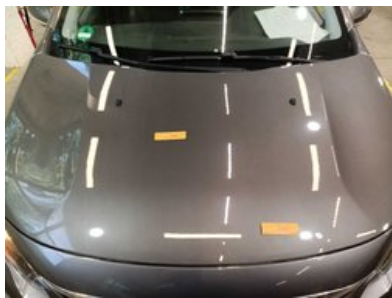
### ✓ 1. Front: Hood - Visual Damage

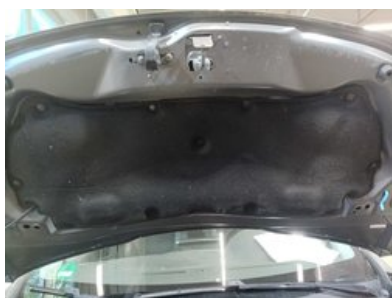
### ✓ 2. Front: Hood Sound Insulation - Condition

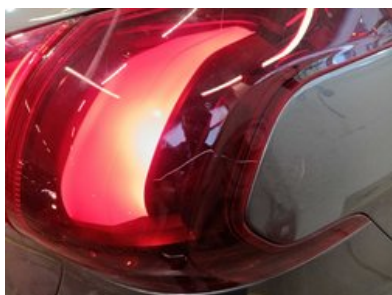
### ✓ 3. Other: Additional Polishing Tasks

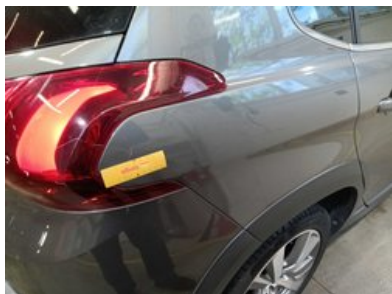
### ✓ 4. Side: Left and Right Side - Visual Damage and Scratches

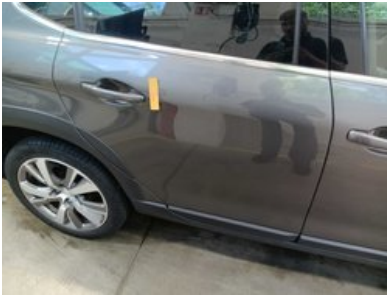
✓ **5. Side:** Left and Right Side - Visual Damage and Scratches

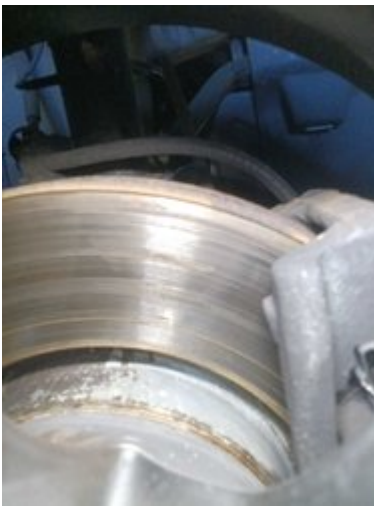
✓ **1. BRAKES:** Front Brake Discs Both

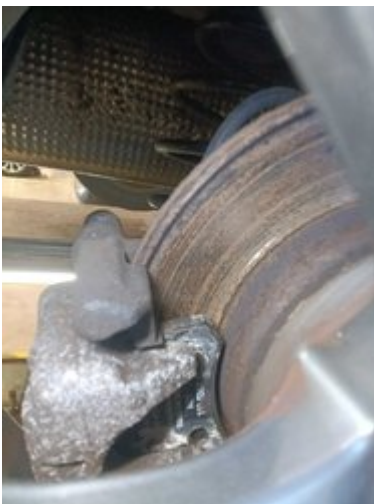
✓ **2. BRAKES:** Rear Brake Disc (Both)

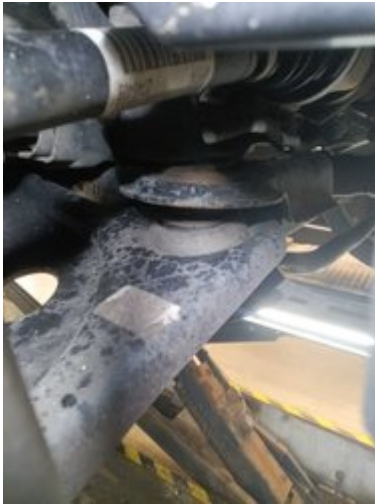
✓ **5. SUSPENSION:** Suspension Lower Arm Both

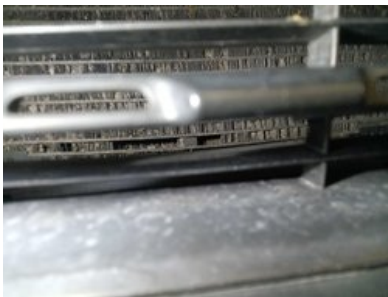
✓ **6. AIR CONDITIONING AND HEATING:** Condenser
