# Diagnosis report of 2016 OPEL MOKKA Innovation

# Preparation and repair report of 2016 OPEL MOKKA Innovation

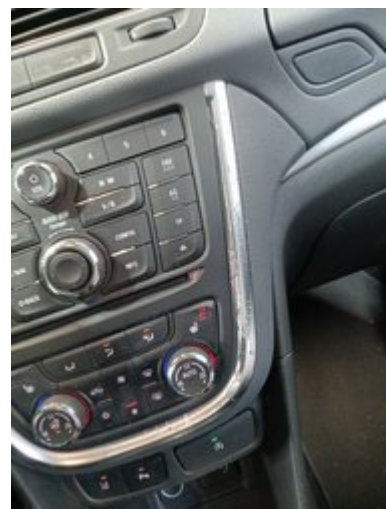
- ✔ 1. Front: Trims - Condition

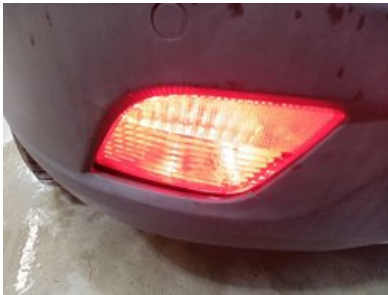
- ✓ **1. Lights:** Rear Lights (Brake, Fog, Indicator) - Basic Functioning, Damage, and Color

- ✓ 1. Change Rear Fog Lights

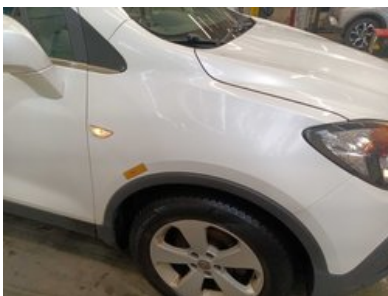
- ✓ **2. Side:** Left and Right Side - Visual Damage and Scratches

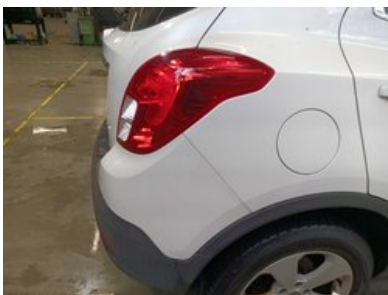
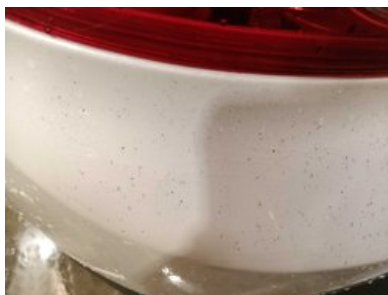
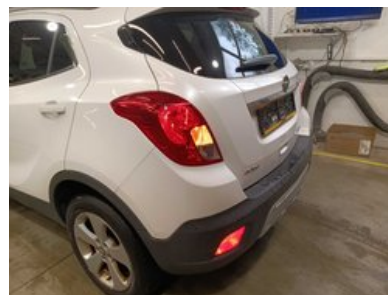
- ✓ **3. Rear:** Rear Bumper - Condition and Alignment

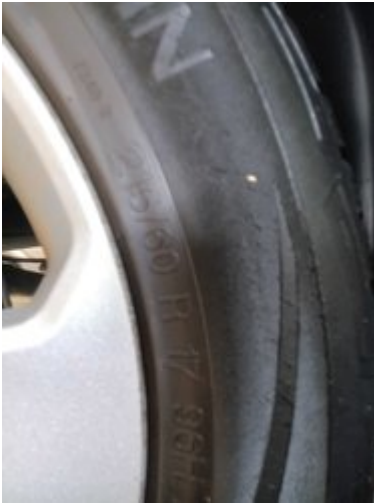
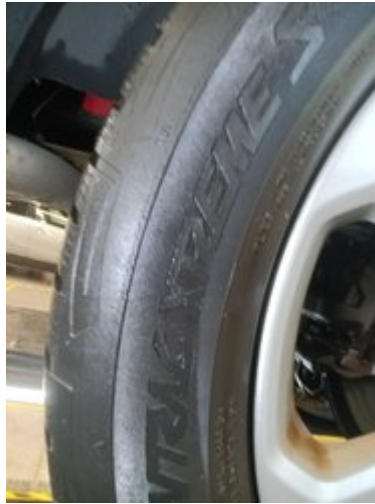
✓ **3. OTHER:** Change Tires

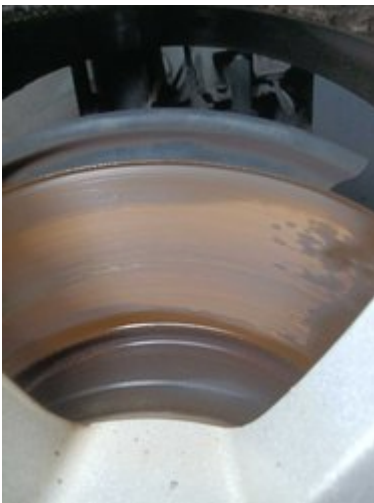
✓ **4. BRAKES:** Front Brake Discs Both

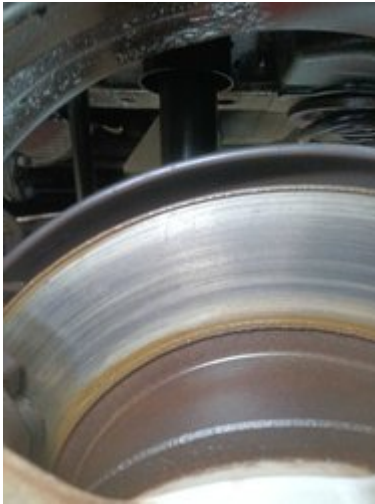
✓ **5. BRAKES:** Rear Brake Disc (Both)

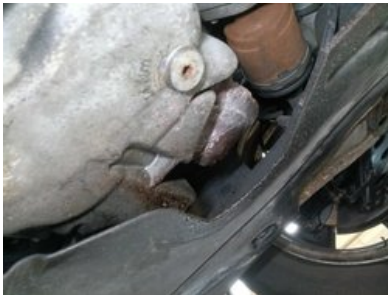
✓ **6. COOLING SYSTEM:** Water Pump

- ✓ 1. Water Pump
- ✓ 2. Engine Oil & Filter Change
