# Diagnosis report of 2015 KIA CEED ComfortLine

# Preparation and repair report of 2015 KIA CEED ComfortLine

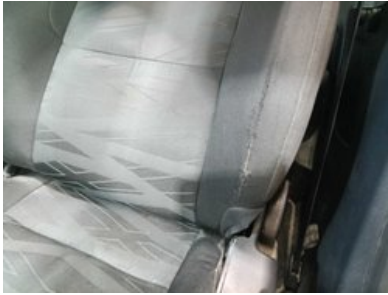
### ✓ 1. Seats: All Seats - Condition

- ✓ 1. Body wet wash
- ✓ 2. Full interior deep clean using only hypoallergenic cleaning products
- ✓ 3. Post cleaning body polish

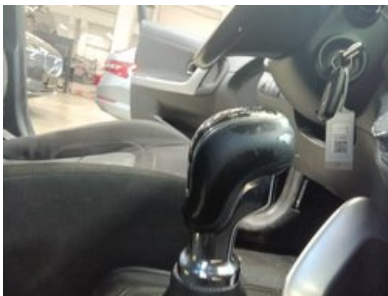
### ✓ 2. Inside: Gear Shift Boot and Gear Shift Knob - Condition

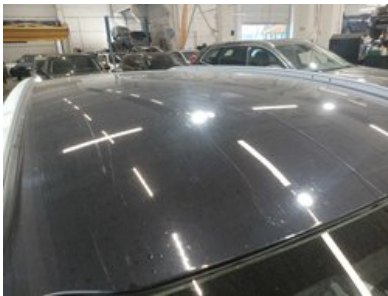
### ✓ 1. Other: Additional Polishing Tasks

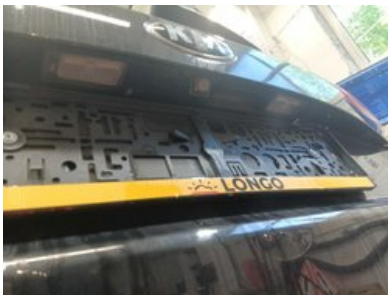
### ✓ 2. Lights: Light Bulbs

- ✓ 1. Yaw Rate and G Sensor
- ✓ 2. Engine Oil & Filter Change
- ✓ 3. Change Bulb for License Plate Lights
- ✓ 4. Anti-Roll Bar Link - Outer

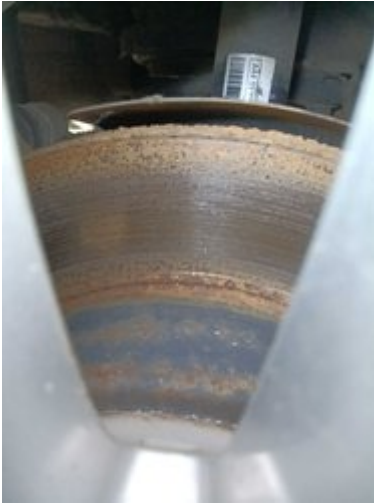
✓ **2. BRAKES:** Rear Brake Disc (Both) with Pads

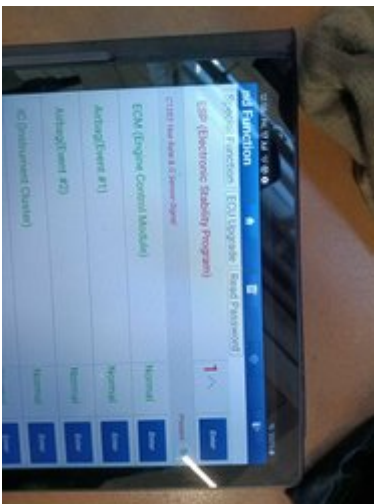
✓ **3. ENGINE:** Yaw Rate and G Sensor

- 1. Engine Oil 3.6L
- 2. Oil Filter (OP617/1)
- 3. Stabilizer Link (TC2663)
- 4. Oil Pan Seal (85932456)
- 5. ESP Acceleration Yaw Rate Sensor Hyundai 956903X100 (EFB128)

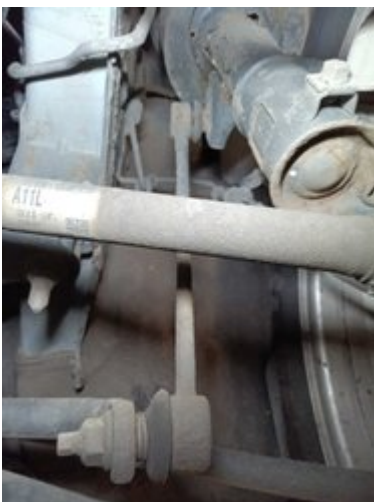
✓ **4. SUSPENSION:** Anti-Roll Bar Link, Outer
