# Diagnosis report of 2017 PEUGEOT 308 Allure

# Preparation and repair report of 2017 PEUGEOT 308 Allure

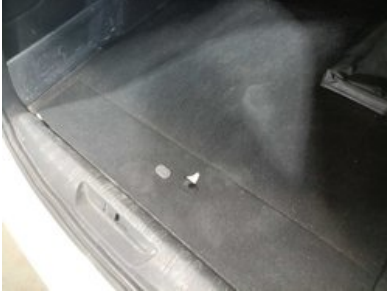
### ✓ 1. Inside: Carpets - Condition

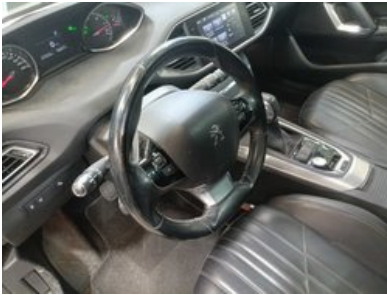
### ✓ 2. Front: Steering Wheel - Condition

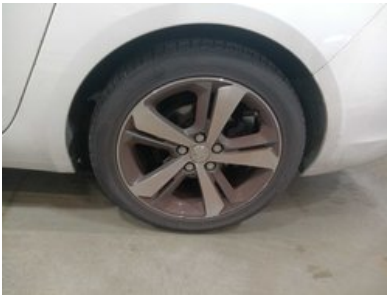
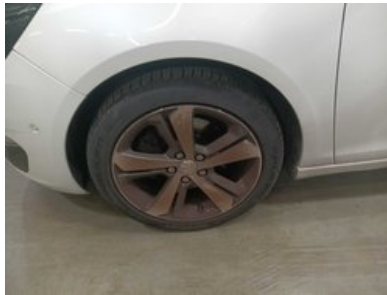
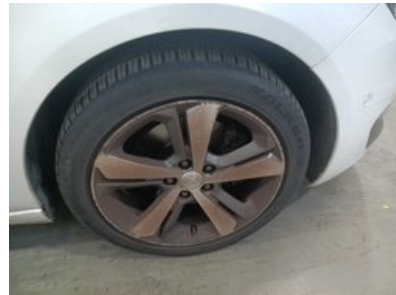
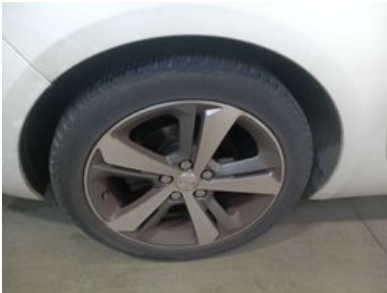
### ✓ 1. Side: Wheels - Condition

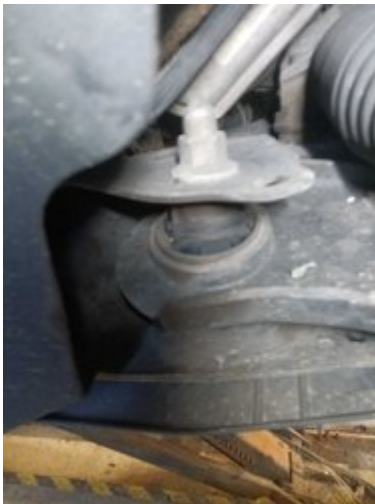
✓ **2. SUSPENSION:** Suspension Lower Arm

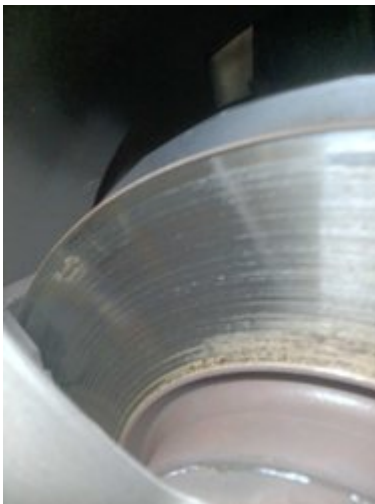
✓ **3. BRAKES:** Front Brake Discs Both

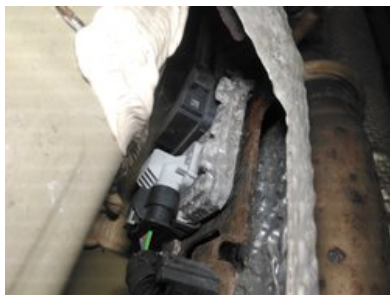
✓ **4. EXHAUST SYSTEM:** NOx

- ✓ 1. NOx
- ✓ 2. Engine Oil & Filter Change

- 1. Engine Oil 5.3L
- 2. Oil Filter (OP540/1)
- 3. Oil Drain Plug (257.865.001)
- 4. NOX Sensor PSA 9678570780 (JOT24483)
