# Diagnosis report of 2015 OPEL MOKKA Active

During the comprehensive diagnosis conducted by Longo, 15 issues were identified in the vehicle.

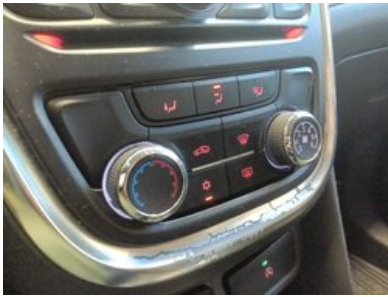
✓ **1. Front:** Trims - Condition

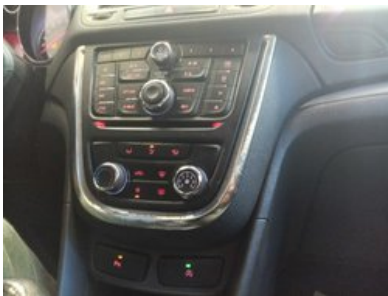
✓ **2. Front:** Trims - Condition

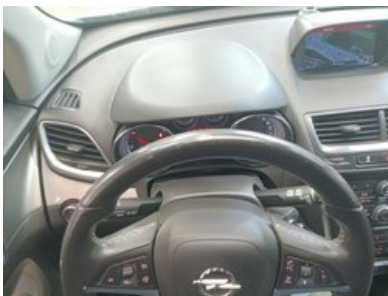
✓ **3. Front:** Steering Wheel - Condition

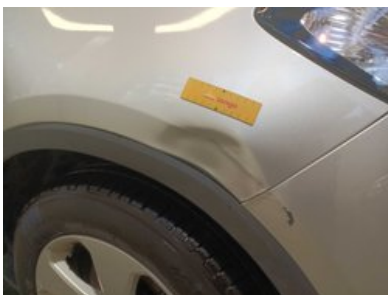
✓ **1. Side:** Left and Right Side - Visual Damage and Scratches

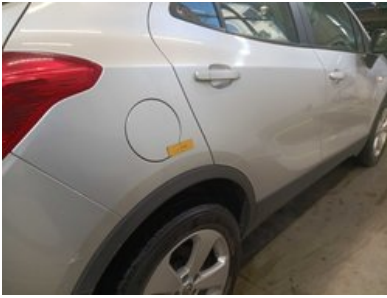
✓ **2. Side:** Left and Right Side - Visual Damage and Scratches

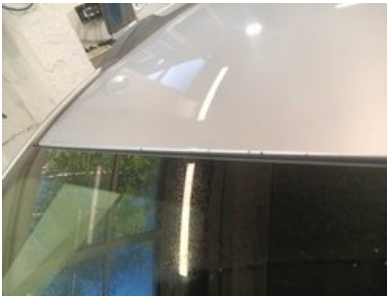
✓ **3. Other:** Roof - Visual Damage (e.g., Hail Damage)

- ✓ 1. Change Element in Front Panel
- ✓ 2. Other: PDR in LSS

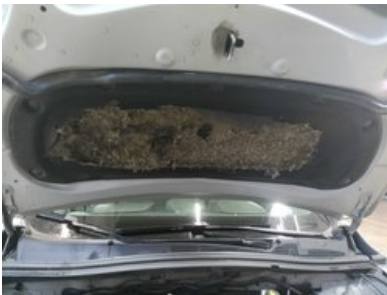
✓ **4. Front:** Hood Sound Insulation - Condition

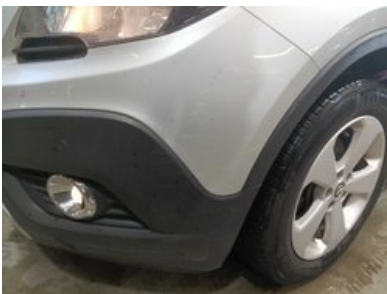
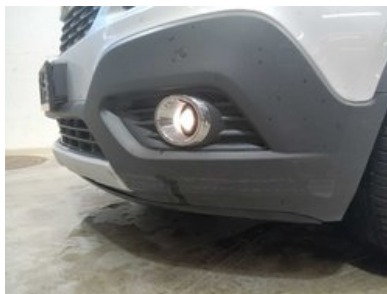
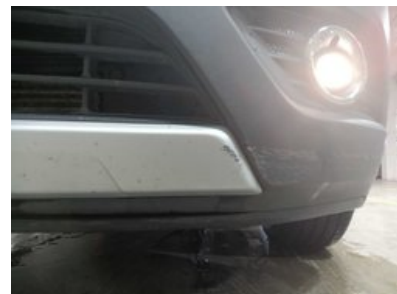
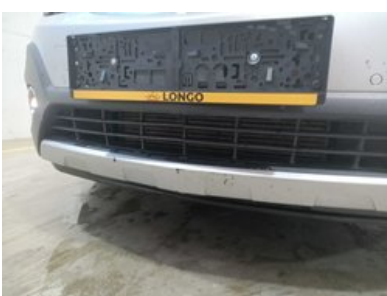
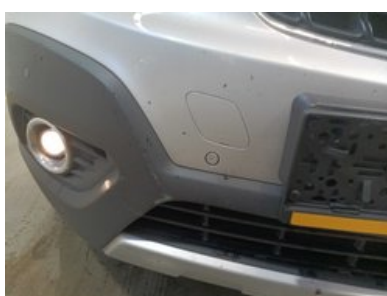
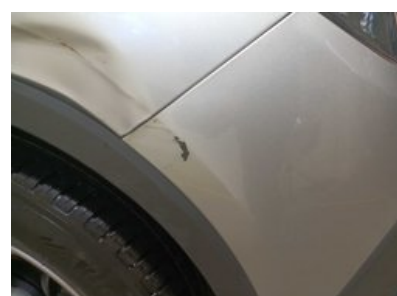
✓ **5. Front:** Front Bumper - Condition and Alignment

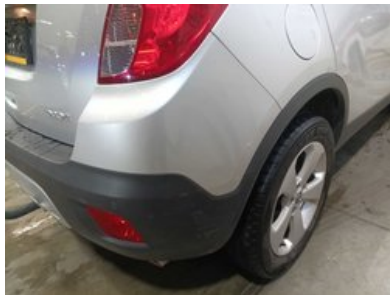
✓ **6. Rear:** Rear Bumper - Condition and Alignment

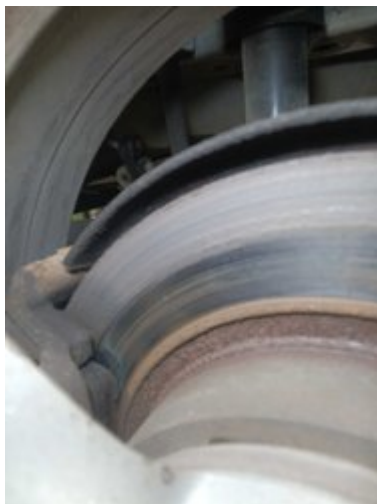
✓ **2. BRAKES:** Rear Brake Disc (Both)

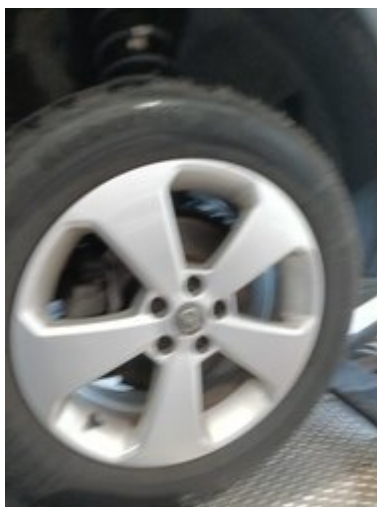
✓ **3. FINAL DRIVE, SHAFT & AXLES:** Wheel Bearing Set

- ✓ 1. Track Rod End Joint
- ✓ 2. Front Wheel Alignment (Toe)
- ✓ 3. Ball Joint - Lower (Both)
- ✓ 4. Wheel Bearing Set
- ✓ 5. Engine Oil & Filter Change

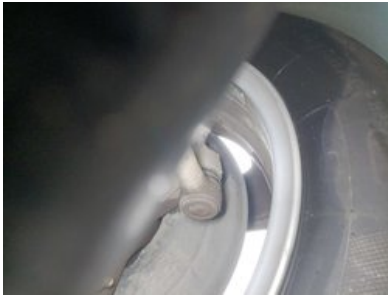
✓ **5. STEERING:** Track Rod End Joint
