# Diagnosis report of 2018 TOYOTA C-HR Executive

# Preparation and repair report of 2018 TOYOTA C-HR Executive

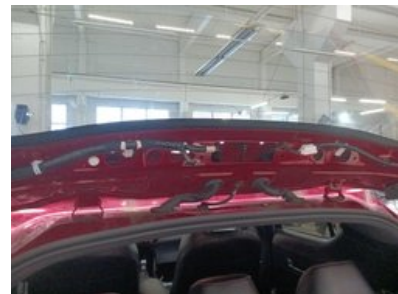
- ✔ 1. Front: Window Wash System - Functioning (Front and Rear)

- ✓ 1. Repair Washer Mechanism

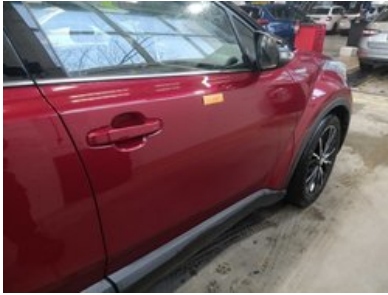
- ✓ **1. Side:** Left and Right Side - Visual Damage and Scratches

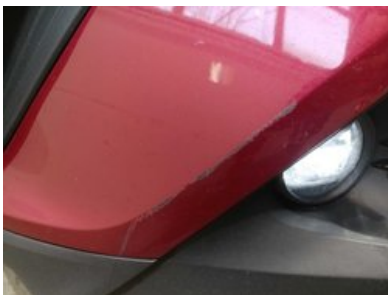
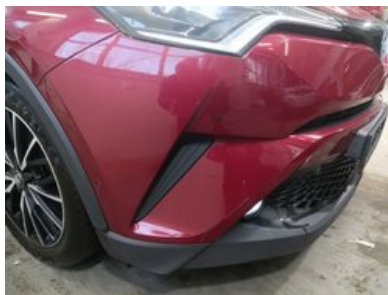
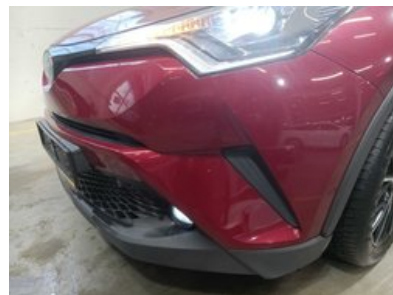
- ✓ **2. Front:** Front Bumper - Condition and Alignment

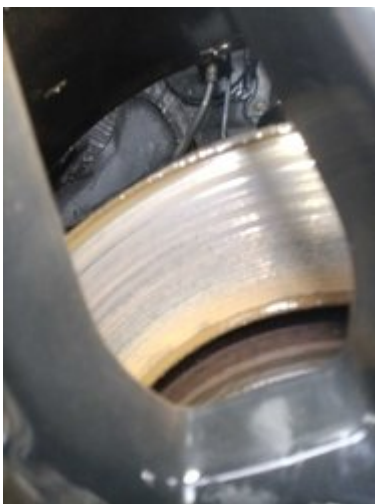
- ✓ **2. BRAKES:** Front Brake Discs Both

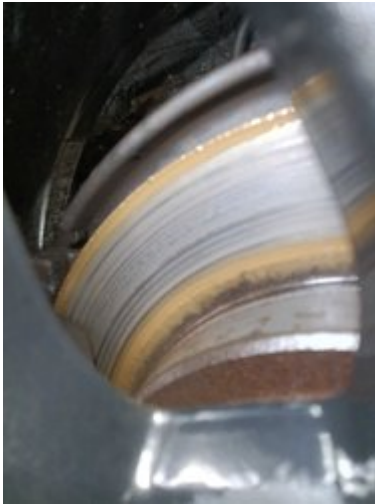
✓ **3. BRAKES:** Rear Brake Disc (Both)

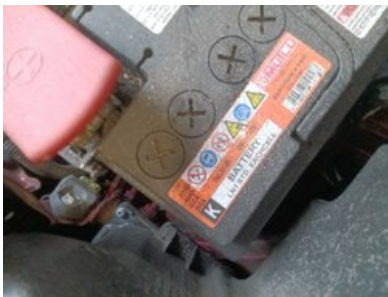
✓ **4. GENERAL ELECTRICS:** Battery

- ✓ 1. Battery
- ✓ 2. Engine Oil & Filter Change
- ✓ 3. System Evacuation/Recharging
