# Diagnosis report of 2016 HYUNDAI TUCSON Executive

## Diagnosis details

## Summary of diagnosed issues

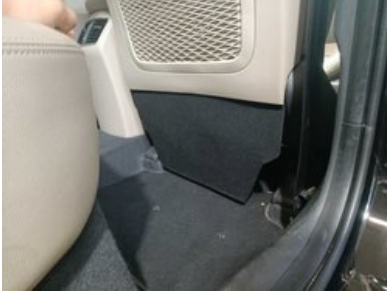
- ✓ **1. Seats:** All Seats - Condition

- ✓ 1. Change Lights on Car Side
- ✓ 2. Repair Seat

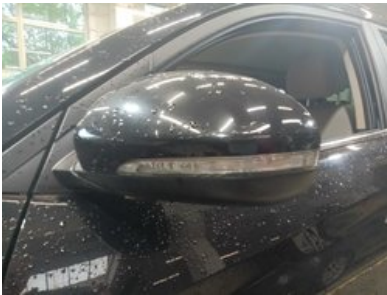
- ✓ **1. Lights:** Car Side Lights - Basic Functioning, Damage, and Color

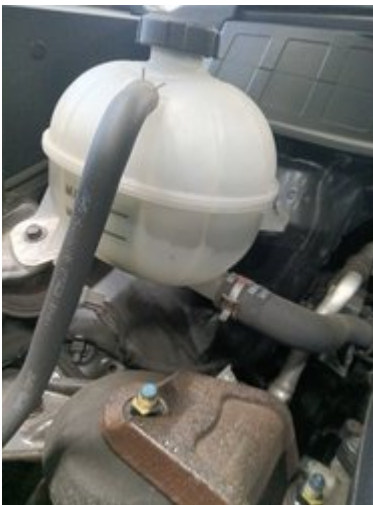
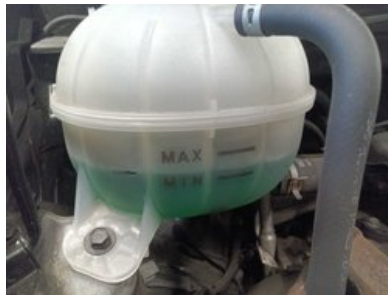
- ✓ **1. OTHER:** Coolant Refill

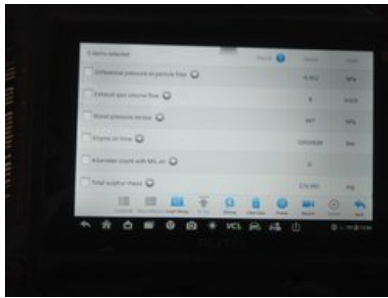
✓ **4. OTHER:** DPF Filter Regeneration/Cleaning

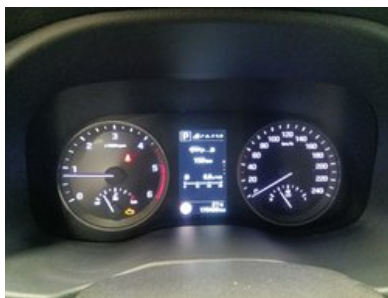
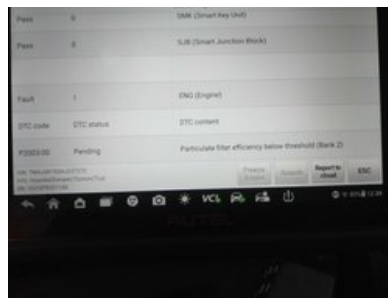
✓ **5. OTHER:** Check Failures
