# Diagnosis report of 2018 PEUGEOT 3008 Executive

# Preparation and repair report of 2018 PEUGEOT 3008 Executive

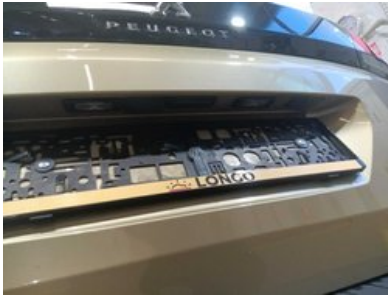
✓ **2. Lights:** Light Bulbs

- ✓ 1. Stabilizer Link
- ✓ 2. Change Bulb for License Plate Lights
- ✓ 3. Cabin Heater Core

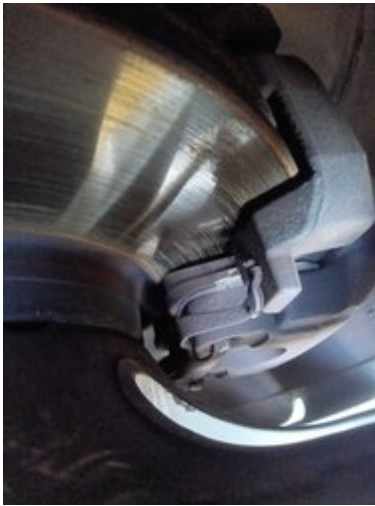
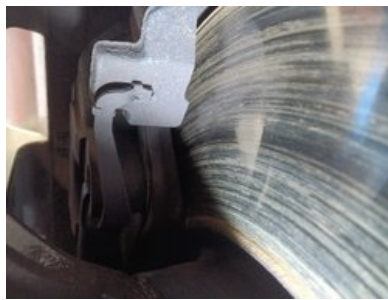
✓ **2. OTHER:** Front Brake Discs Including Pads

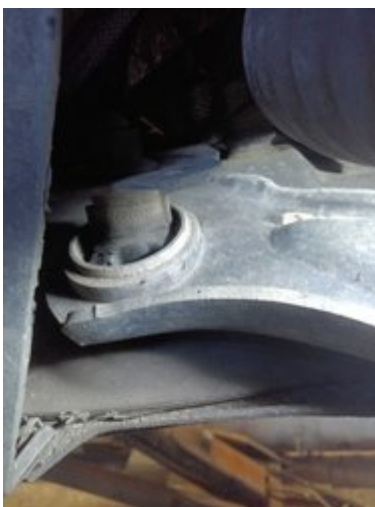
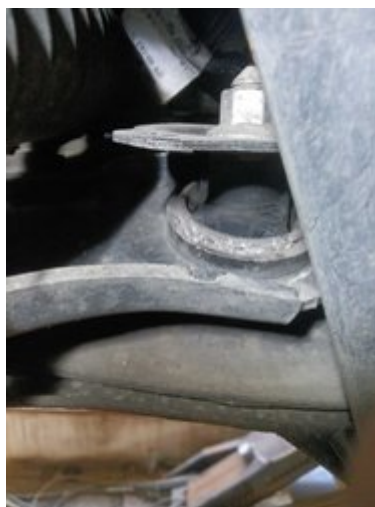
✓ **3. OTHER:** Suspension Lower Arm

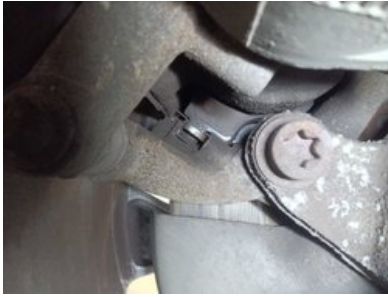
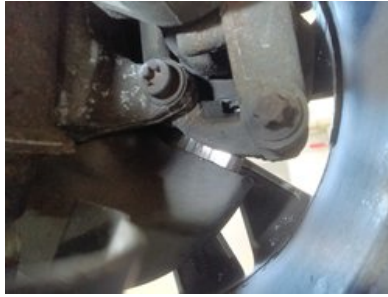
✓ **4. OTHER:** Rear Brake Disc and Pads

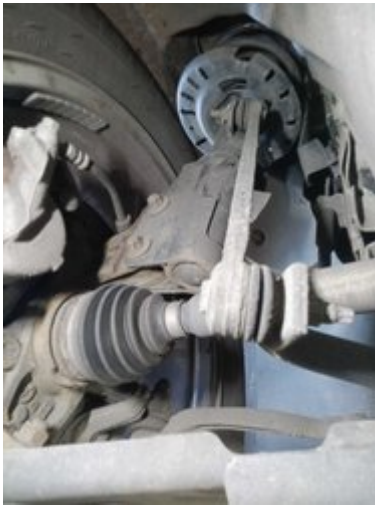
✓ **5. OTHER:** Stabilizer Link

- 1. Stabilizer (FE19397)
- 2. Heat Exchanger, Interior Heating (NRF54422)
