# Diagnosis report of 2017 PEUGEOT 3008 Premium

# Preparation and repair report of 2017 PEUGEOT 3008 Premium

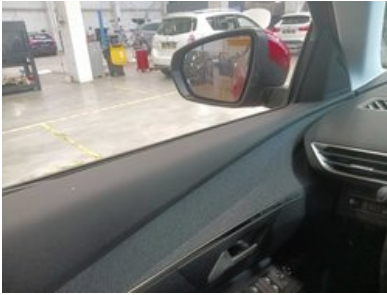
- ✔ **1. Doors:** Exterior Side Mirrors - Electronic Controls, Folding, and Adjustment

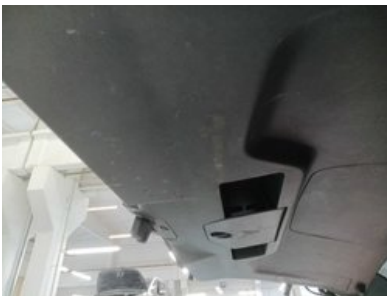
- ✔ **2. Inside:** Trims - Condition

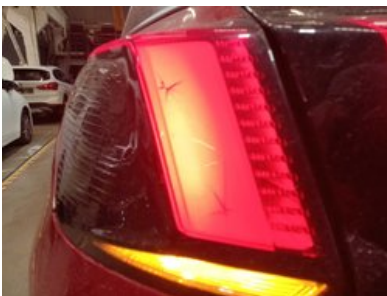
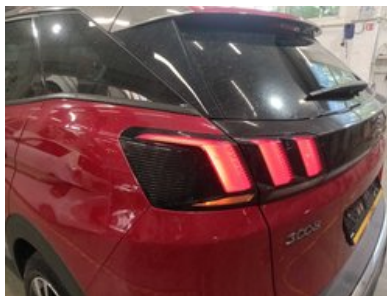
- ✔ **1. Lights:** Rear Lights (Brake, Fog, Indicator) - Basic Functioning, Damage, and Color

- 1. Oil Filter (OP540/1)
- 2. Oil Pan Gasket (834.823)
- 3. Track Rod End (TA2934)
- 4. 5W30 Quartz Ineo RCP 208L 3.5L
- 5. Imperial Tire 205/55R19 97W Ecosport 2 XL Summer (IM000487)
- 6. Tail Light Left Outer 3008 II 9810477180 (PIK19077)

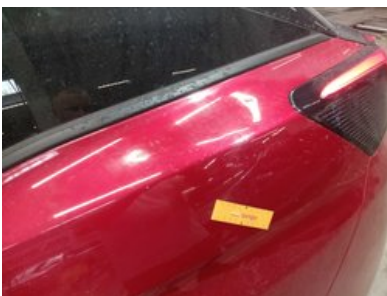
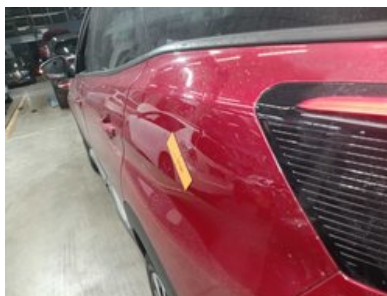
- ✔ **2. Side:** Left and Right Side - Visual Damage and Scratches

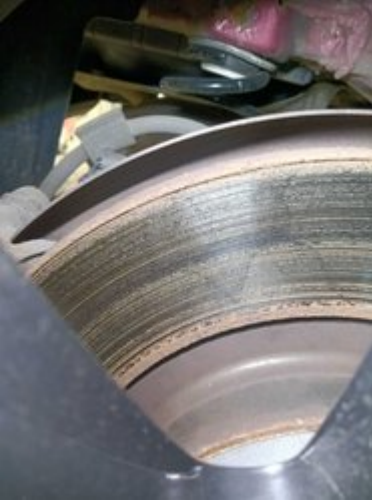
✓ **1. BRAKES:** Rear Brake Disc (Both)

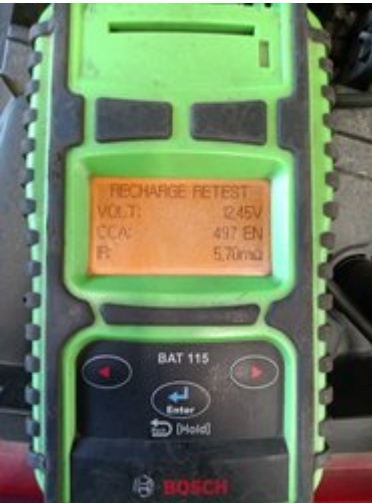
✓ **2. OTHER:** Charge Battery

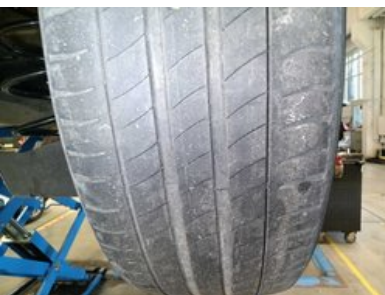
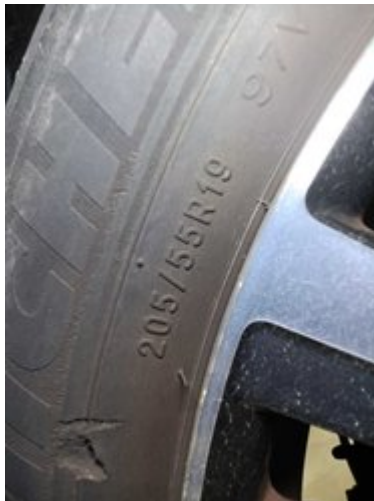
✓ **4. OTHER:** Change Tires

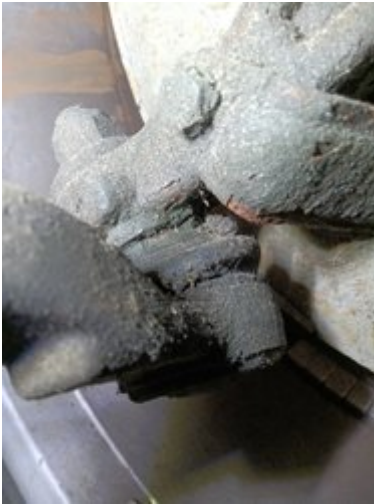
✔ **5. STEERING:** Track Rod End Joint

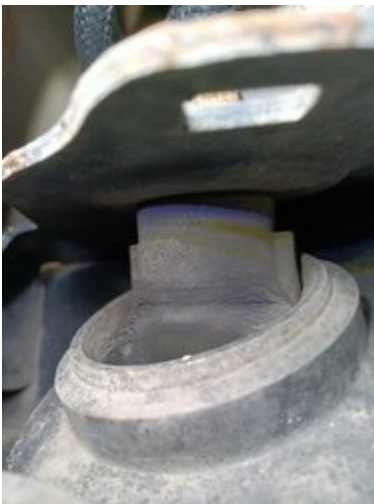
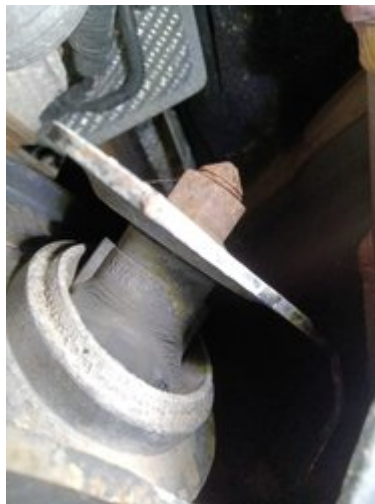
✔ **7. SUSPENSION:** Suspension Lower Arm Bushes Both
