# Diagnosis report of 2019 PEUGEOT 2008 Allure

# Preparation and repair report of 2019 PEUGEOT 2008 Allure

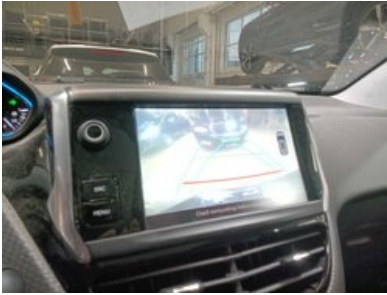
- ✓ **1. Operation:** Rear View Camera / Proximity Sensors - Functioning

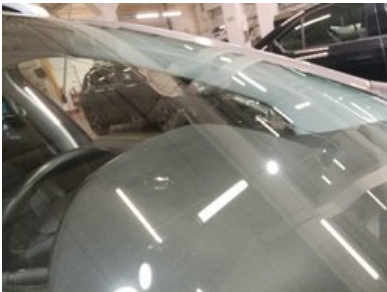
- ✓ **1. Front:** Windscreen Integrity - Free from MOT-Excluding Damage

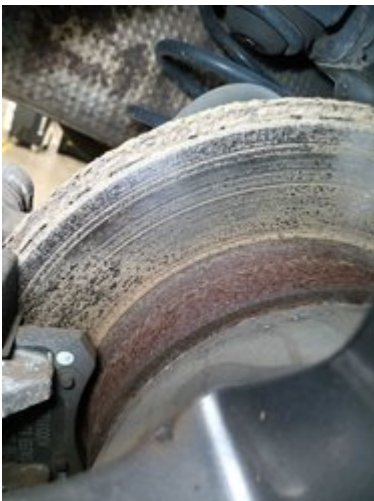
- ✓ **1. BRAKES:** Rear Brake Disc (Both)

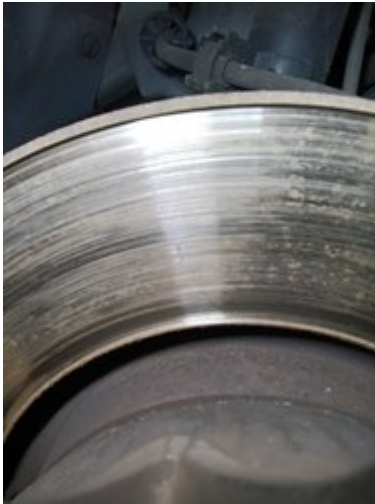
✓ **2. BRAKES:** Front Brake Discs Both

- ✓ 1. Engine Oil & Filter Change
- ✓ 2. Charge Battery
- ✓ 3. Front Brake Discs (Both)
- ✓ 4. Change Tires

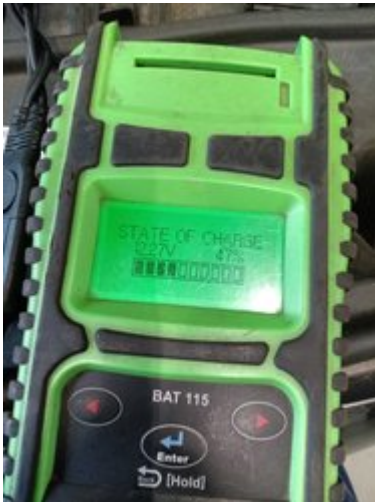
✓ **3. OTHER:** Charge Battery

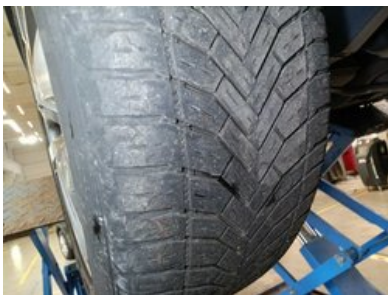
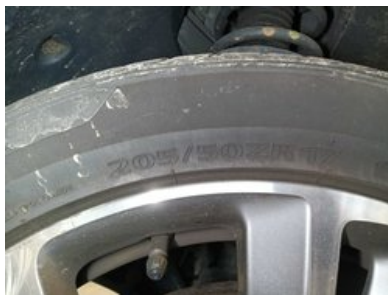
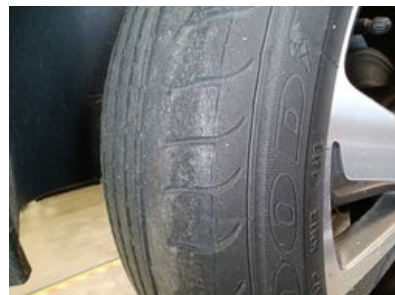
✓ **5. OTHER:** Change Tires

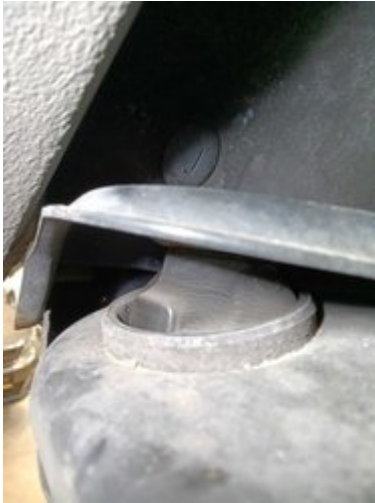
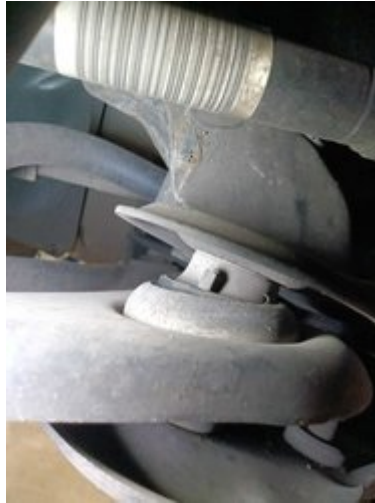
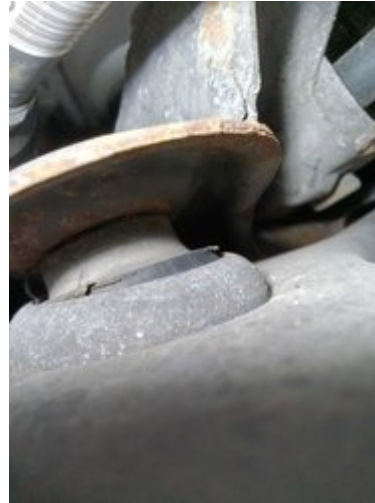
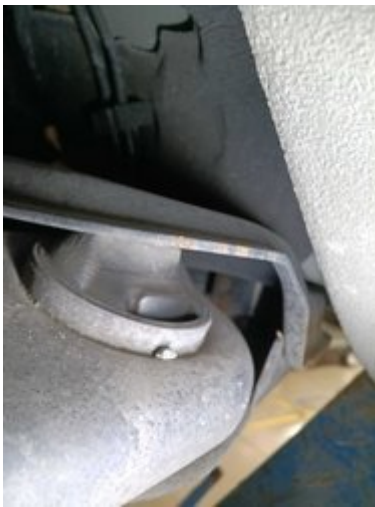
✔ **6. SUSPENSION:** Suspension Lower Arm Both
