# Diagnosis report of 2015 MITSUBISHI OUTLANDER Executiv

During the comprehensive diagnosis conducted by Longo, 14 issues were identified in the vehicle.

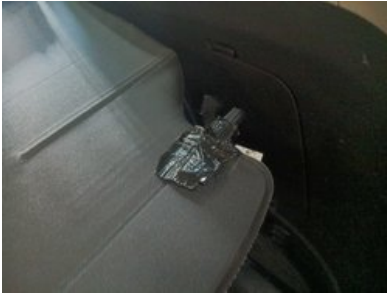
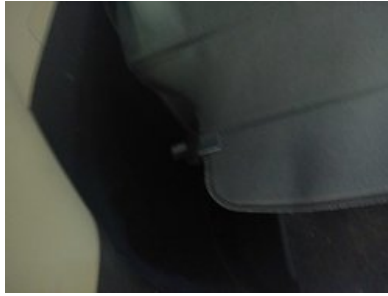
### ✔ 1. Inside: Parcel Shelf - Operation and Condition

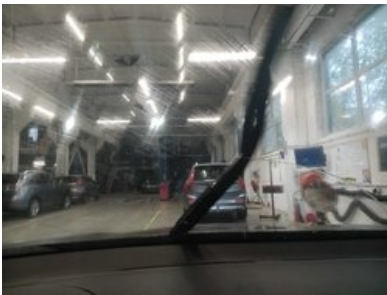
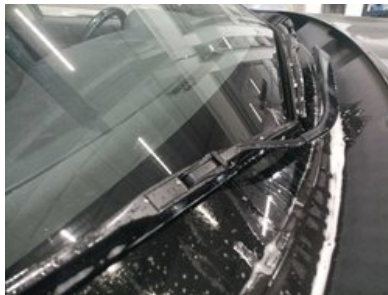
### ✔ 2. Front: Window Wiper Rubber and Handle (Front and Rear) - Condition

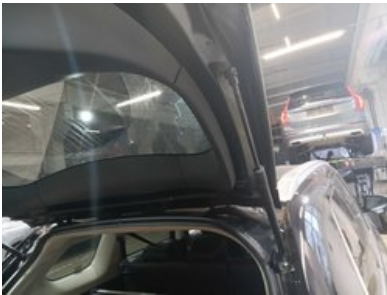
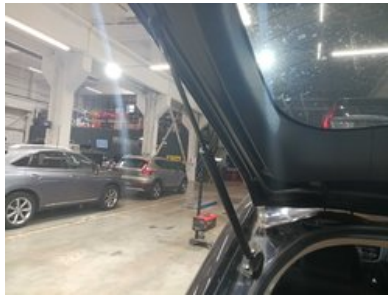
### ✔ 1. Rear: Trunk - Opening and Holding Mechanism

- ✓ 1. Headlamp Alignment
- ✓ 2. Change Trunk Holding Mechanism

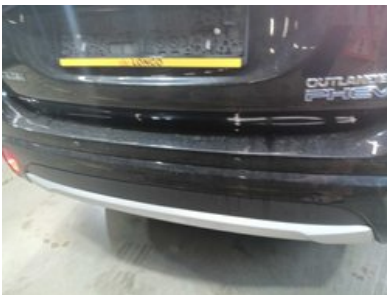
### ✔ 2. Rear: Rear Bumper - Condition and Alignment

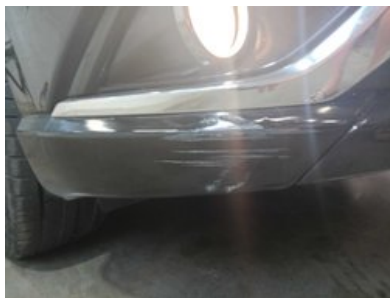
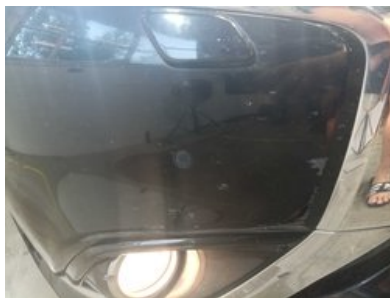
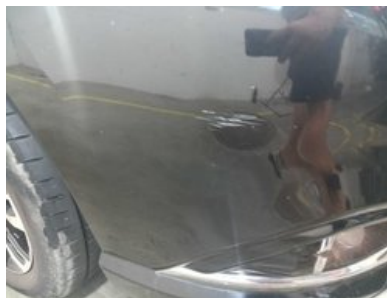
✓ **3. Front:** Front Bumper - Condition and Alignment

- ✓ 1. Paint Front Bumper

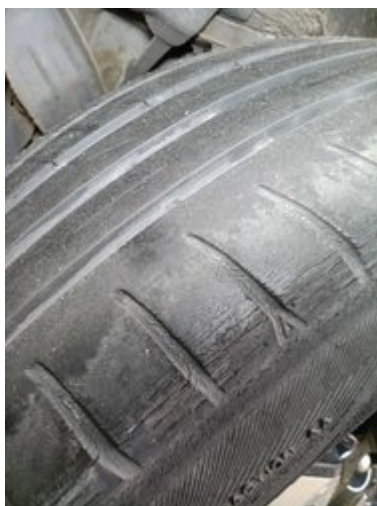
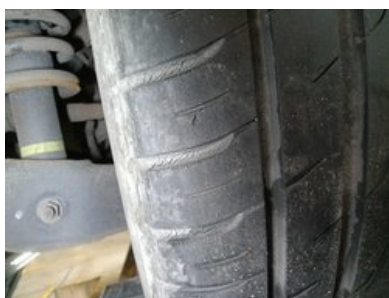
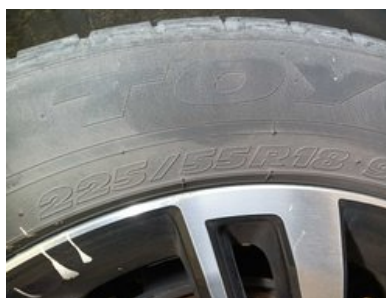
✓ **2. OTHER:** Change Tires

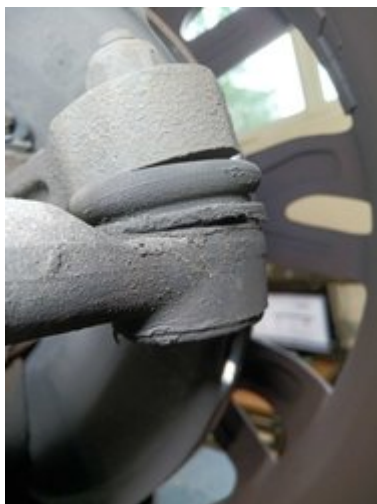
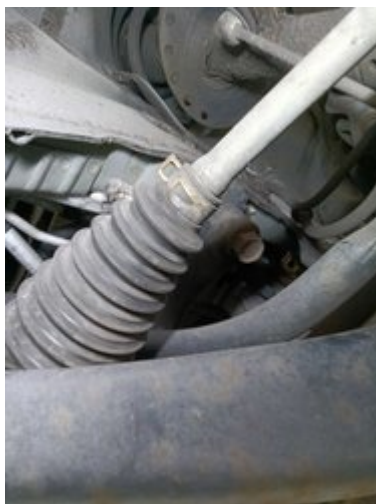
✓ **4. STEERING:** Track Rod

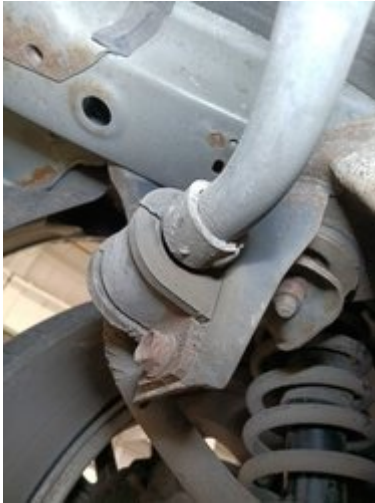
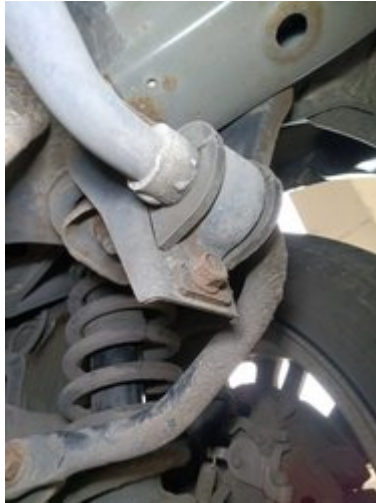
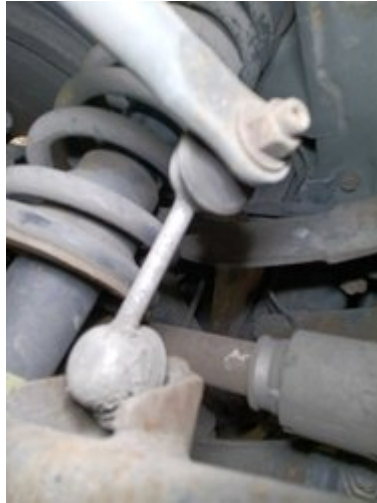
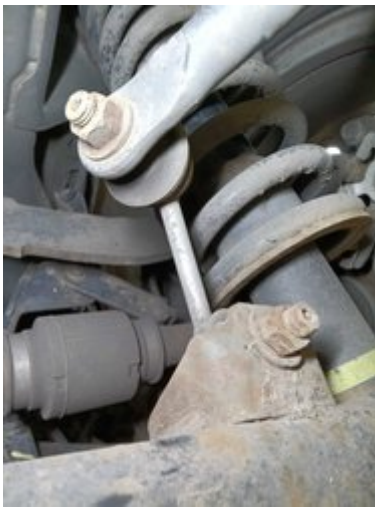
✓ **5. SUSPENSION:** Anti-Roll Bar

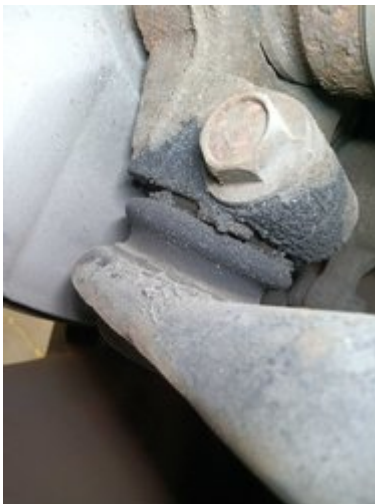
✓ **6. SUSPENSION:** Ball Joint

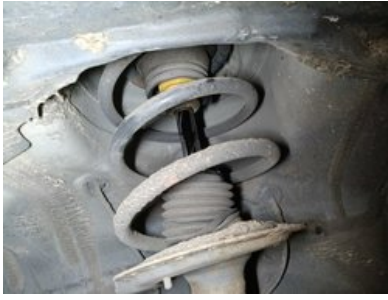
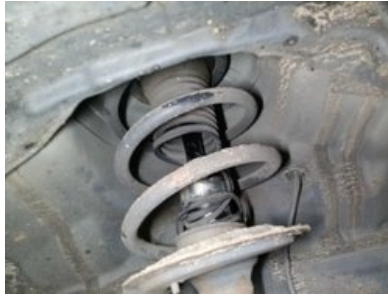
✔ **7. SUSPENSION:** Shock Absorbers Dust Cover

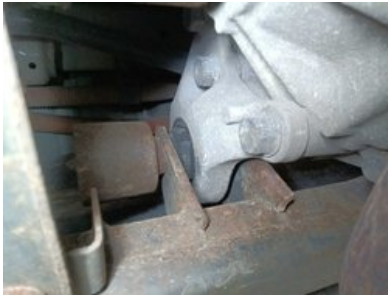
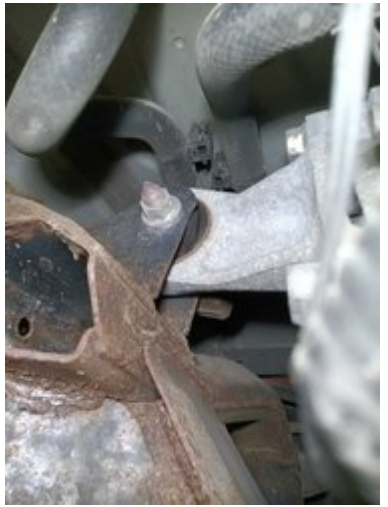
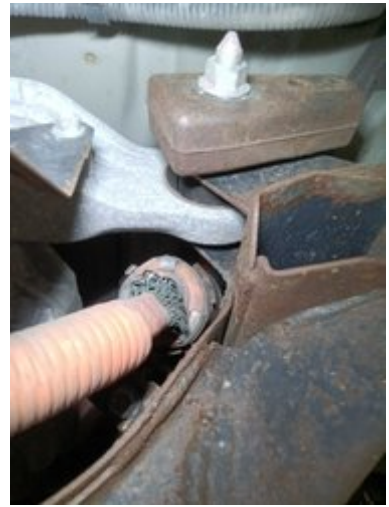
✔ **8. FINAL DRIVE, SHAFT & AXLES:** Differential Bushes

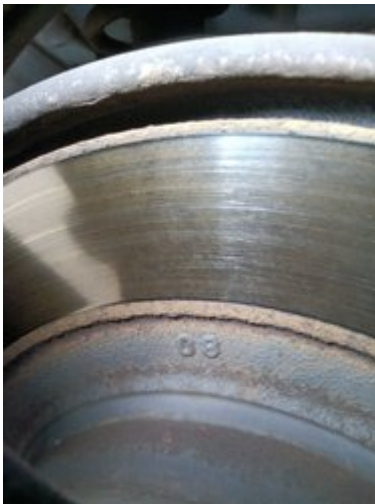
✔ **9. BRAKES:** Rear Brake Disc (Both)
