Diagnosis report of 2015 RENAULT CAPTUR Dynamique

Mileage on completion date: 179 287 km

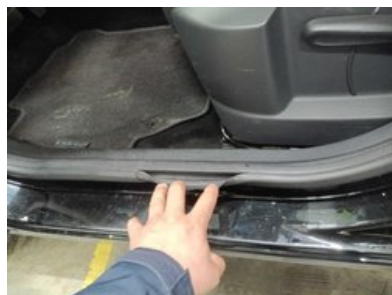
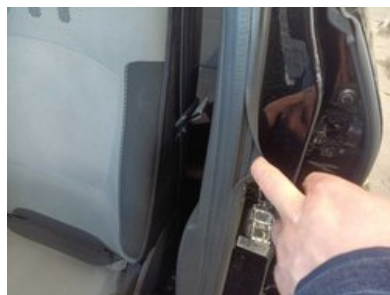
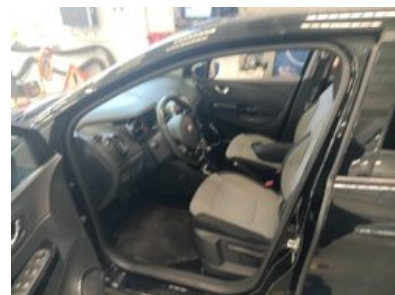
- ✔ **1. Doors:** Door Rubber Seals

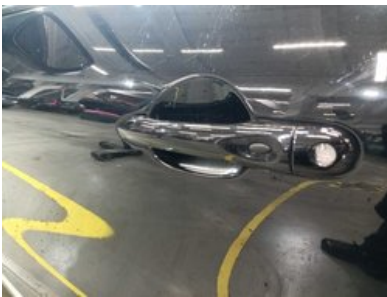
✔ **1. Other:** Door and Trunk Locking Mechanisms Including Fuel Hatch

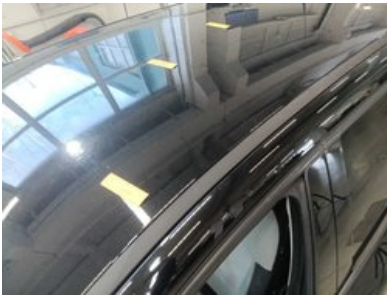
✔ **2. Other:** Roof - Visual Damage (e.g., Hail Damage)

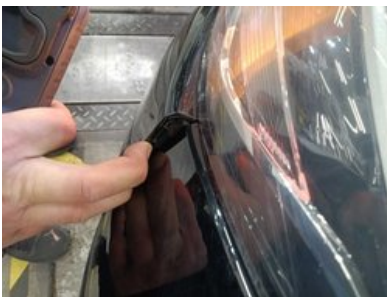
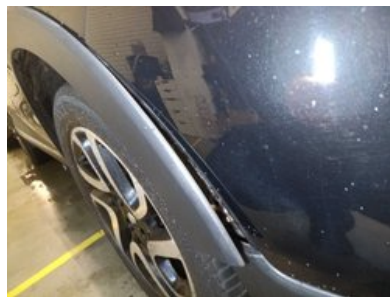
✔ **3. Front:** Front Bumper - Condition and Alignment

- ✔ 1. Other: Attach Normally
- ✔ 2. Windshield Repair
- ✔ 3. Other: Front Bumper Corners and Fender Plastics

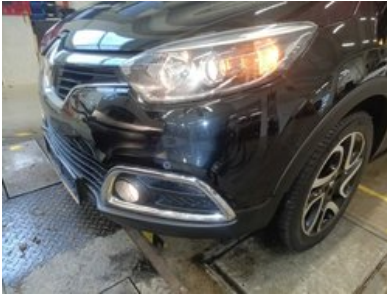
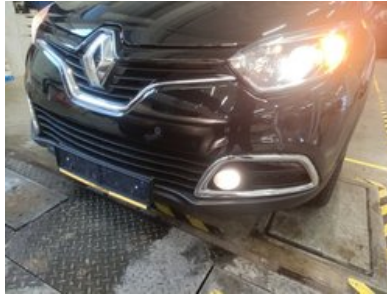
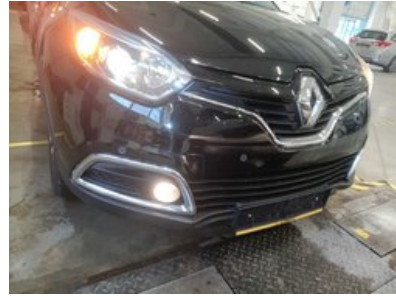
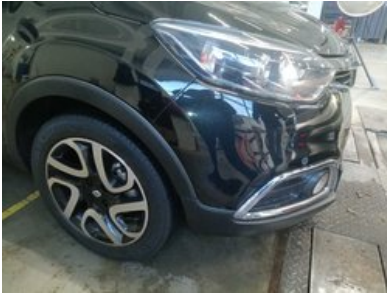
✔ **4. Front:** Front Bumper - Condition and Alignment

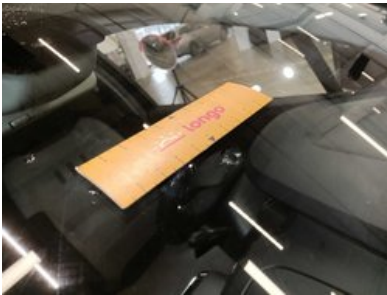
✔ **5. Front:** Windscreen Integrity - Free from MOT-Excluding Damage

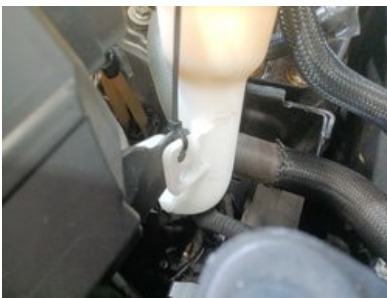
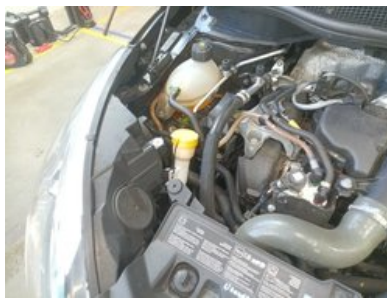
✔ **6. Front:** Window Washer Fluid Level (In Winter Also Winter-Adequate Fluid)

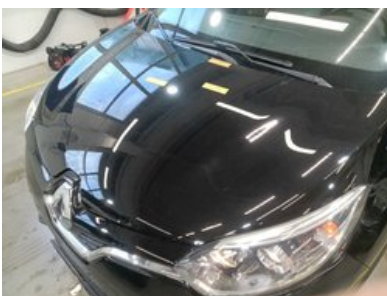
✔ **7. Front:** Hood - Visual Damage

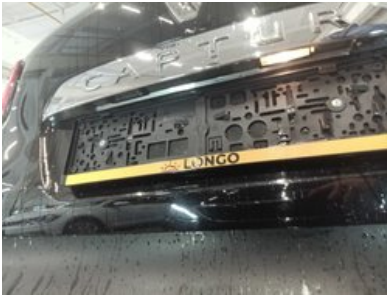
✔ **8. Lights:** Light Bulbs

- ✔ 1. Change Bulb for License Plate Lights
- ✔ 2. Charge Battery
- ✔ 3. Both Sides Brake Drums

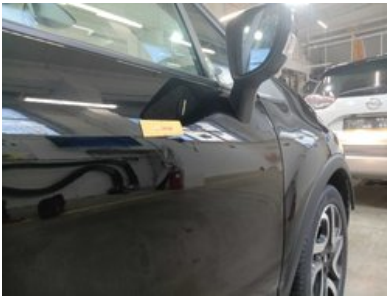
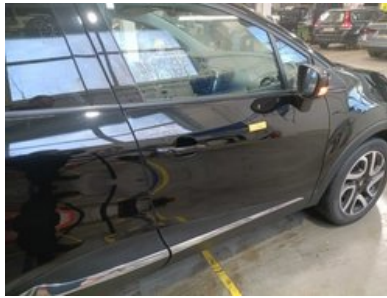
✔ **9. Side:** Left and Right Side - Visual Damage and Scratches

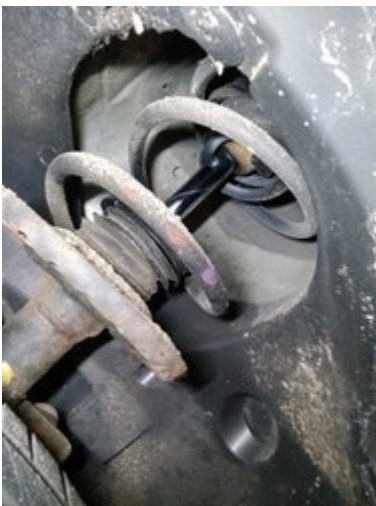
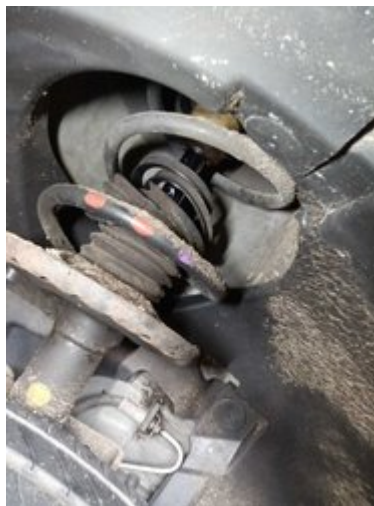
✔ **2. OTHER:** Shock Absorber Protection
