# Diagnosis report of 2016 PEUGEOT 2008 Active

# Preparation and repair report of 2016 PEUGEOT 2008 Active

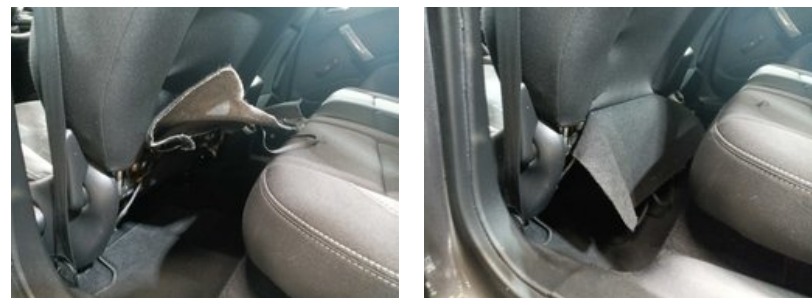
- ✔ 1. Seats: All Seats - Condition

- ✓ 1. Repair Seat

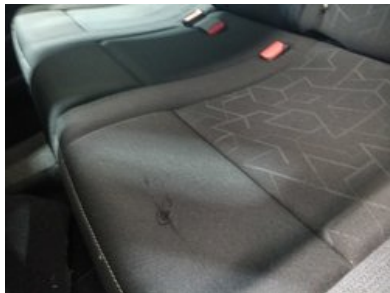
✓ **2. Seats:** All Seats - Condition

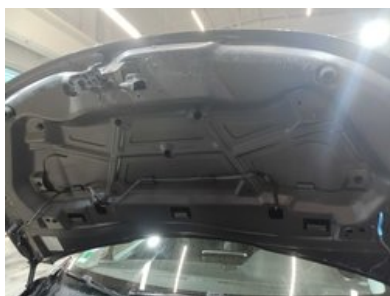
✓ **1. Front:** Hood Sound Insulation - Condition

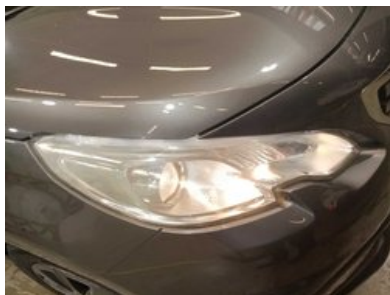
✓ **2. Other:** Additional Polishing Tasks

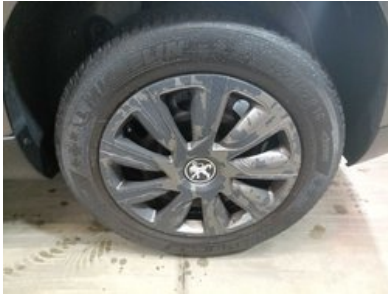
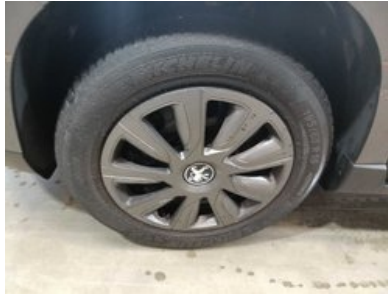
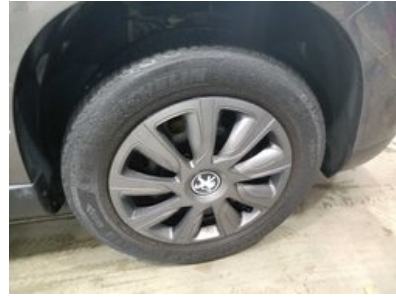
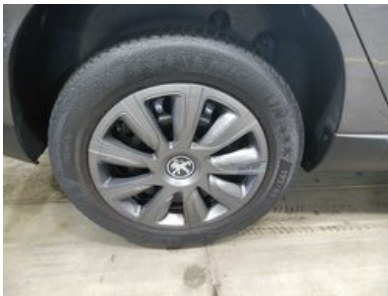
✓ **3. Side:** Wheels - Condition

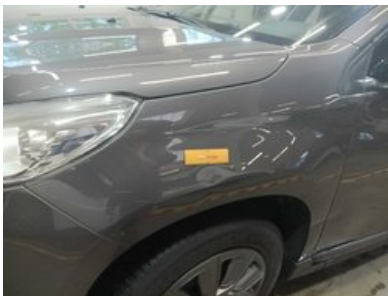
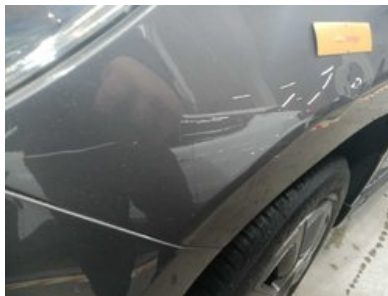
✓ **4. Side:** Left and Right Side - Visual Damage and Scratches
