# Diagnosis report of 2021 PEUGEOT 2008 GT

# Preparation and repair report of 2021 PEUGEOT 2008 GT

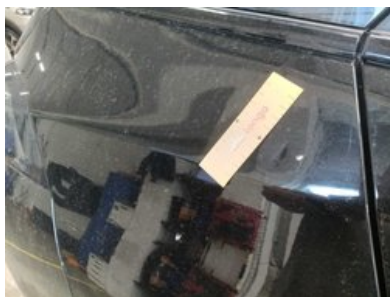
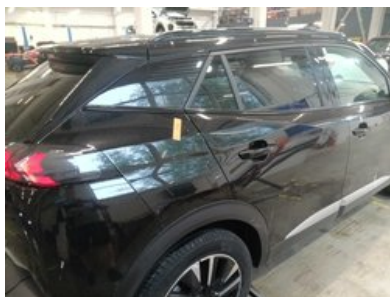
### ✓ 1. Side: Left and Right Side - Visual Damage and Scratches

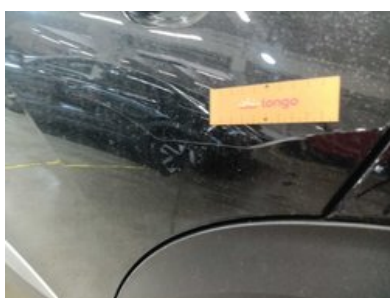
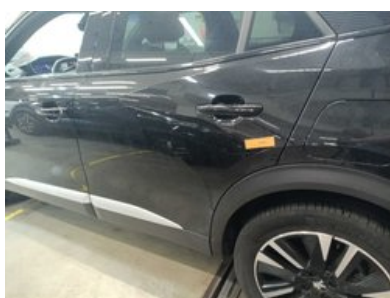
### ✓ 2. Side: Left and Right Side - Visual Damage and Scratches

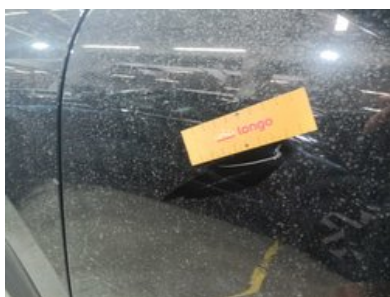
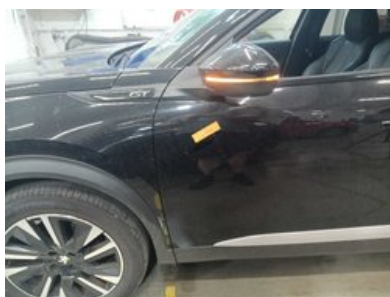
### ✓ 3. Side: Left and Right Side - Visual Damage and Scratches

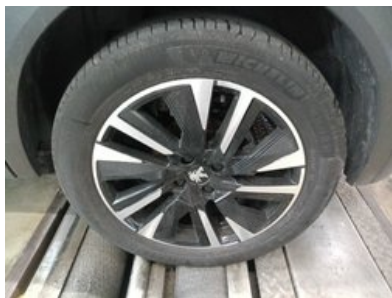
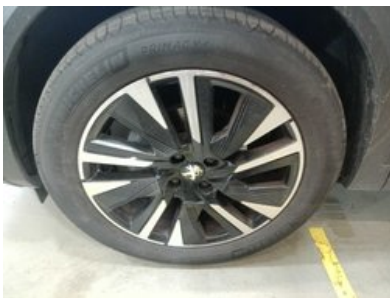
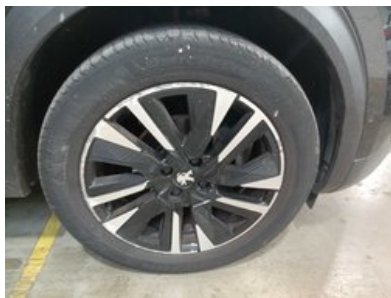
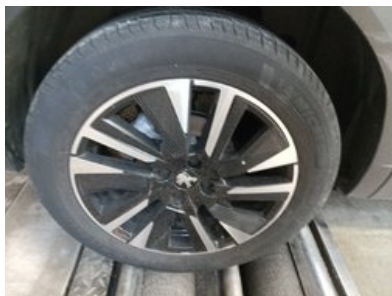
✓ **4. Side:** Wheels - Condition

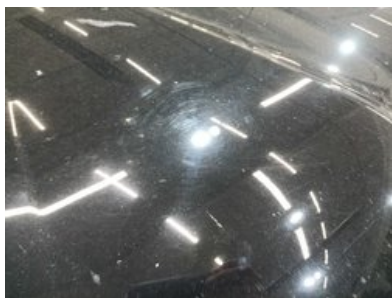
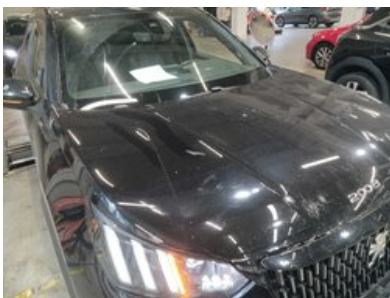
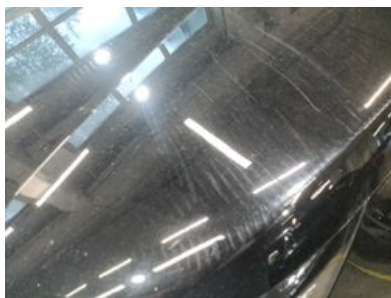
✓ **5. Other:** Additional Polishing Tasks

- ✓ 1. Body wet wash
- ✓ 2. Full interior deep clean using only hypoallergenic cleaning products
- ✓ 3. Post cleaning body polish

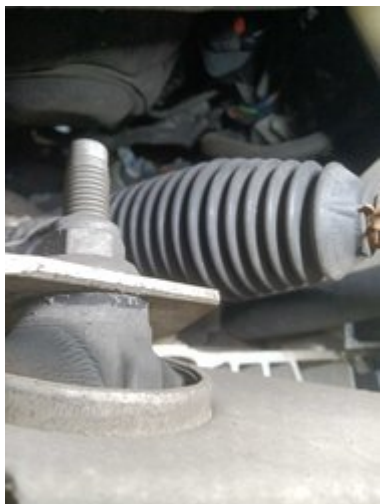
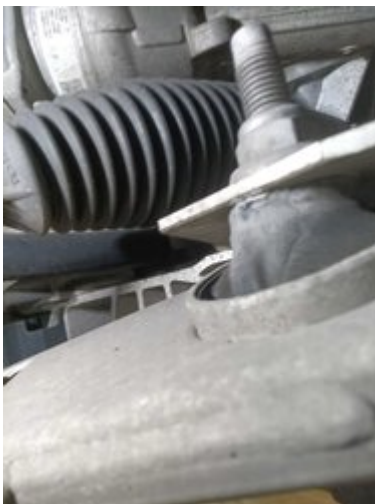
✓ **1. SUSPENSION:** Suspension Lower Arm Both

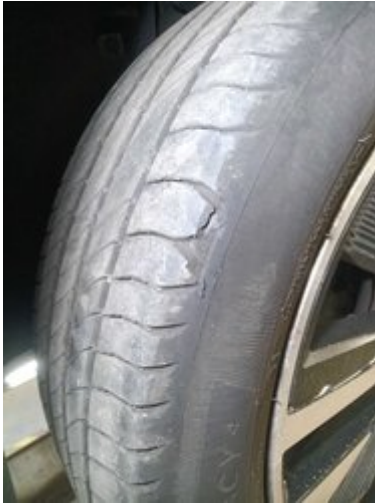
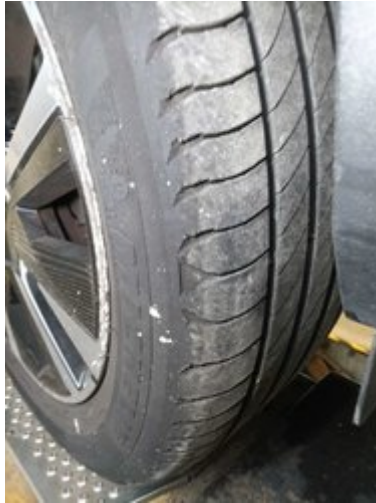
✓ **3. OTHER:** Change Tires

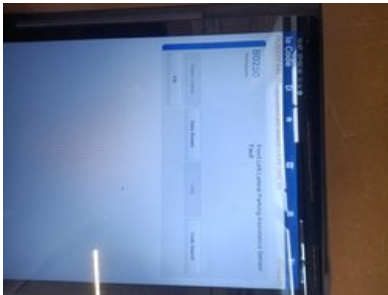
✓ **4. GENERAL ELECTRICS:** Parking Sensor Fault

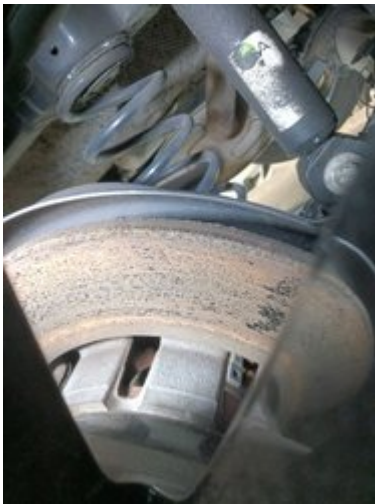
✓ **5. BRAKES:** Rear Brake Disc (Both)

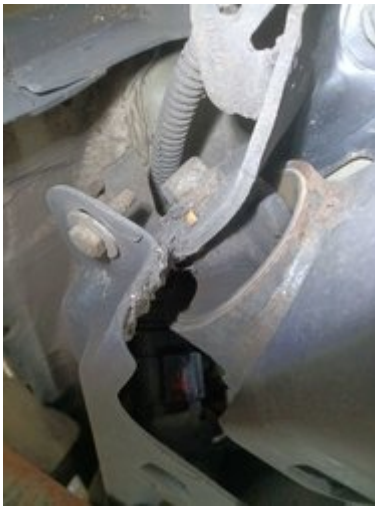
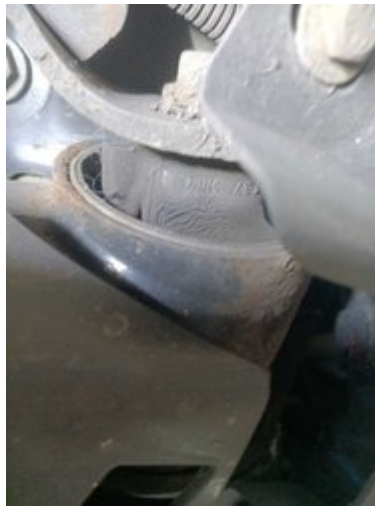
✓ **6. FINAL DRIVE, SHAFT & AXLES:** Bridge Silent Blocks

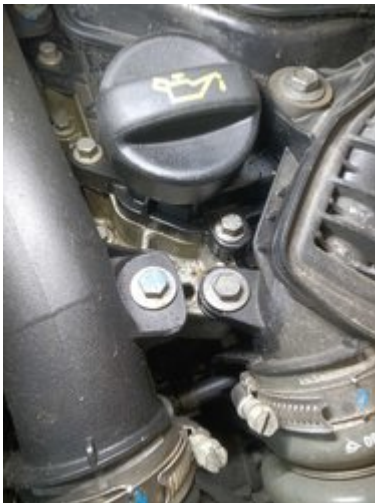
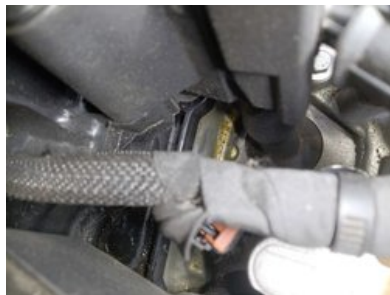
✓ **7. ENGINE:** Camshaft Cover

- ✓ 1. Camshaft Cover
- ✓ 2. Engine Oil & Filter Change

- 1. Oil Filter (OP540/1)
- 2. Oil Pan Gasket (834.823)
- 3. 5W30 Quartz Ineo RCP 208L 3.5L
- 4. Gasket Cylinder Head Cover (EL534720)
