Diagnosis report of 2015 MITSUBISHI OUTLANDER Instyle

Summary of diagnosed issues

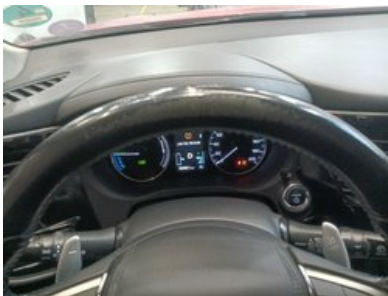
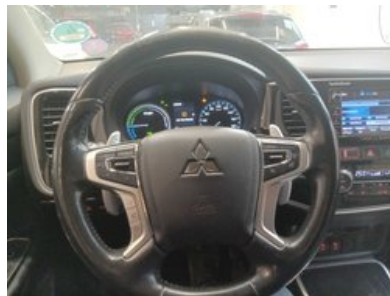
✔ **1. Front:** Steering Wheel - Condition

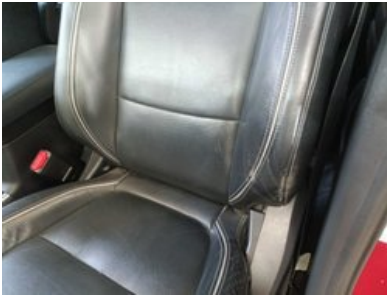
✔ **2. Seats:** All Seats - Condition

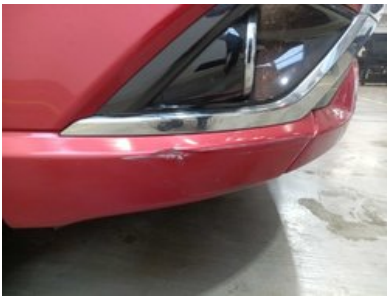
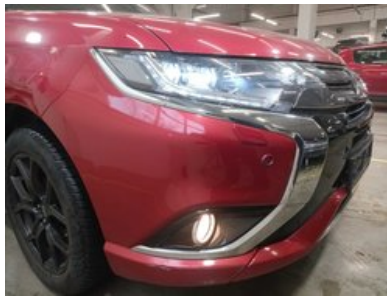
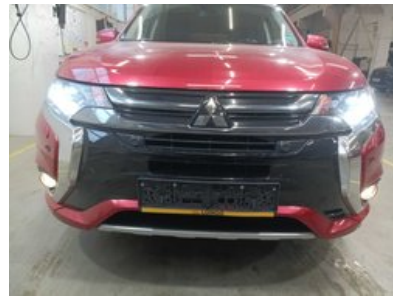
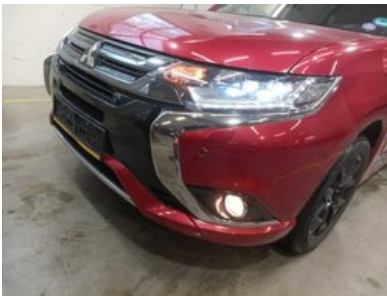
✔ **1. Front:** Front Bumper - Condition and Alignment

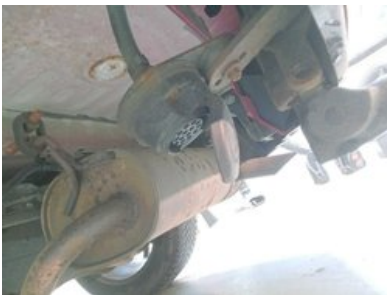
✔ **2. Rear:** Tow Hitch (Attachment, Removal Mechanism, External Light Connector, Connector Thickness)

- ✓ 1. Socket Cover

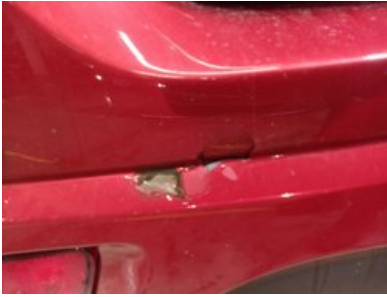
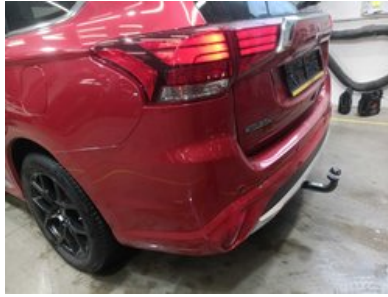
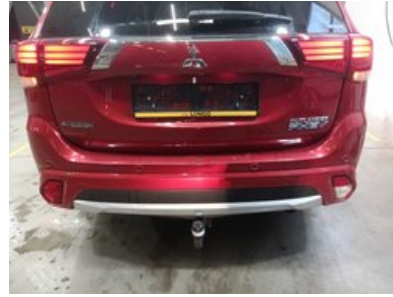
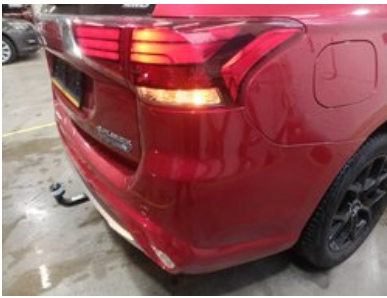
✓ **3. Rear:** Rear Bumper - Condition and Alignment

- ✓ 1. Paint Rear Bumper

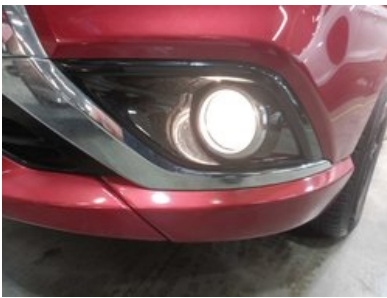
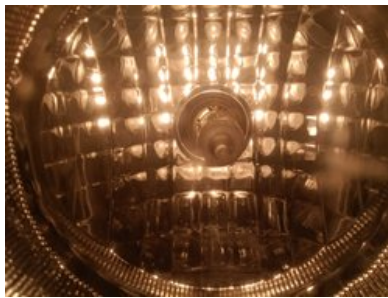
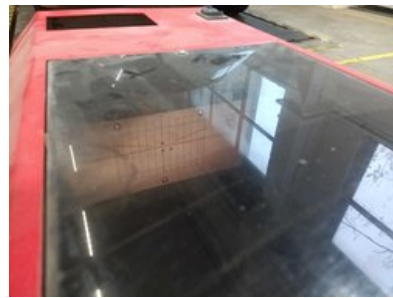
✓ **4. Lights:** Front Lights (City, Regular, Full Headlight, Fog, Indicator) - Basic Functioning, Damage, and Color

- ✓ 1. Change Front Fog Lights
