# Diagnosis report of 2021 OPEL MOKKA Business Elegance

During the comprehensive diagnosis conducted by Longo, 7 issues were identified in the vehicle.

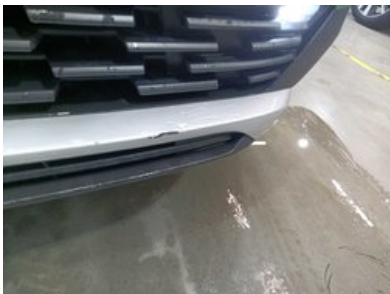
- ✔ **1. Front:** Front Bumper - Condition and Alignment

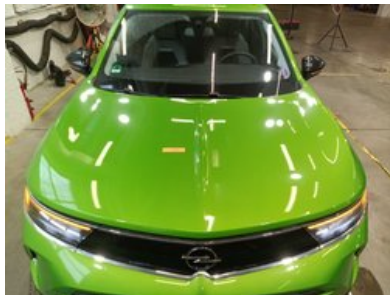
✓ **2. Front:** Hood - Visual Damage

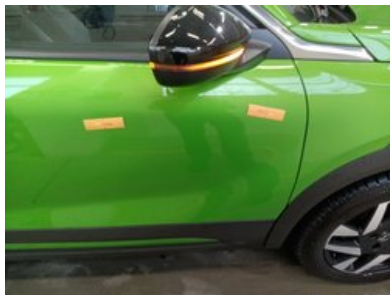
✓ **3. Side:** Left and Right Side - Visual Damage and Scratches

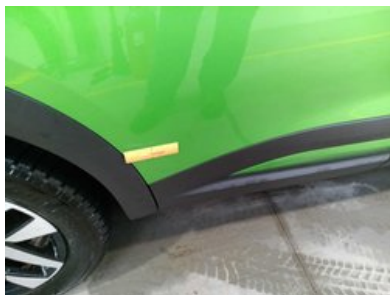
✓ **4. Side:** Left and Right Side - Visual Damage and Scratches

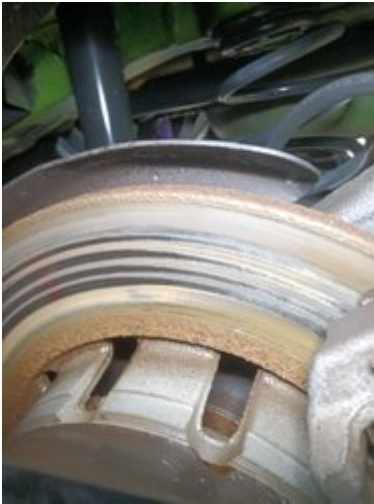
✓ **2. BRAKES:** Rear Brake Disc (Both)

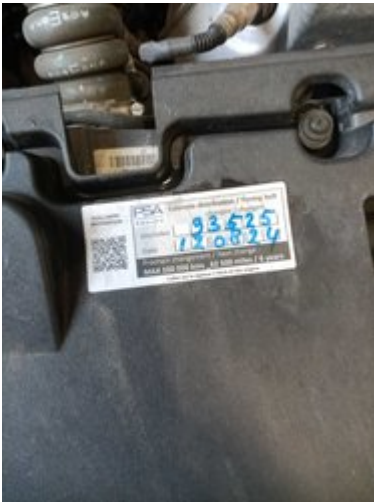
✓ **3. ENGINE:** Camshaft Drive Belt
