# Diagnosis report of 2022 PEUGEOT 2008 Allure

| VIN Code: VR3USHNSSNJ630019 | Fuel consumption: 5.90 l/100km |

During the comprehensive diagnosis conducted by Longo, 4 issues were identified in the vehicle.

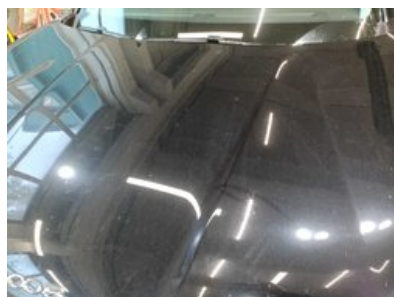
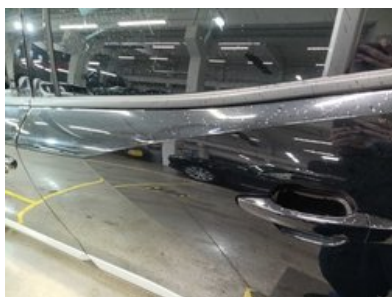
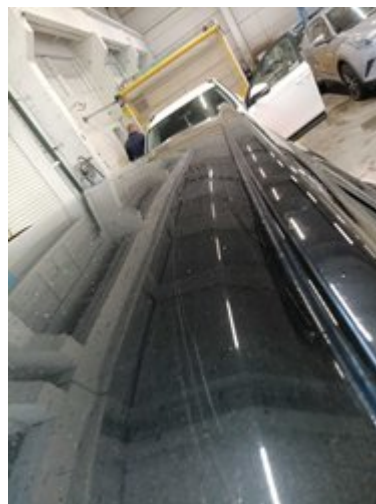
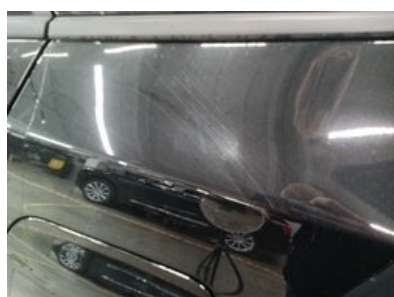
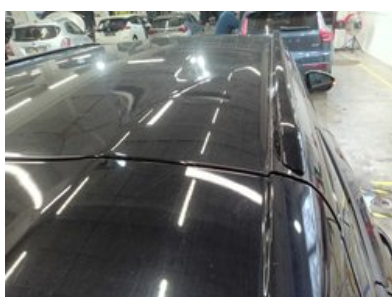
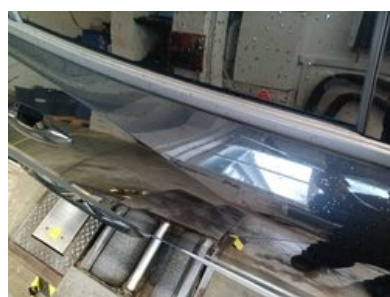
### ✓ 1. Other: Additional Polishing Tasks

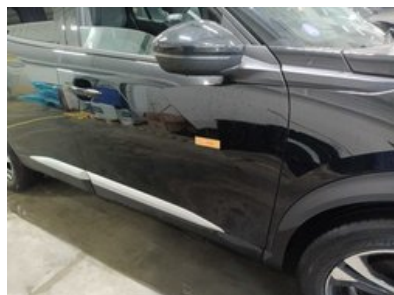
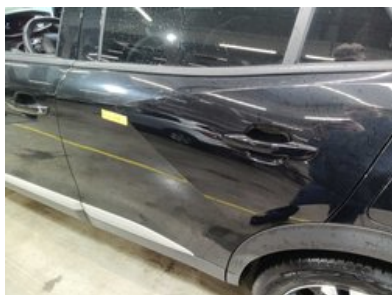
### ✓ 2. Side: Left and Right Side - Visual Damage and Scratches

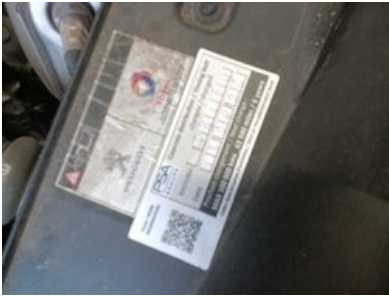
✓ **2. ENGINE:** Camshaft Drive Belt
