Diagnosis report of 2016 TOYOTA AVENSIS Aspiration

Preparation and repair report of 2016 TOYOTA AVENSIS Aspiration

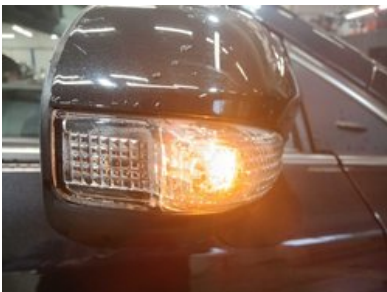
- ✔ **1. Lights:** Car Side Lights - Basic Functioning, Damage, and Color

- ✓ 1. Change Lights on Car Side

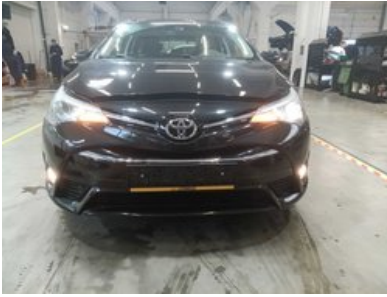
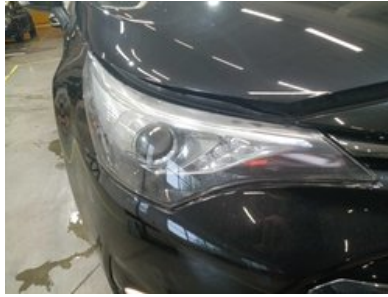
✔ **2. Lights:** Light Bulbs

- ✓ 1. Engine Oil
- ✓ 2. Tires
- ✓ 3. Front Brakes
- ✓ 4. Change Bulb for Headlights

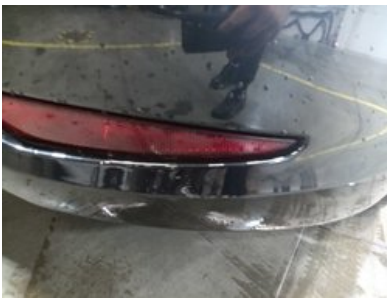
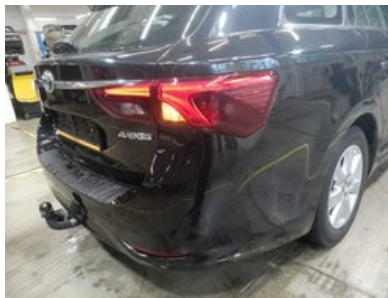
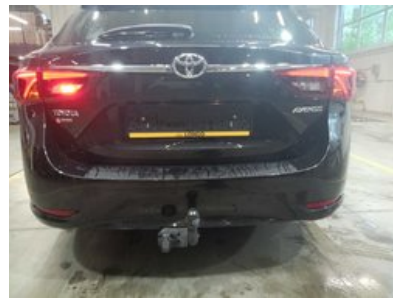
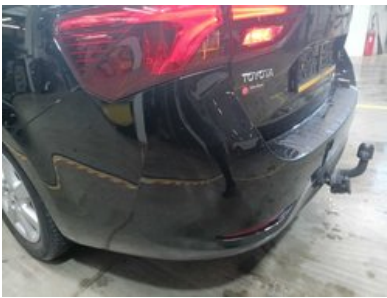
✔ **3. Rear:** Rear Bumper - Condition and Alignment
