# Diagnosis report of 2019 PEUGEOT 5008 Executive

During the comprehensive diagnosis conducted by Longo, 7 issues were identified in the vehicle.

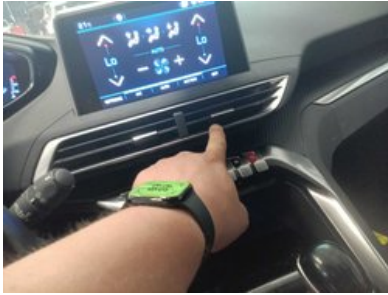
### ✓ 1. Front: Trims - Condition

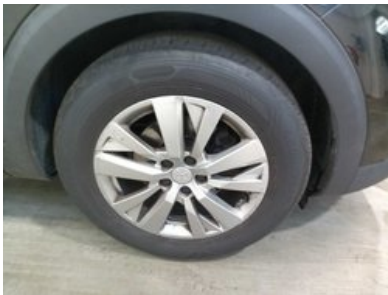
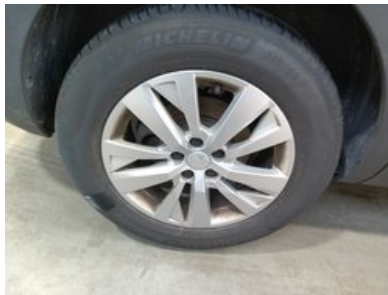
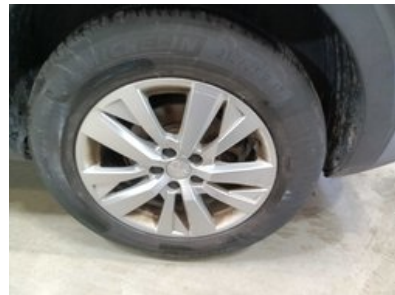
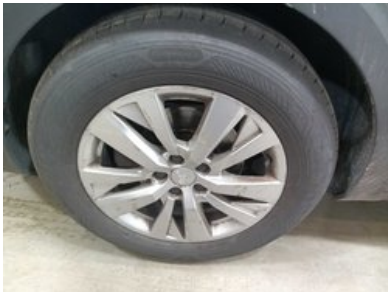
### ✓ 1. Side: Wheels - Condition

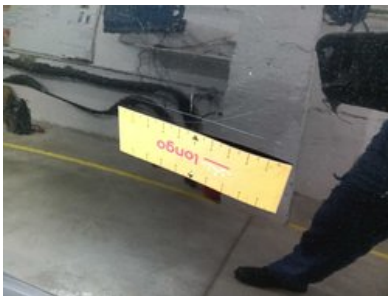
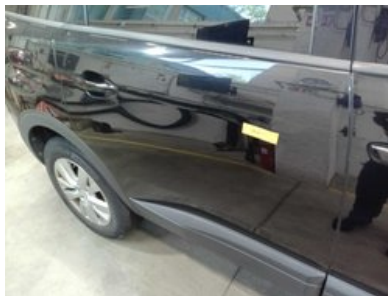
### ✓ 2. Side: Left and Right Side - Visual Damage and Scratches

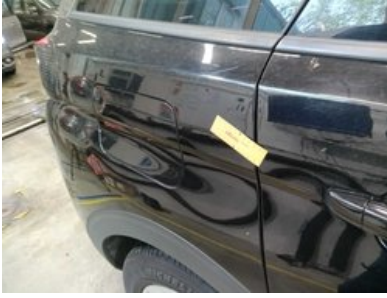
✓ **3. Side:** Left and Right Side - Visual Damage and Scratches

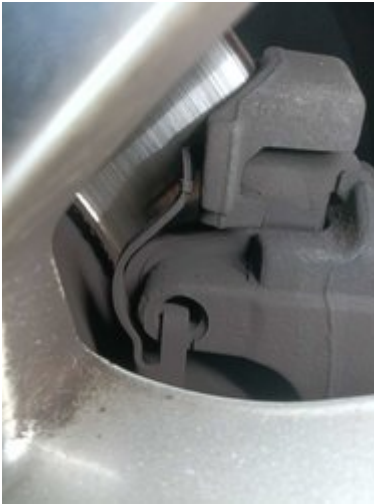
✓ **2. BRAKES:** Front Brake Pads (All) - Wheels Removed

- ✓ 1. Front Brake Pads (All) — Wheels Removed
- ✓ 2. Engine Oil & Filter Change

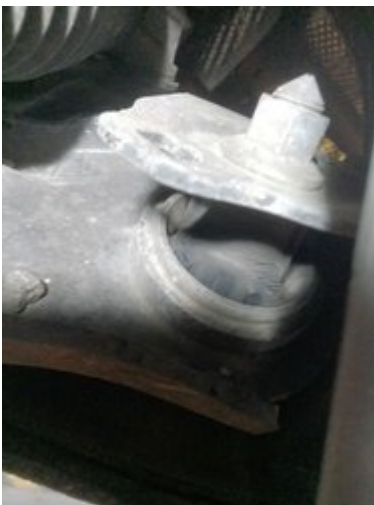
✓ **3. SUSPENSION:** Suspension Lower Arm Both
