# Diagnosis report of 2015 MITSUBISHI OUTLANDER AWD Bu

Diagnosis report of

2015 MITSUBISHI OUTLANDER AWD Bu

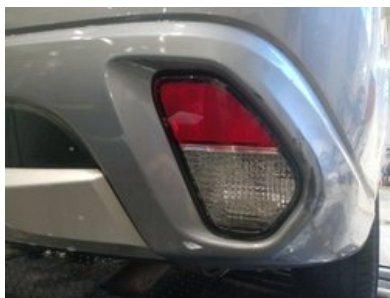
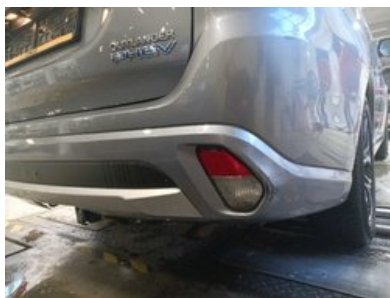
✓ **10. Lights:** Rear Lights (Brake, Fog, Indicator) - Basic Functioning, Damage, and Color

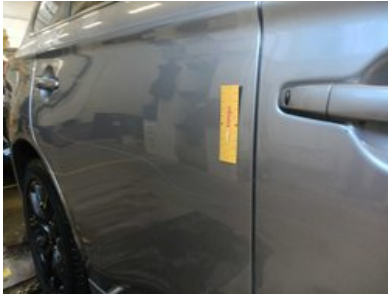
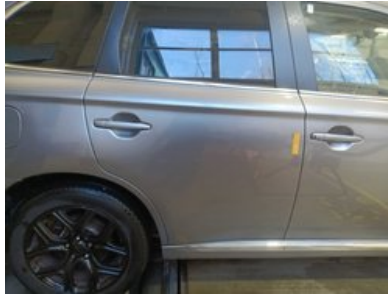
✓ **11. Side:** Left and Right Side - Visual Damage and Scratches

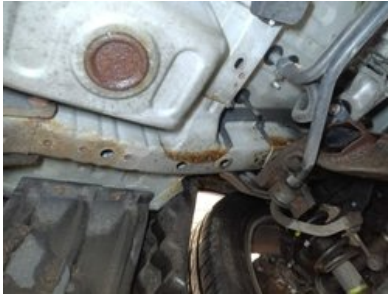
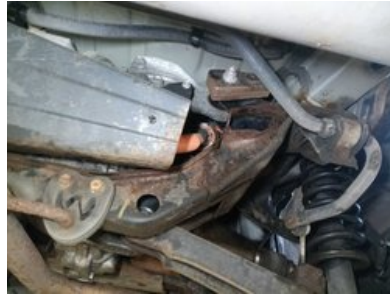
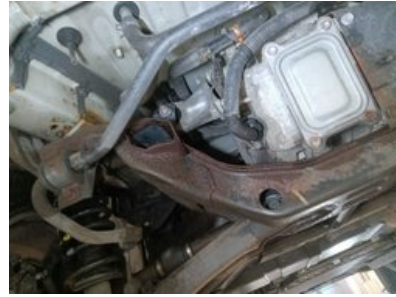
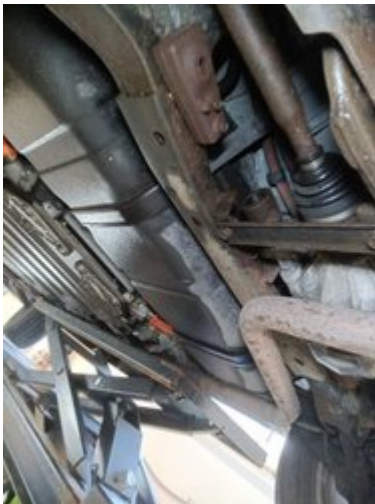
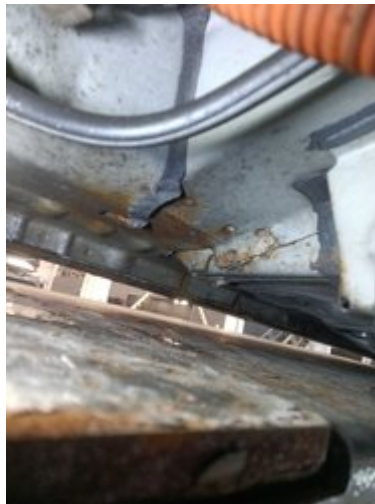
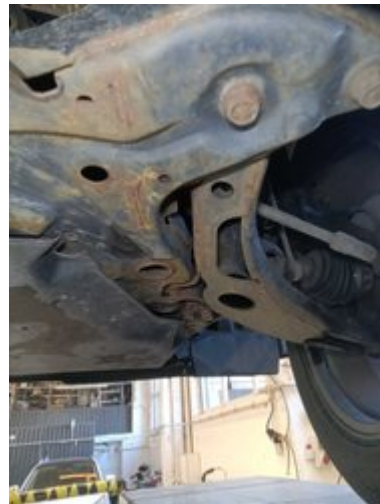
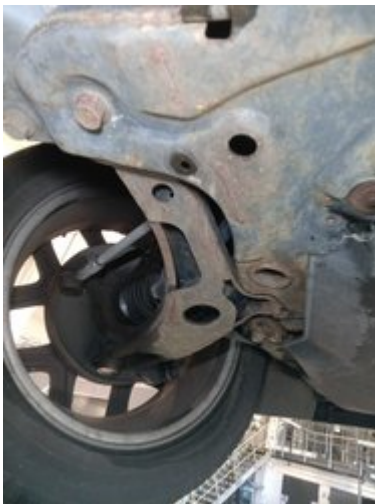
✓ 7. BODY - REAR SECTION: Corrosion
