# Diagnosis report of 2015 RENAULT CAPTUR Helly Hansen

# Preparation and repair report of 2015 RENAULT CAPTUR Helly Hansen

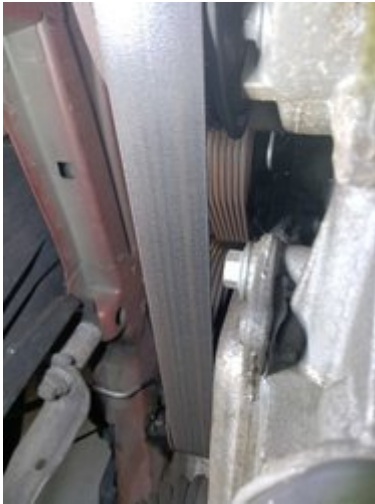
✓ **7. ENGINE:** Auxiliary Drive Belt
