# Diagnosis report of 2016 CITROEN C4 PICASSO Business

Mileage on completion date: 242 918 km

During the comprehensive diagnosis conducted by Longo, 21 issues were identified in the vehicle.

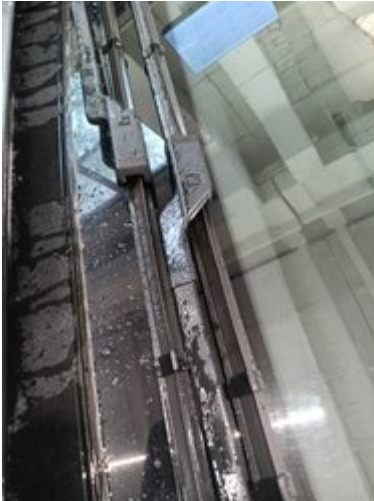
- ✓ **1. Front:** Window Wiper Rubber and Handle (Front and Rear) - Condition

- ✓ 1. Engine Oil & Filter Change
- ✓ 2. Change Front Wiper (Mechanical)
- ✓ 3. Shock Absorbers (Pair)

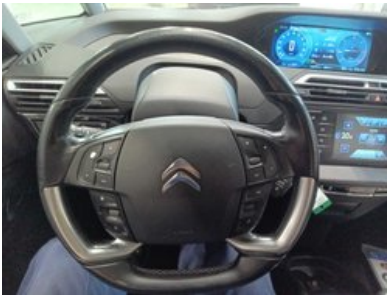
- 
- ✓ **2. Front:** Steering Wheel - Condition

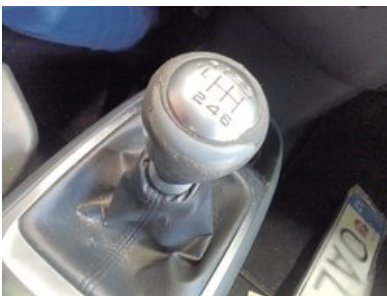
- 
- ✓ **3. Inside:** Gear Shift Boot and Gear Shift Knob - Condition

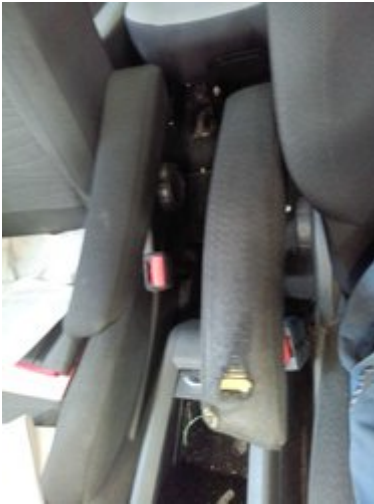
✓ **4. Inside:** Armrest - Operation and Condition

- ✓ 1. Headlamp Alignment
- ✓ 2. Change Bumper Grills
- ✓ 3. Change Armrest

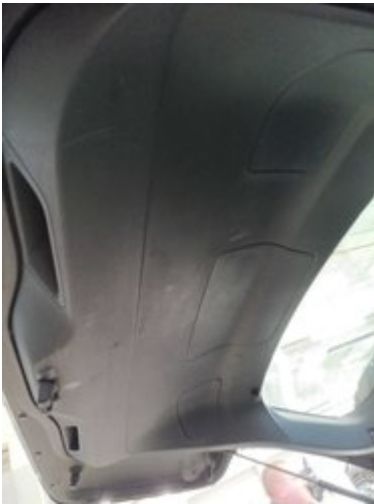
✓ **5. Inside:** Trims - Condition

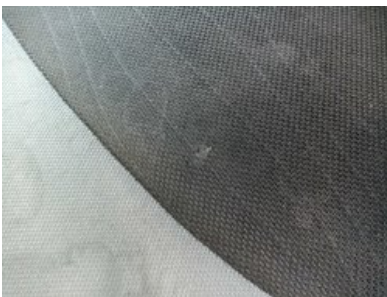
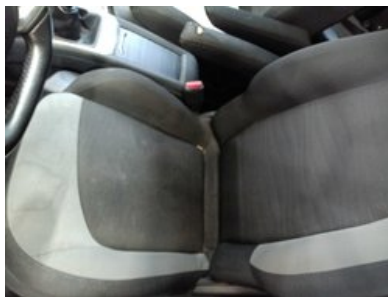
✓ **6. Seats:** All Seats - Condition

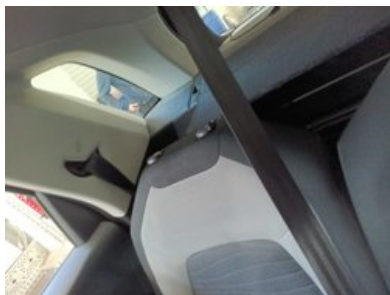
✓ **7. Seats:** All Seats - Condition

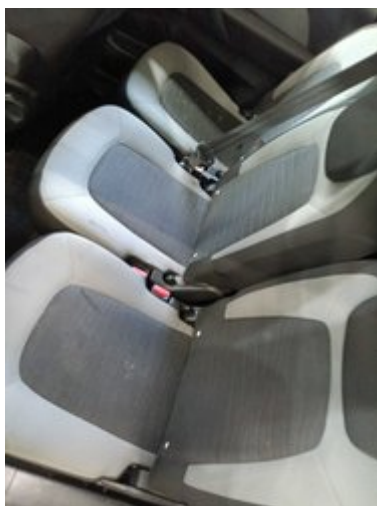
✓ **8. Seats:** All Seats - Condition

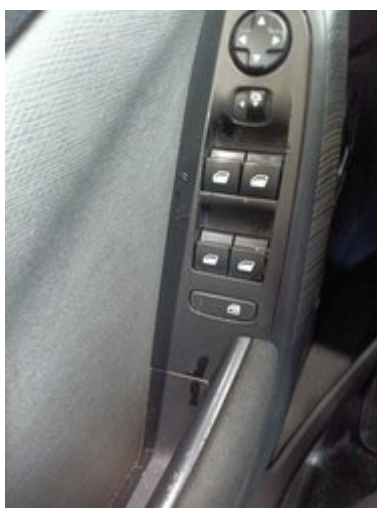
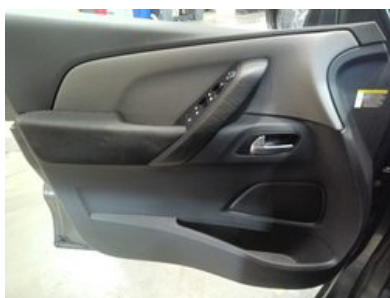
✓ **9. Doors:** Trims - Condition

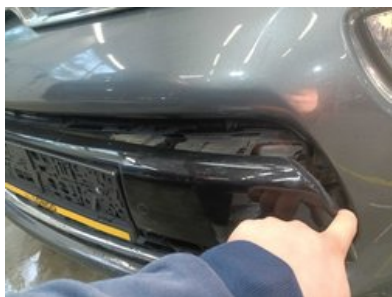
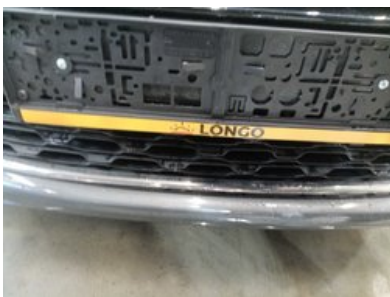
### ✔ 1. Front: Front Grille - Condition

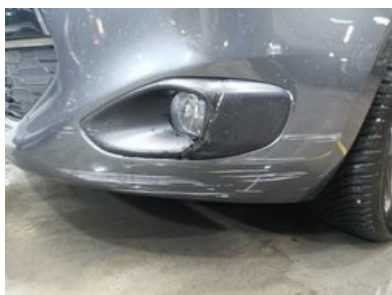
### ✔ 3. Front: Front Bumper - Condition and Alignment

- ✓ 1. Paint Front Bumper

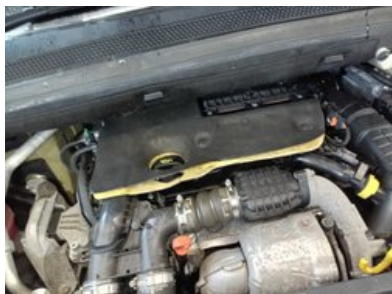
### ✔ 4. Front: Engine Cover Integrity

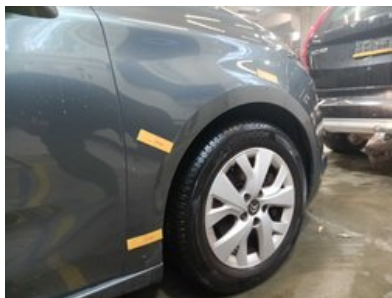
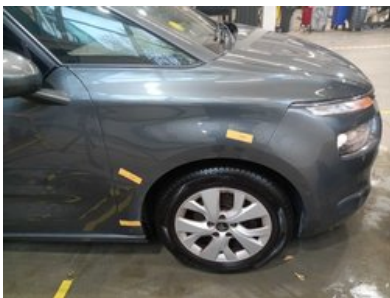
✓ **5. Side:** Left and Right Side - Visual Damage and Scratches

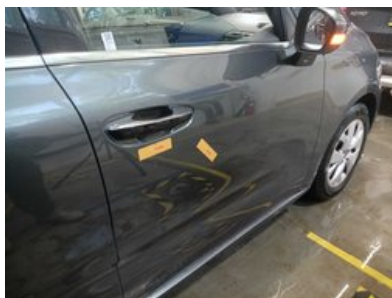
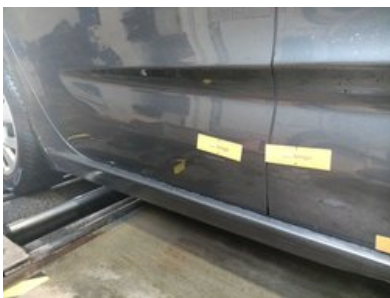
✓ **6. Side:** Left and Right Side - Visual Damage and Scratches

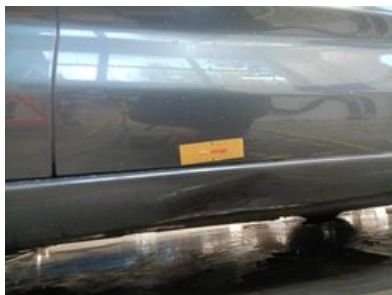
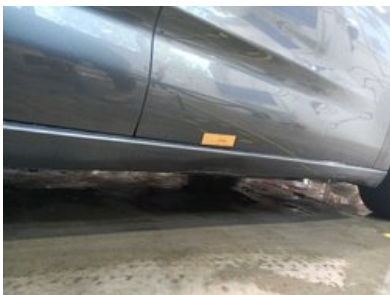
✓ **7. Side:** Left and Right Side - Visual Damage and Scratches

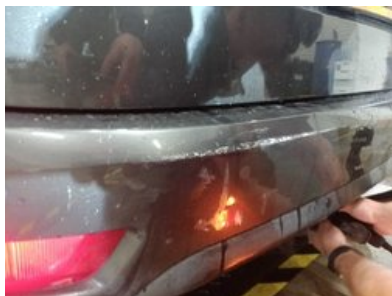
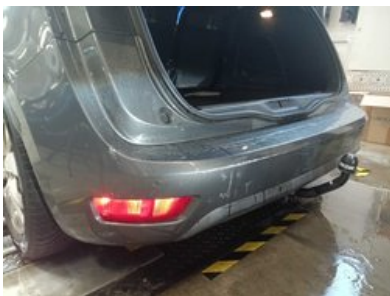
✓ **8. Rear:** Rear Bumper - Condition and Alignment

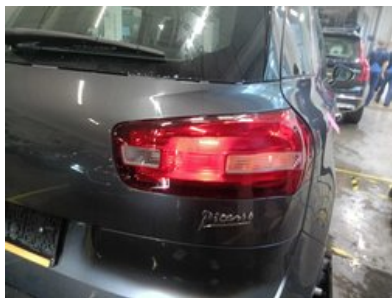
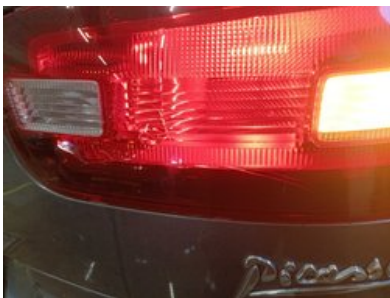
- ✔ **9. Lights:** Rear Lights (Brake, Fog, Indicator) - Basic Functioning, Damage, and Color

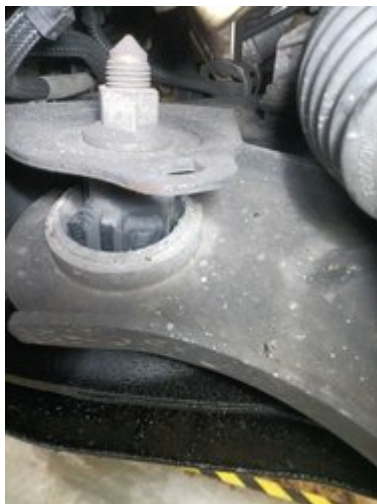
- ✔ **1. OTHER:** Engine Oil & Filter Change
- ✔ **2. SUSPENSION:** Suspension Lower Arm Bushes Both
