# Diagnosis report of 2018 TOYOTA C-HR

# Preparation and repair report of 2018 TOYOTA C-HR

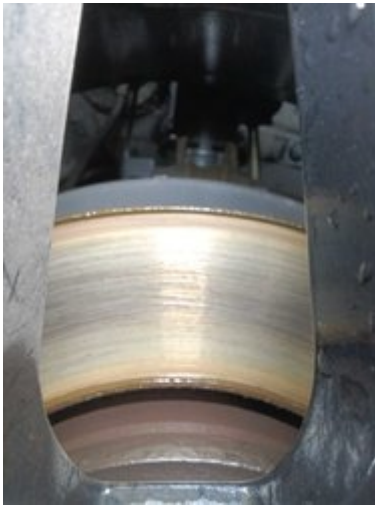
✓ **1. OTHER:** Engine Oil & Filter Change

✓ **2. BRAKES:** Front Brake Discs Both

- ✓ 1. Engine Oil & Filter Change
